Remedial measures to facilitate the construction of stable bridge approach fills: A case study

V. Diyaljee

ABSTRACT: The proposed construction of a north-south log haul road from Secondary Road (SR 686) to North of the Little Cadotte River was to form part of the roadway infrastructure requirements for the proposed Daishowa Pulp Mill in Peace River, Alberta. This paper deals primarily with stability issues associated with the Cadotte River crossing. After the construction of 5 m of the proposed 20 m high bridge approach fill in November 1988 deep seated movements were noted at a depth of 22 m below the original ground from monitoring of slope indicators on the north approach. Remedial measures consisting of wick drains, stone columns, flatter approach fill head and sideslopes, and interceptor drains were then implemented. However, as a result of the movements that were taking place at depth it was decided to abandon the proposed 3-span bridge and construct a one-span Bailey bridge. This paper addresses the geotechnical investigation, evaluation and assessment of the bridge approach fills and the remedial measures implemented to minimize the movements.

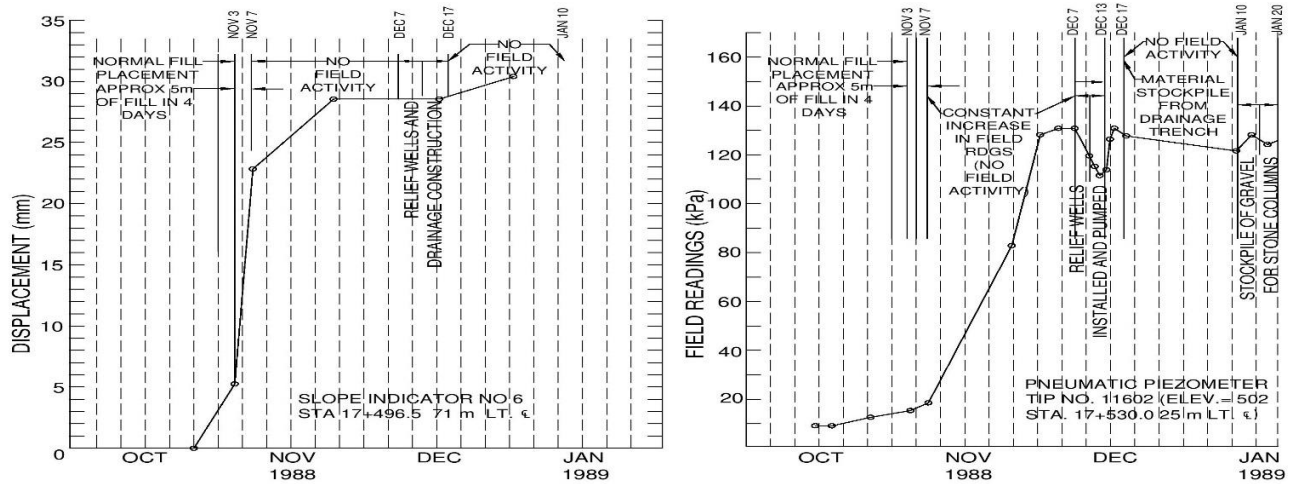
Figure 3. Porewater pressures and displacements versus time

Piezometer readings showed substantial increases in porewater pressure than previously recorded during fill construction. On the basis of these field observations it was concluded that deep seated movements were indeed occurring at the site.

2200 gallons of water were pumped. During this period porewater pressures were monitored and from Figure 3 it can be seen that a drop of 27 kPa in piezometric pressure occurred. This observation along with the observation of large underground flow during testpitting opposite SI 6 outside of the fill slope led to the idea of installation of trench drains to aid in removal of trapped or seepage water.

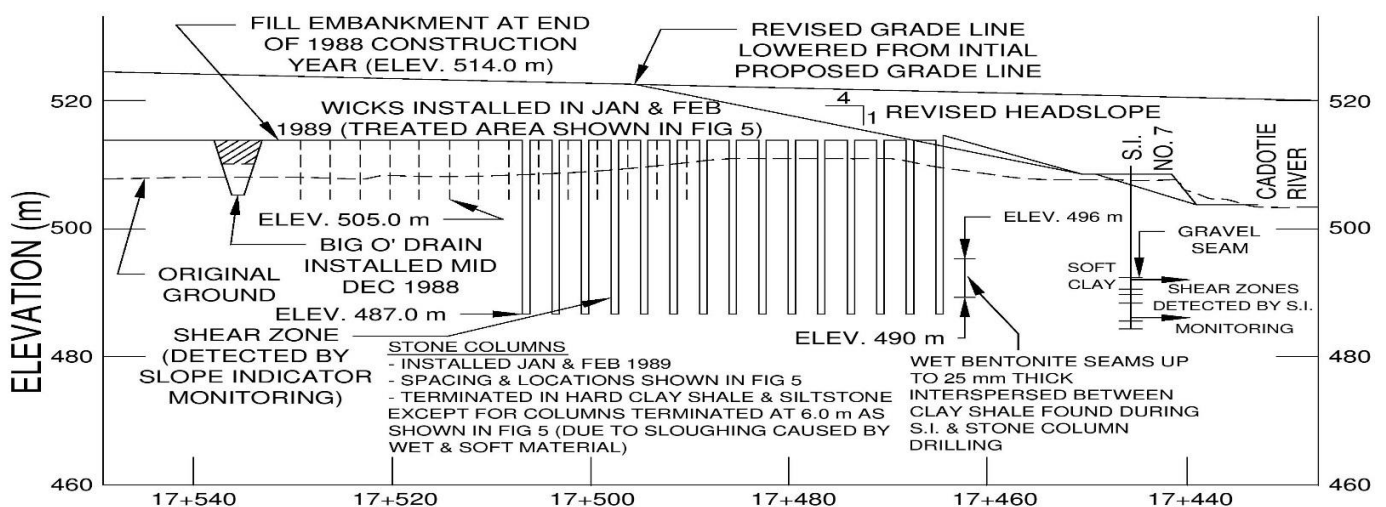
Figure 4. Cross section at North Approach Fill showing weak zones

This observation added credence to the belief that this site had undergone prior movements. The folding led to the belief that glacial thrusting, for lack of a better explanation had occurred. The presence of bentonite near the surface was also of valuable significance since it confirmed the laboratory visual observations. As well, the movements recorded by the slope indicators were becoming more reasonable to understand. In short there was now more evidence from field observations to conclude that this site presented some very complex ground conditions. A number of probe testholes were subsequently done to determine whether bentonitic zones could be defined and also to define the wet areas and seepage zones. As shown in Figure 4 soft wet zones about 1 m in thickness were observed to be sandwiched between very intact and competent shale material. At first it was felt that poor drilling methods might have caused this to occur but careful drilling and scrutiny of cores showed that these zones resulted from softening due to shearing action. The presheared zone was very soft with pocket penetrometer readings varying from 0.25 to 0.5 Tons/ft². Also shown in Figure 4 is the depth range at which bentonite was observed.

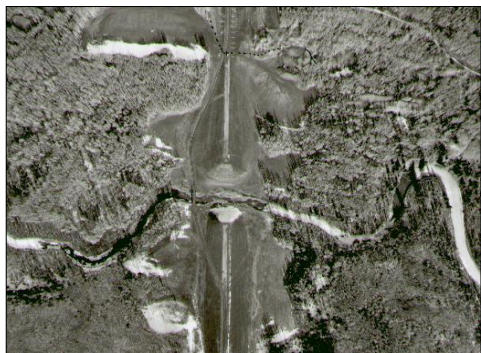
Figure 6. Aerial Photo Showing Bridge

The implementation of the remedial measures did not fully arrest the ground movements. As a result, the approach fill slope on the north headslope was modified from 2.5:1 to 4:1 with side slopes of 4:1. On the south side the initial design of the approach fill slopes of 2.5:1 headslope and 3:1 sideslopes were maintained. In addition, as a result of the movements it was decided to utilize a Bailey Bridge at the crossing location. This bridge is shown in Fig 6. Monitoring of

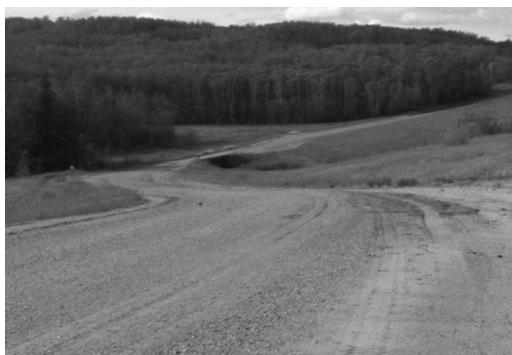
Figure 7. Site photo taken in August 2013

this bridge by survey hubs between June 2 and October 11, 1990 showed initial movements of 7 mm per day to July 4 and thereafter 1.2 mm per day. A recent site observation in August 2013 (Figure 7) shows that the bridge is still serviceable after 23 years.
