A4 motorway operation in the area of linear discontinuous surface deformations

M. Grygierek

J. Kawalec

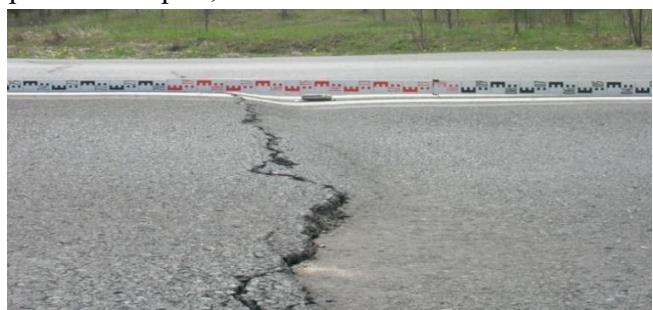
Significantly more complicated situation occurs in the case of discontinuous deformations. In such cases the ground surface continuity is broken and sudden changes in the ground profile originate, including the roadway (Pic. 1). Deformations are frequently accompanied by discontinuities of surface nature (Pic. 4). The case described in the paper is related to the motorway, on which linear discontinuous deformations have been appearing since the beginning of its use and which originated from the past mining operations and from impacts of the current mining. For the analysed motorway section the consecutive events have been presented chronologically, related to: the historical and current

Pic. 2-1. A linear-type discontinuous surface deformation (Grygierek 2010)

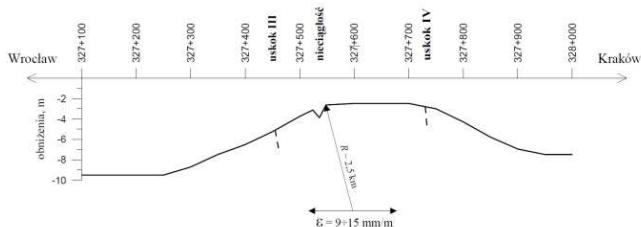
The past mining operations in the analysed area were carried out from 1947 in 15 seams, most frequently with caving. The mining depth ranged from 200 m to 900 m. The mining was concentrated west and east of existing there fault zones III and IV. The result of mining carried out this way was a large difference in subsidence, because in the section connecting the fault zones the subsidences were approx. 1.5 m and west and east of the fault zones they reached 10 m (Fig. 1). Papers (Kotyrba et al 2009) (Kotyrba et al 2015) (Kotyrba A. 2006) present a detailed analysis of mining conditions.

Figure 2-1. Surface subsidence in motorway axis, in the area of fault III and IV zone before the construction start, caused by the past mining operations (Kotyrba et al 2009). uskok = fault; obniżenia = subsidence

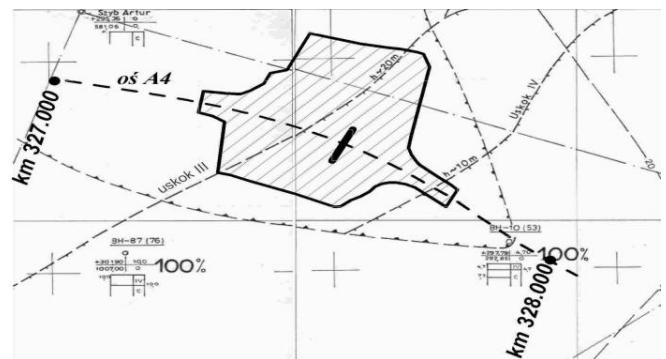
in the MOP area there are two faults marked as III and IV, with throws of 20 m and 10 m, respectively.

Fig. 3-2. The course of fault III and IV in relation to MOP and A4 motorway (Kotyrba & Kowalski 2009)

In fault zones (fault III and IV) in a section approx. 100 m long an additional reinforcement was applied in the form of a geomattress 50 cm thick, with inserts of uniaxial polypropylene geogrids of high short-term tensile strength at the bottom and at the top. The geomattress was built-in on a layer of so-called "sand pad" and was situated around 2 m deep from the road formation line.

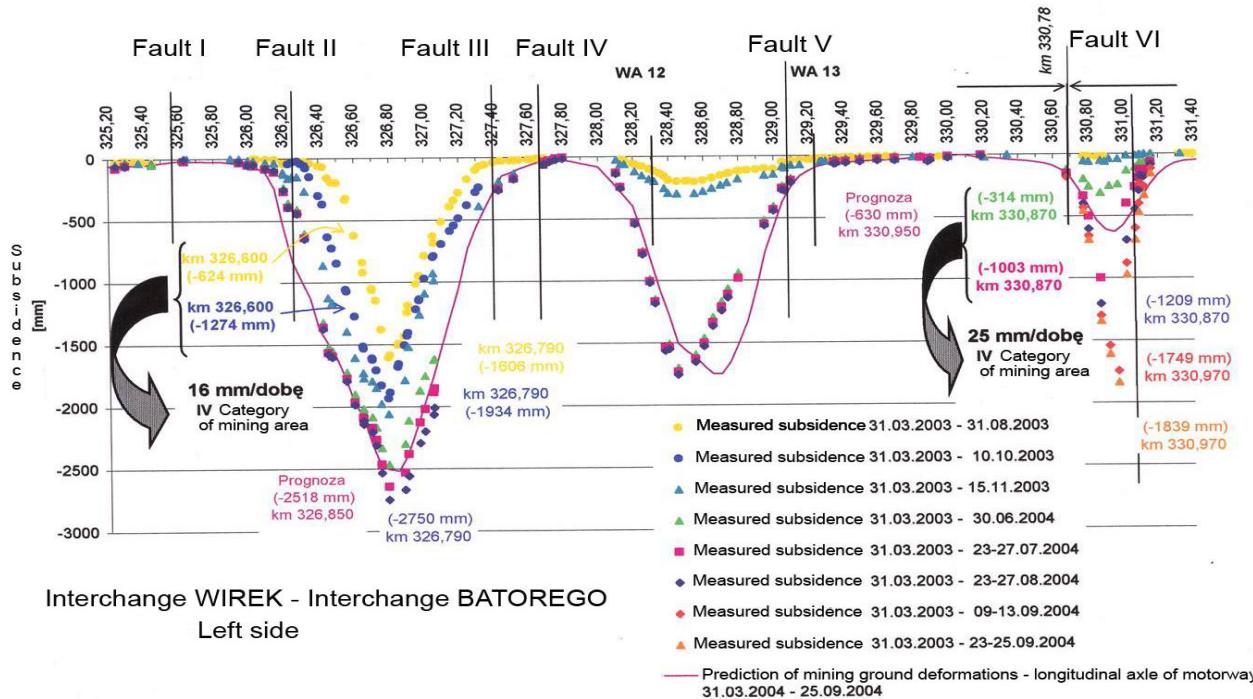
Fig. 6-3. Subsidence of A4 motorway right-of-way measured in the period Mar 2003 - Nov 2004 (Chlipalski et al 2010)

During the carried out construction works the intensity of ground surface mining deformations, including the motorway right-of-way, was extremely high, nearly along the entire contract section (6 km). It is worth noticing that the greatest subsidence exceeded the value of 2.5 m (between 2002 and 2004).

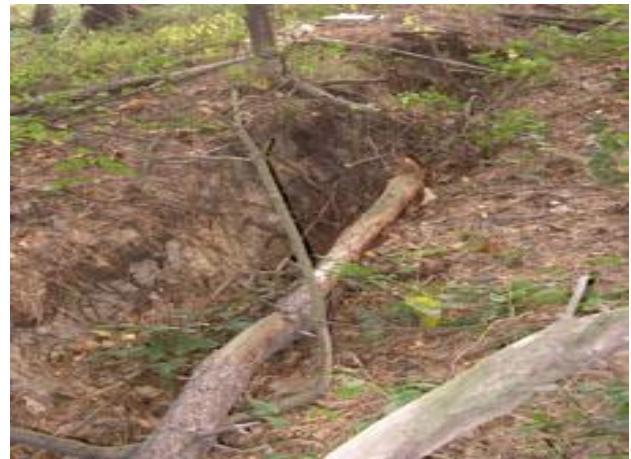
Pic. 4-2. Survey of the next phase of discontinuous deformations development - 16 October 2003 (Strycharz B. et al 2005)

Permanently superimposing tensions in the rock mass resulted in the origination in the fault zone of so-called linear discontinuous surface deformations, which first symptoms were visible as early as during the motorway construction in the forest area adjacent to the motorway right-of-way.

Till the construction works completion (2004), the discontinuous deformations emerged only in the ground strip adjacent to the motorway right side. No

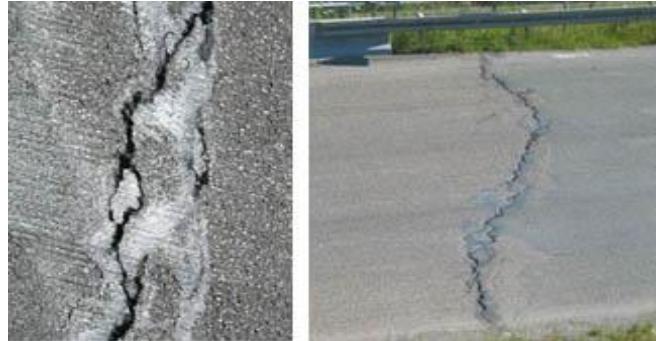
The next discontinuities in the analysed area were recorded in May 2005, that is less than a year from the motorway commissioning. Deformations occurred on both roadways (Pic. 3) and in the area immediately adjacent to the roadway, including the area of MOP still under construction.

Pic. 6-3. Pavement damage observed in May 2005 (Kowalski 2015).

The course of those deformations did not coincide with the course of earlier faults III and IV. Unfortunately, deformations occurred on the motorway section not protected against such mining impacts. On the roadways the deformations caused unevenness in the form of corrugations, accompanied by cracks of significant opening (fissures). The cracks were going in the NE direction. Corrugations that occurred on roadways were cold milled and the cracks sealed; afterwards a repair design preparation started. An unfavourable geological structure of the rock mass, the existence of faults III and IV zone in the area where no mining operations were carried out, the Carboniferous strata outcrops on the surface, the lack of younger strata overburden, as well as the past mining before the motorway construction west and east of the fault zone, which resulted in the origination of a zone with accumulations of horizontal tensile deformations, were considered causes of deformations observed in the motorway right-of-way at that time.

The mining operations carried out during the motorway construction resulted in increments of horizontal deformations on the ground surface of around 1.8mm/m, including 0.6 mm/m after the motorway construction. Also we should not forget the total values of deformations from the period before the motorway construction (1947 – 2003), when the deformations were estimated at +9 mm/m to +21.0 mm/m

The geophysical - electric resistance studies performed at that time allowed finding the existence of open cracks not filled with the soil at deeper parts,

Because of the originated deformations, the pavement was repaired in a section approx. 20 m long - removing the pavement layers to the floor of broken aggregate subgrade 0/31.5 (bottom subgrade layer). Finally, in 2007 the following arrangement of layers was executed:

- 5 cm, wearing course SMA 0/12.8,
- 10cm, binding course BAWMS 0/25,
- 10cm, base course BAWMS 0/31.5,
- 22cm, aggregate base course 0/31.5

Flat biaxial geomesh of welded strips 40/40 (PP)

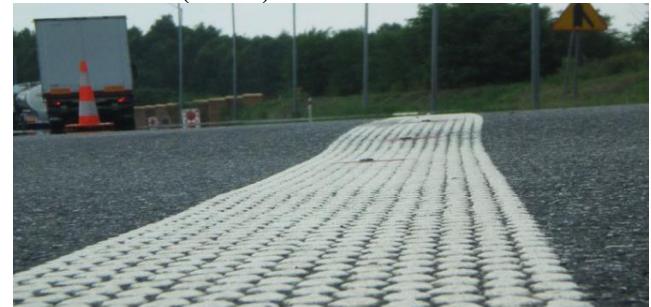
The pavement repair described in section 4.1 was implemented in 2007. Shortly after in the area of discontinuity existing between faults III and IV the discontinuous deformations opened again. If for the first time (2004) the deformations occurred in a strip of around 20 m passing skew to the road axis, i.e. at an angle of approx. 66° (SW-NE), then in the next years the deformations concentrated in a very narrow trail, i.e. in the form of a step passing in the central part of 20 m strip and with a course consistent with the direction of previous damage.

The cohesion of MMA (mix asphalt) layers was seldom disturbed due to a relatively slow deformation build-up. A small deformation increase with time and the asphalt mix flexibility (viscous properties) in the period of higher temperatures existence allowed the asphalt mix to adapt to the deforming subsoil on a current basis (Pic. 4).

Pic. 7-4. Deformation of the northern roadway of A4 motorway - 5 August 2010 (Grygierek et al. 2015)

In the analysed period the reproducing step caused restrictions in the traffic due to a limited speed and unevenness. This situation forced to make the next repairs, which took place in 2011 and in 2014. Both

repairs consisted only in the profiling of the longitudinal pavement profile, i.e. in cold milling and building in a levelling and the wearing course.

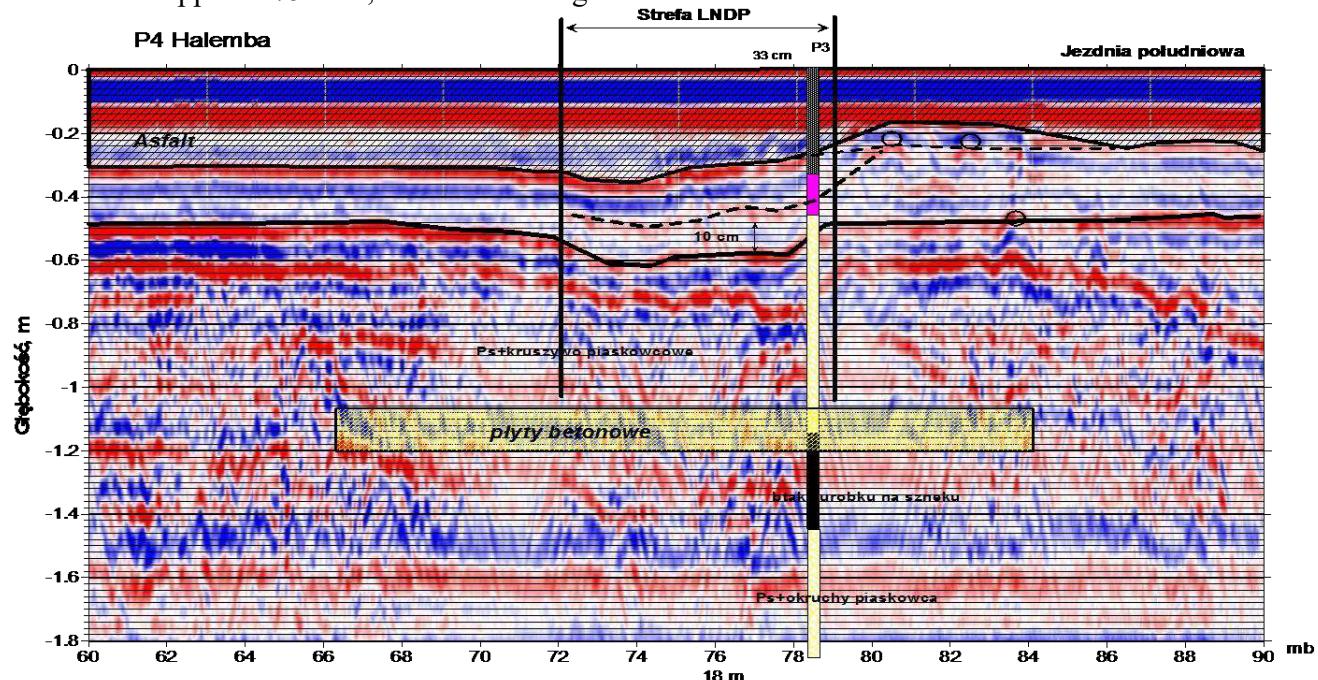
Fig. 7-4. Deformations of the embankment layers down to approx. 1.0 m. (Kotyrba et al 2015) (Grygierek et al 2015) GŁębokość = Depth; Strefa = Zone; Jezdnia południowa = Southern roadway; kruszywo piaskowcowe = sandstone aggregate; płyty betonowe = concrete slabs; okruchy piaskowca = sandstone chips.

cracks. Even more, based on georadar surveys it was found that the biggest anomalies, including profile deformations, existed in the embankment layers, i.e. situated at a depth of approx. 1.20 m between the native subsoil and the mineral-asphalt pavement.

This observation was one of arguments, based on which an alternative solution was suggested, which *inter alia* consisted building-in a reinforced concrete - pin jointed slab at a depth, at which the deformations disappear (Fig. 4). Attention was also paid to the subsidence, on the radarogramme, in the area of actual fault III outcrop. In fault III area, during the surveying work, a mild pavement deformation was

Finally, the pavement subsoil structure consisting of a package of a few geogrid geomattresses featuring a very high long-term strength, a slip layer and other aggregate layers was made as a protection, in total 2.0 m thick. The pavement structure was built on the subsoil prepared this way.

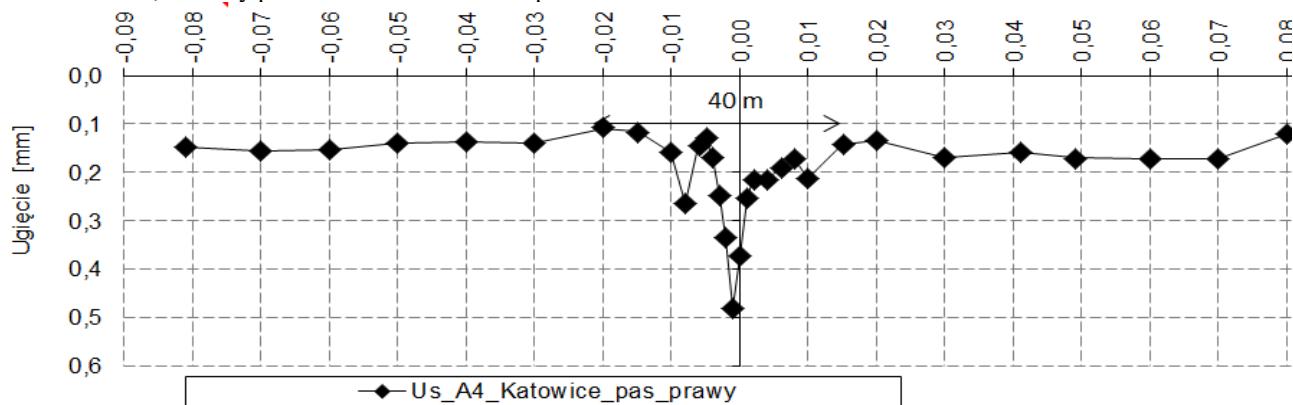
Fig. 8-5. Results of pavement deflections measured by an FWD (Falling Weight Deflectometer) (Grygierek M. & Kawalec J. & Kwiecień S. & Mencel R. 2015). pas_prawy = right-hand lane.

found, visible in particular on the edge line. The work preceding the construction works included the performance of pavement deflection measurements using an FWD instrument, to evaluate the impact of discontinuities on the pavement deflections distribution, and thus on the stiffness of the layer system building the pavement structure (Fig. 5). The test force of 90 kN was applied during the test for a better penetration of the pavement and subsoil layers. The obtained deflections distribution reflects well the results of georadar surveys. Zones of similar profile deformation length were obtained on both graphs - georadar and deflection increase (FWD). It is worth noting that beyond the discontinuities zone (approx. 30-40 m), the pavement featured very small deflections, i.e. below 0.20 mm at the MMA layers temperature of 20°C and the test force of 90 kN.
