Site investigation, monitoring and stability analysis of a built-up slope involved by gas pipeline explosion

ABSTRACT: The paper describes the results of site investigations, monitoring and stability analyses of a built-up slope located near Pineto (Italy). In March 2015 the explosion of a gas pipeline in the upper portion of the slope caused extensive damage to existing buildings and lifelines. Soon after the event, a site investigation and monitoring program was planned. The site investigation included 3 boreholes (25-30 m depth) and 3 flat dilatometer tests DMT (15 to 30 m depth) carried out inside the boreholes by use of the "torpedo" system. The boreholes were instrumented for inclinometer and piezometer measurements. A detailed topographic survey was carried out to reconstruct the ground profile. Hydrological data were analysed for possible critical rainfall events. The slope is formed by OC clay, covered with an upper, 10-14 m thick clayey-sandy silt colluvial layer. The stability of the slope was analysed both in pre- and in post-explosion conditions. The pre-explosion conditions were back-analysed assuming different levels of the groundwater table (at the time of the expl

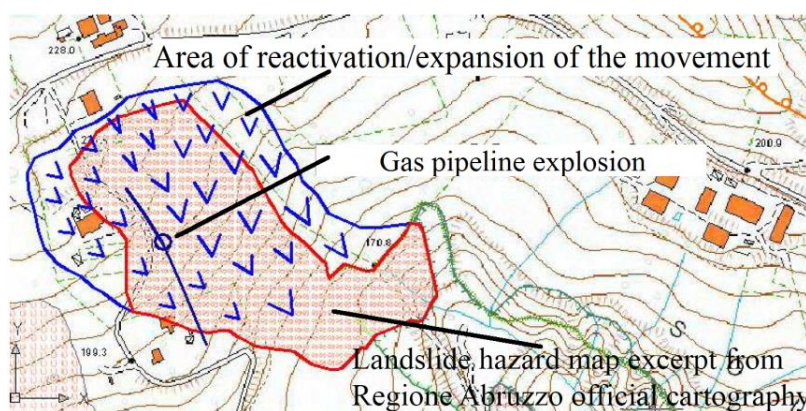
As featured in various maps, including regional ones, the area of Colle Cretone has long been affected by slow movements. Figure 1 shows the area of reactivation/expansion of the movement which occurred on March 6, 2015, involving the gas pipeline. Figure 1 also shows an excerpt from a planimetric map retrieved from official cartography of the Abruzzo regional authority, dating back nearly 20 years ago.

Figure 1. Area of reactivation/expansion of the movement occurred on March 6, 2015, involving the gas pipeline.

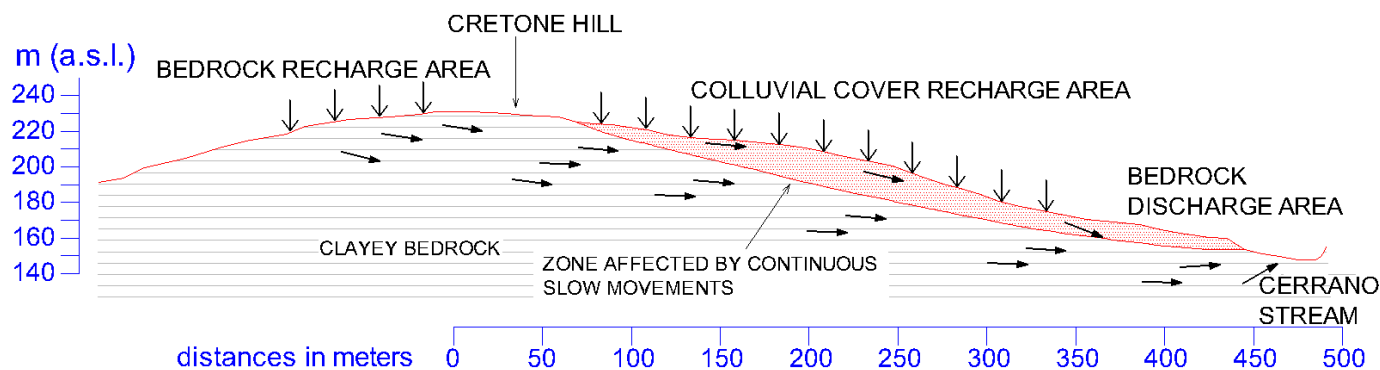
Figure 2 shows a schematic section of the water flow system that affects the slope from Colle Cretone (Cretone Hill) towards the Cerrano stream at its toe. In this context, the continuous influx of storm-water promotes saturation/imbibition of the colluvial cover, causing a reduction of shear strength and thus giving rise to the reactivation of the movement.

Figure 2. Schematic section of the water flow system across the slope.

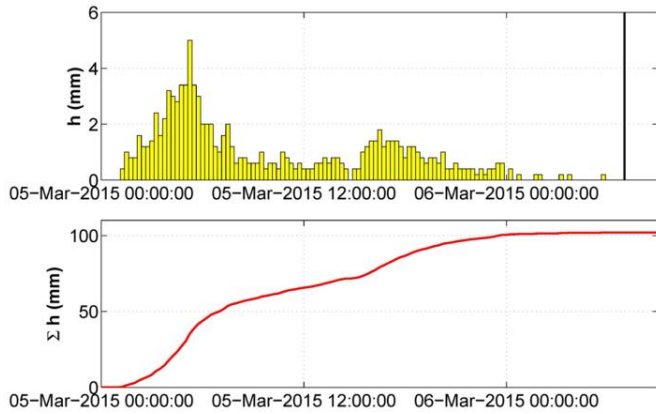
Figure 3. Height of rain recorded by pluviograph (March 5-6, 2015 event).

Figure 3 shows the values of the height of rain recorded by pluviograph. Figure 4 reports the height of rain cumulated during the event. The analysis of the data indicates that the event began on the night of March 5 (01:30 UTC) and lasted continuously until late in the evening (23:45 UTC), with a total height of rain of 102 mm. Peak intensity occurred at 5:15 UTC, in the first stage of the event, reaching the value of 20 mm/hour.

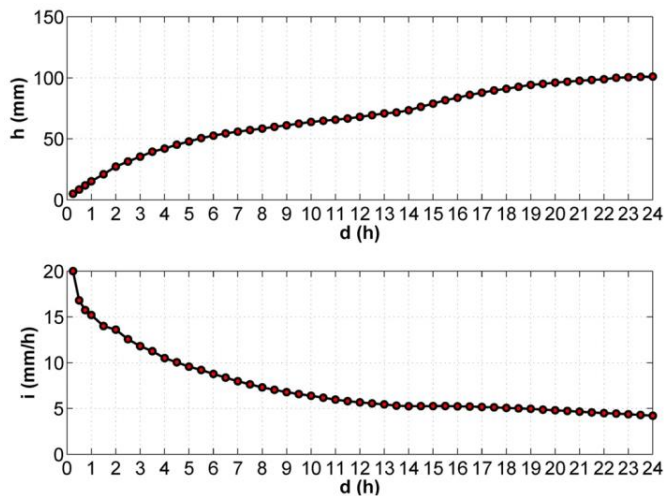
Figure 4. Height of rain cumulated during the March 5-6, 2015 event.

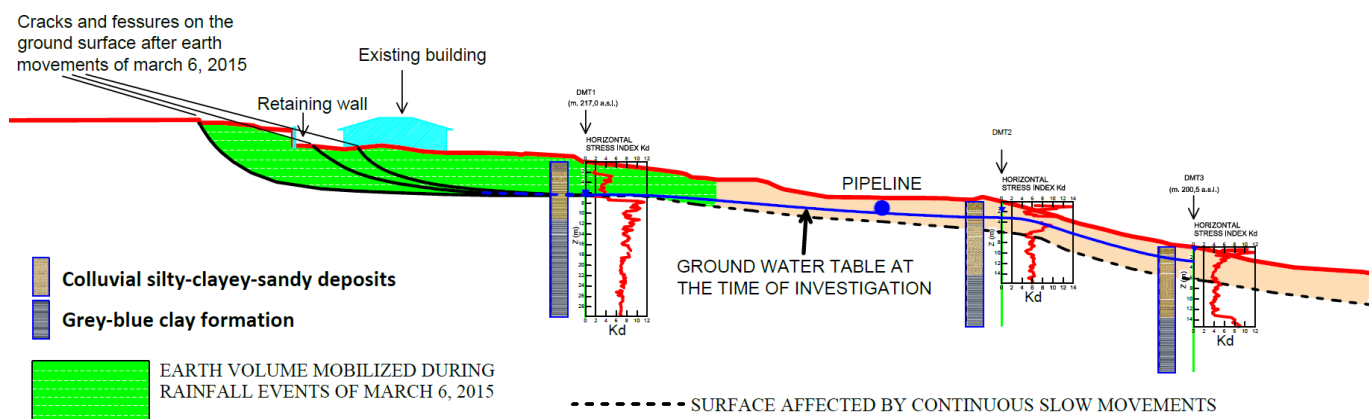
The three borehole logs (Figure 6) show that the upper colluvial silty-clayey-sandy deposit has a thickness varying between 11 m (at the topmost borehole location) and 14 m (at lower elevation).

Significant evidence regarding the thickness of soil above the pipeline involved by the landslide is provided by the K_D profile from DMT 1. The section in Figure 6 shows that, above the pipeline, the soil is quite altered/remoulded to a depth of approximately 7.6 m, with a minimum peak of $K_D \approx 2$ just at that depth. Based on this information and taking into account the location of cracks and fissures on the surface, it was possible to reconstruct the geometry of the landslide mobilised by the rainfall event of March 5-6, 2015.

The inspection of the K_D profiles from DMT 2 and DMT 3 (Figure 6 and Figure 7, top) does not reveal any zones with $K_D \approx 2$ or recently remoulded soil layers. Hence it can be concluded that a “neo-formation” roto-translational landslide was triggered on March 6, 2015, involving the portion of slope above the pipeline. The investigation then confirms the geomorphological interpretation, which indicates an extension due to retrogression of a pre-existing slow slope movement.

Figure 6. Longitudinal section of the slope and results of site investigation (boreholes and flat dilatometer tests).

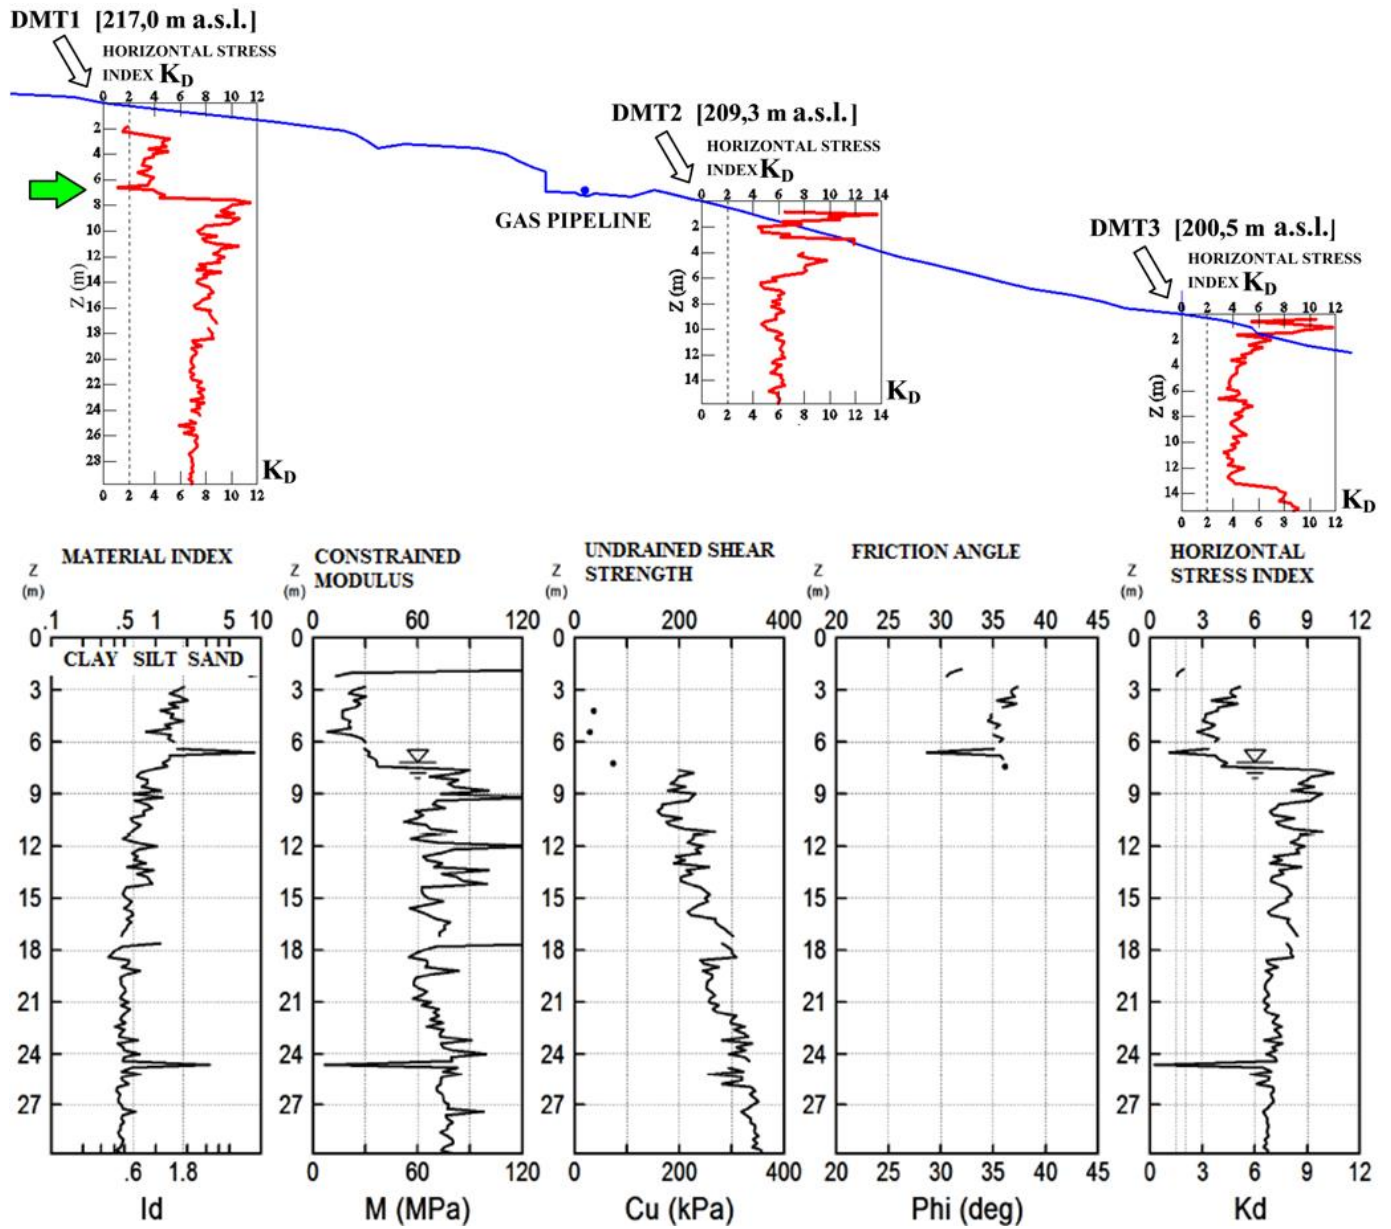
Figure 7 shows the profiles of the constrained modulus M and of the undrained shear strength c_u obtained from DMT 1. It can be noticed that the landslide, by remoulding the soil, has produced a substantial deterioration of the mechanical properties in the upper 7-7.5 m.

Figure 7. Profiles of K_D from all DMTs (top) and parameters interpreted from DMT 1 (bottom).

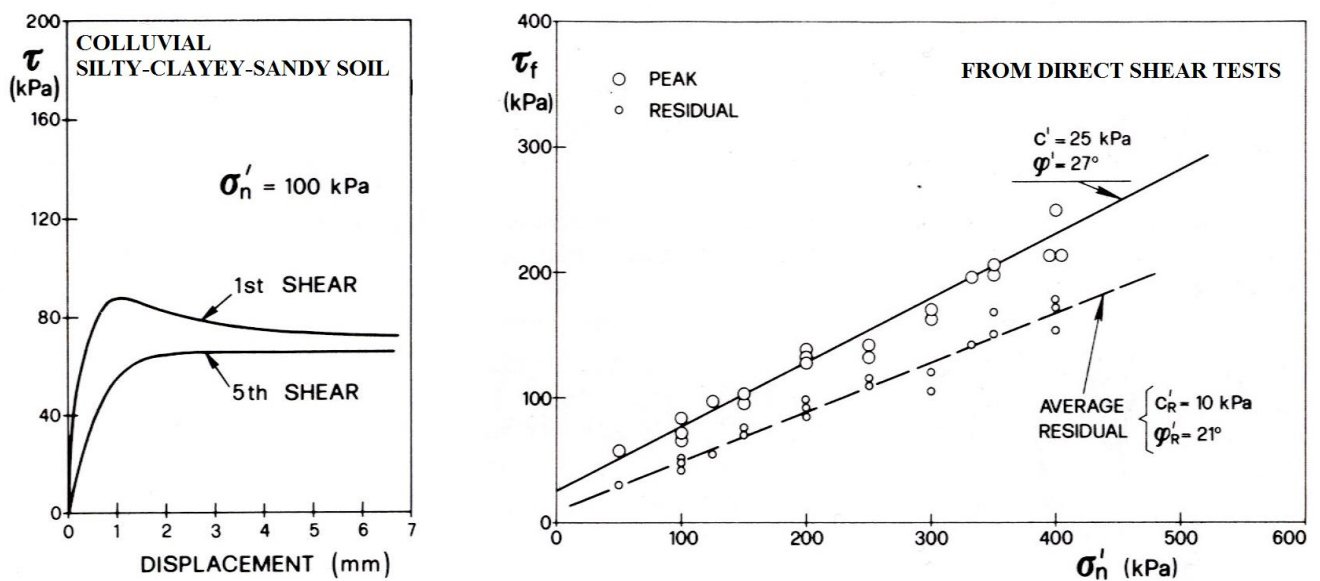
Direct shear tests, with measurement of the residual shear strength after several reversal cycles, were executed on samples retrieved from the colluvial, soft to stiff (when dry) clayey-silty-sandy layer. Figure 8 (left) shows typical shear strength vs. horizontal displacement curves. The interpreted shear strength values are shown in Figure 8 (right). The relatively high values of the residual friction angle of the soil may depend on the scarce activity of the clay minerals.

Figure 8. Results of direct shear test on a sample retrieved in borehole S1 (depth 6.00 m).

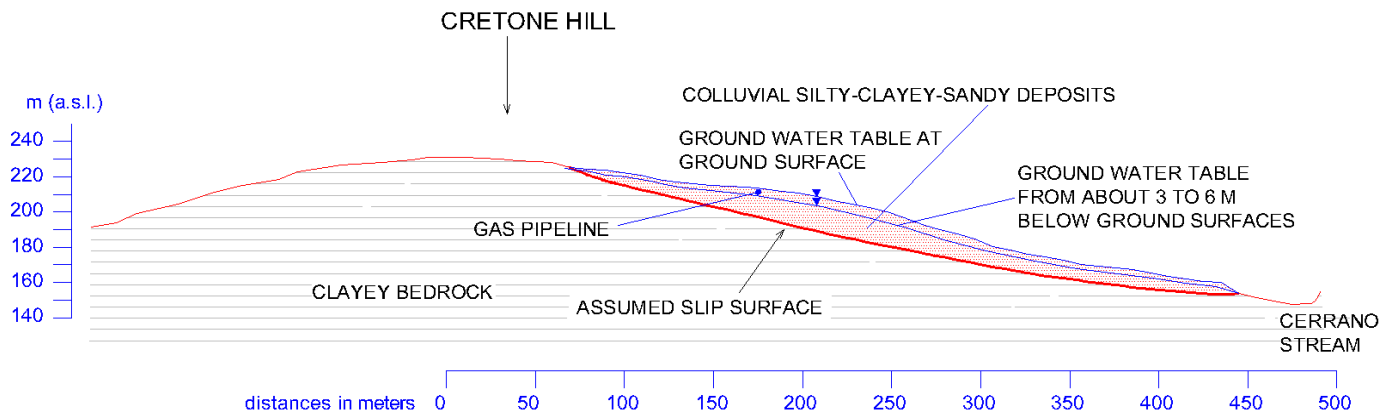
The stability of the slope in the zone of the landslide occurred on March 6, 2015 was back-analysed assuming two different ground water conditions (Figure 9): (1) ground water table at ground surface; (2) ground water table from about 3 to 6 m below ground surface.

If the peak shear strength is assumed in the colluvial cover, the safety factor (F_s) variations are scarcely influenced by changes in pore water pressures. If one refers to the residual shear strength, the values of F_s vary from 0.95 to 1.05. Such values may explain well the movement of the colluvial cover.

Figure 9. Slip surface and ground water conditions assumed in the back-analysis.
