# Case study importance in geotechnical engineering - educational approach

A.Popa, V. Farcas & N. Ilies

## 1 INSTABILITY CAUSES FOR SHEET PILE WALL IN CLUJ NAPOCA – BAUMAX PLATFORM

## 2 VERIFICATION OF THE STABILITY FOR A SHEET PILE WALL (TANGENT PILES) ON KAUF LAND -ZALAU

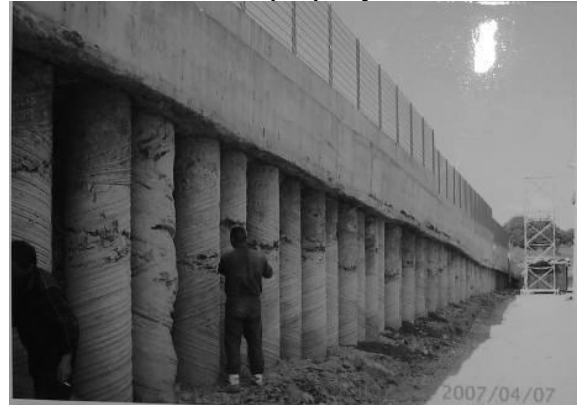
a.

The degradation seen on the wall was, Figure 1:

- After finishing excavation (2-4 days, September 2006) the piles located between final sectors (8 - 22) start to lean, in two hours horizontal displacement of the girder was between ~15cm on marginal sectors to 1 cm on pile no. 39. To impede the displacement earth filling was made to realize a ground slope adjoining the wall (onto head girder). In the same period was made excavation on the bottom of the wall to relocate a gas pipe ( $\Phi$ 200mm). Earth cut having ~2.00m height and 1,50m width produced on ~40m wall length, in 10 hours, 2,5cm horizontal displacement of the

piles (pile no. 100 to 108). Displacement developments continue during September 2006 – March 2007, reaching final value of 5.4cm. To stop the phenomenon earth cut was filled and it executes a slope (~1.50m) on the wall bottom.

- In the present pile 1 reached 15cm horizontal displacement (amortized in 2 days after beginning), pile 110 reached 5.4cm horizontal displacement (having displacements with reduced values on a long period). Earth cut for the gas pipe moved in the corner area of the property.

Figure 1. Degradation on the sheet pile wall.

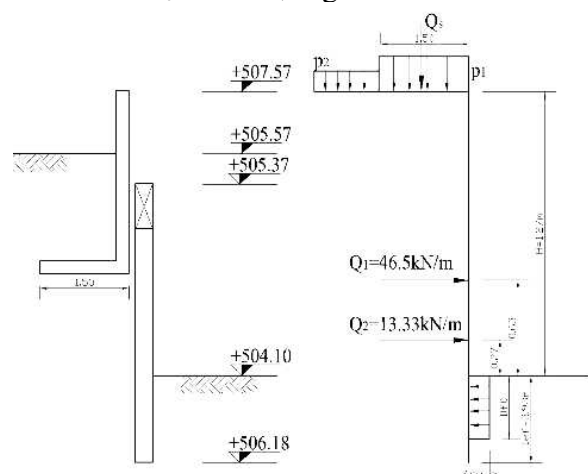
In case A,  $t=3.63\text{m} < t_{ef}=3.92\text{m}$  and in case B,  $t=1.10\text{m} < t_{ef}=3.92\text{m}$ , Figure 2.

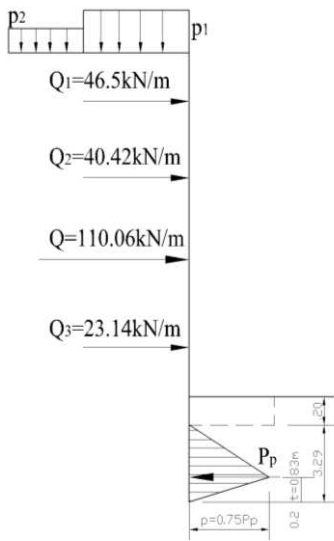
For the wall bottom, having the bigger earth cut height (P110) calculus check scheme is given in Figure 3.

In case A,  $t=7.43\text{m} > t_{ef}=5.29\text{m}$  and in case B,  $t=3.10\text{m} < t_{ef}=5.29\text{m}$ . For more than 2 m earth cut height and 2 m width situation, because that lateral support is missing rotation movement get started which lead to redistribution of reaction diagram on the wall. Diagram of resistive efforts became from a rectangular one, a triangular one on the fixed support length, Figure 4. It resulted overturning of the wall until the remobilization of the entire passive resistance of the ground in front of the wall.

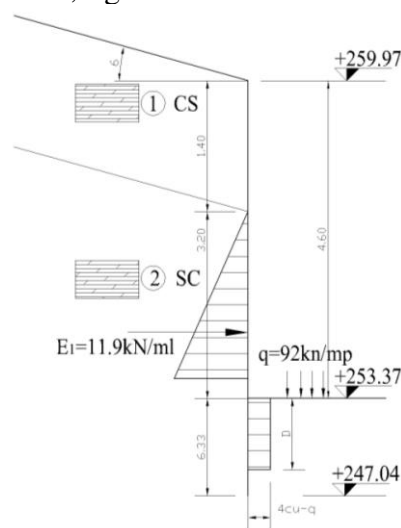
$k_a$  – active earth pressure coefficients were determinate according to SR EN 1997 – 1 – 2007 (EC 7). On the surface level  $p_{a1}=0$  and is not negative because taking in consideration water infiltration. The value of undrained shear characteristics  $C_v=50\text{kPa}$ , to take into consideration the decay of the marl base layer. From moment equation it result  $D=0.60\text{m}$  and  $D_f=0.75\text{m} \ll 6.33$ (existing value) and the capable moment of the pile is bigger than maximum moment, Figure 6.

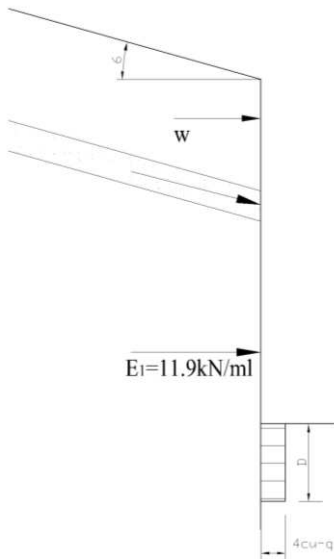
borehole. Considering the equilibrium equation on the sliding surface earth pressure is  $W_h=83.6\text{kN/ml}$ . From the moment equation can conclude that  $D=3.54$  and  $D_f=4.25<6.33$ . Maximum moment value is for  $T=0$ ,  $M_{\max}=440.60\text{kNm}<M_{\text{cap}}=473\text{kNm}$ . The wall displacement, for the pile bottom, for the section having free support is  $\Delta=15.67\text{mm}\ll\Delta_{\text{existent}}=60\text{mm}$ , Figure 7.

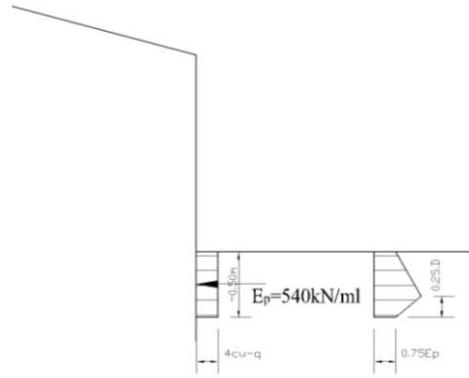
If the displacement on the superior part of the wall,  $\Delta=60\text{mm}$ , results that at the depth to verify lateral pressure there is a displacement  $\Delta_1=3.81\text{cm}$ , which gives to the ground a pressure (2), Figure 8.

The wall displacement make the pressure diagram to transform from uniform distributed on fixed support length ( $4C_u=q=108\text{kPa}$ ) one, into a triangular one,  $p_p=174\text{kPa}$ ,  $k_p=1/2k_p\approx 1.3$  an  $P_p=130,5\text{ kPa}$  at  $1.25\text{m}$  from the bottom.

By the wall displacement passive earth reaction decreased significant toward the calculated displacement,  $P_p=325\text{kN/ml}<540\text{kN/ml}$ , which can produce continuous movement of the wall.
