# **Proposal of Japanese Geotechnical Society for More Reliable Installation of Prefabricated Piles**

**Ikuo Towhata<sup>1</sup> and Hiroshi Furuya<sup>2</sup>**

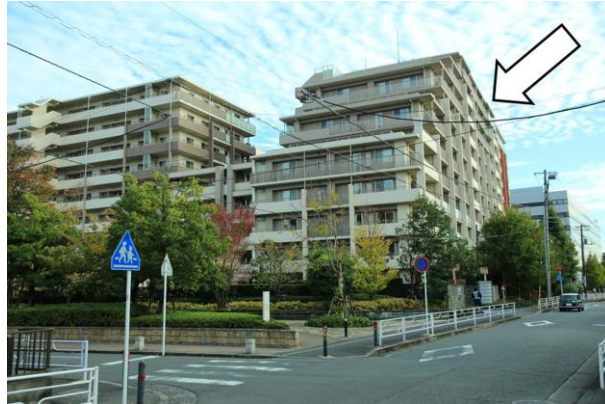
This paper addresses an incident of a condominium building in Yokohama City, Japan, that was constructed in 2007, was of 10-12 stories and later subsided unexpectedly (Fig. 1). The differential subsidence was detected by residents in November, 2014. According to many public reports, differential settlement between two neighboring condominium buildings was about 2cm while the length of the affected building was 56 m. Thus, the gradient of tilting is  $0.02\text{m}/56\text{m} =$  approximately 0.04 %. Although many discussion and documents have been published since then, no final conclusion has been reached yet. Hence, the present paper is of an intermediate nature and cannot provide sources of all information.

**Figure 1. Subsided building in Yokohama**

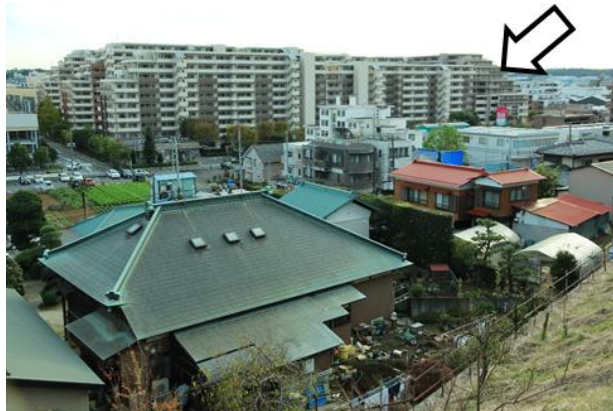
The site is situated in a shallow valley near a hilly terrain (Fig. 4). The valley is filled with very soft alluvial soil that was deposited by a river (Fig. 5). Because of the ancient erosion procedure, the bearing layer, which continues to the nearby hill slope, is not horizontal. Its depth varies from place to place by the order of meters (Fig. 6). The data in this figure was obtained from a public data base but no bore hole data within the condominium site is released to the public.

**Figure 4. View of the condominium site from nearby hill (tilted building shown by an arrow)**

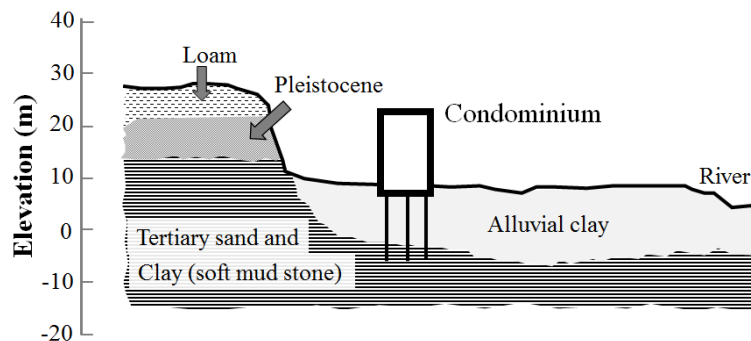
In principle, the depth of piles had to be determined by carrying out subsoil investigation. However, the pile company was asked by the chief contractor to prepare prefabricated piles of 14 meters in length (according to the pile company's own remark). It is argued nowadays that some piles were too short to reach the bearing layer and that the pile engineer could have noticed this problem to take necessary reactions. On the other hand, there had been a big electric factory prior to the construction of the condominium buildings and it is argued that the chief contractor had known upon demolition of the factory that the length of the end-bearing piles was 18 meters, which was 4 meters longer than the new piles. This may imply that 14 meters was an underestimation. If the previous bore hole data had been released to the public, the present pile company could have known more clearly the problematic nature of the subsoil. To see the argument on 14 m or 18 m, the first author feels that the depth of the bearing layer and the required length of piles (including necessary embedment in the bearing layer) may be confused.

**Figure 6. Conceptual sketch of the North-South cross section of the site**

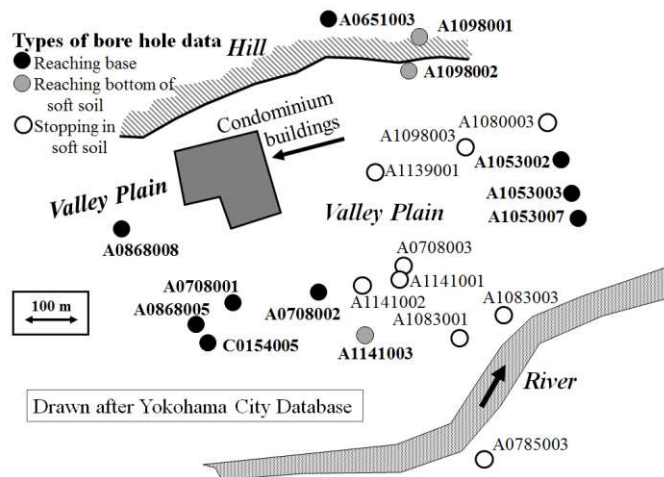
Figure 7 was drawn to show the locations of open-access bore hole data around the condominium site. All of them are located along roads, as mentioned before, and many of them (shown by ○) are limited within the surface soft soil only. Thus, less number of data help assess the depth of the bottom of soft soil (●) or the depth of the bearing layer (soft mud stone in general) (●).

**Figure 7. Location of subsoil data around the condominium obtained from a site of Yokohama City Government (<http://www.asyura2.com/15/hasan104/msg/435.html>)**

According to Fig. 7 there is no open-access bore hole data, reaching the bearing layer, in and around the condominium site. This is a pity because there is a big shopping mall immediately to the east of the site and many bore hole investigations had been carried out for its

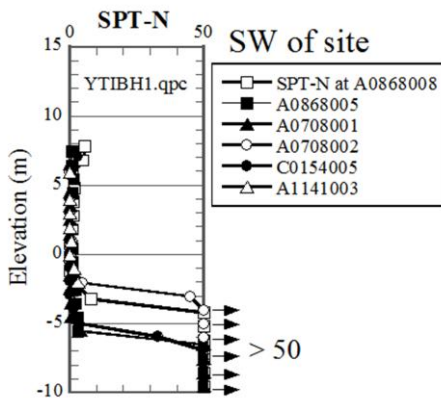
pile foundations. Because of their private nature, their data are not open to the public. Hence, Fig. 8 plots the data at sites of ● symbol to the south and west of the condominium site in spite of the distance of hundreds of meters. Over a substantial depth, SPT- *N* was zero because of very soft clayey and organic soils. *N* value exceeding 50 is the idea of a bearing layer. Bore hole A1141003 (△) did not reach *N* = 50, and stopped at *N*=3 at the depth of 10 m. This figure implies that the data is classified into two groups shown by open symbols of □ and ○ at which the bearing layer was encountered at the elevation of -3 m and solid symbols (■, ▲ and ●) for which the bearing layer starts at -7 m. By comparing this data with Fig. 7, it is found that the bearing layer becomes lower towards the river. Moreover, Fig. 9 illustrates SPT-*N* profile reaching the bearing layer at three sites to the east of the condominium site. The elevation of the bearing layer is rather uniform here at -7 to -8 m but deeper than at sites in Fig. 8. This increased depth may be due to their more downstream locations.

**Figure 8. SPT-*N* profiles in soft soil area near the condominium site (SPT-*N* starts from 1 meter below the ground surface)**

Table 1 compares the depth of first (shallowest) SPT- $N$  greater than 50 at those sites. Herein depth means the distance from the local ground surface. It may be seen that the depth is variable to the west or south of the condominium site (first 5 sites) (12-15 m). If this extent of variation is the case at the condominium site as well, a constant length of pile is not a reasonable idea. Ignorance or insufficient attention to local soil conditions leads to a serious problem during construction and after completion.

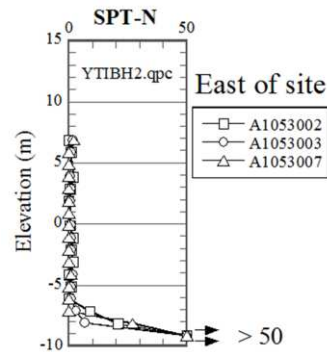
**Figure 9. SPT-*N* profiles in soft soil area to the east of the condominium site (SPT- *N* starts from 1 meter below the ground surface)**
