DIAGNOSTIC ANALYSIS OF DISTRESSED HYDRAULIC STRUCTURES: CASE STUDIES OF GUJARAT, INDIA

Vivek P. Kapadia¹

¹Chief Engineer, Narmada, Water Resources, Water Supply and Kalpasar Department, Government of Gujarat, Block No – 9, New Secretariat, Gandhinagar – 382010 India Email: vivekpkapadia@gmail.com

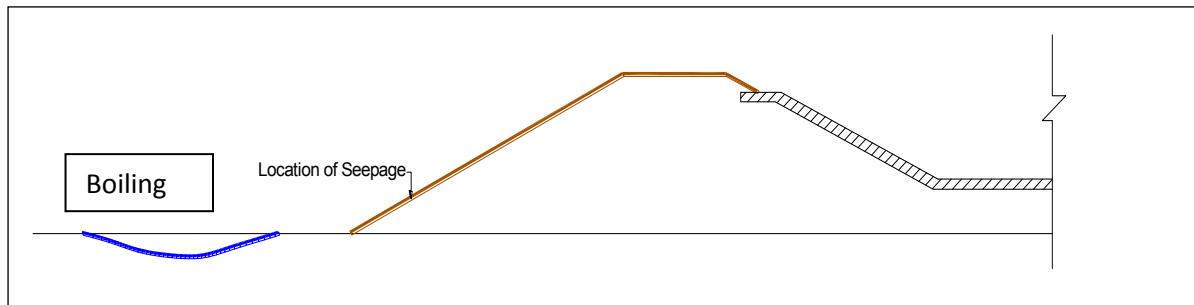
Figure – 2 Conceptual View of Canal Section in Problematic Reach

After construction of the main canal, because of overdependence for the drinking water, it has never been given closure and hence the saturation of embankment has been an issue especially where the embankment is very high. At some locations high groundwater table beneath the canal and at some locations subsurface flow have also manifested some issues. One such location is the upstream side of the Watrak Canal Syphon near Ch.195.00 km which is in heavy banking. The average height of bank is 12.50 m. Water depth in the canal section is 7 meter. Some boiling was observed on left bank at 30 m away from the outer toe of the canal bank during 2001 to 2005. Some seepage was also observed on the outer side of the canal embankment above its toe. This problem was in a length of more than 50 meter.

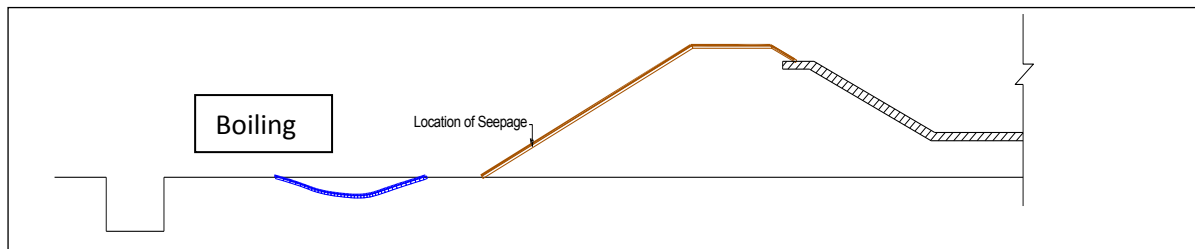
The problem of boiling at some distance from the toe of the canal embankment suggested subsurface flow due to favorable hydraulic gradient. Subsurface flow could not be attributed to the canal flow as the canal was lined and the bed banking was more than 3.5 meter. Some punctures were required to be made in the soil at some distance away from the outer toes of the canal embankments which helped in finding that there was a shallow live aquifer which was not noticed during the construction of the canal. This aquifer might have dried up during the construction period as there were two preceding years lean from rainfall point of view and hence at that time no one could notice anything during the construction. The aquifer was cut due to construction of the canal siphon in the downstream which spread and saturated the surrounding soil above in some years which finally took the form of boiling as the waterway was obstructed. This important finding gave the clue as to why the canal that did not completely resemble a dam manifested a problem that is generally found with dams.

Figure – 3 Initial Stage of Solution

It was planned to provide exit to the subsurface flow by providing a lateral drain somewhat away and establish a steady state of the soil beneath the canal embankment so that crumbling of the foundation resulting in to failure of the embankment could be avoided. This would also stop the capillary action of water in to the canal embankment near the toe if any. The lateral drain which was a collecting drain was extended to a far situated pond for the disposal. This was aimed at releasing the water accumulated in large quantity within the soil beneath the canal embankment. Figure – 3 represents the said arrangement.

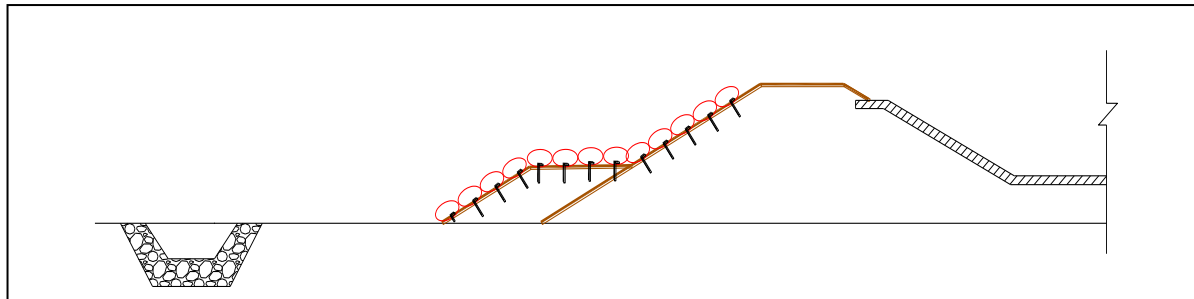
The canal embankment was kept under observation for some days with the aforesaid mechanism working continuously. It was observed that the boiling phenomenon had almost disappeared. It was also observed that seepage from above the toe of the embankment was reduced but was not completely stopped which suggested that the phreatic line had established within the embankment which had an exit above the toe. This state could not be taken lightly.

Figure – 4 Conceptual View of Solution

In order to ensure the phreatic line to be within the width of the embankment, increasing the width of the canal embankment was necessary. Moreover, this could also control the exit gradient within the foundation. It was planned then to provide an additional berm of 5 meter width and 5 meter height to ensure the stability of the embankment in addition to the said two benefits. The additional berm thus constructed resulted in to total disappearance of the boiling phenomenon and the seepage from within the embankment. But the chances of adverse effect of saturated soil already within the embankment and further saturation due to continuous flow in the canal could not be ruled out. In this situation, the solution provided must of a long term nature was the general feeling.

Counter weight through the additional berm was planned to be further improved by providing some additional burden in the form of sand bags which could also function as protection against the rain and the rain-cuts could be avoided. Finally jute textile bags were selected for this purpose which were specially designed in the form of long rolls. They were filled up with cement soil in 1:9 ratio and were nailed on the outer slope of the canal embankment. This was aimed at avoiding rolling down of the jute rolls. The objective was to prove an anti-erosion surface on the outer slope of the embankment and to add extra burden to provide more stability. In course of time the jute might be disintegrated but would have vegetation on it which would provide good drainage facility in addition to protection against rain-cuts. The lateral drain was then provided with a trapezoidal section with inner side having dry pitching which could easily collect the water without any destabilization. Figure – 4 represents the conceptual view of the solution.

The said solution was provided between Ch.195.225 KM and Ch. 195.375 KM was carried out during June-2005 to August-2005. The extra length of the solution on both – upstream and downstream of the problematic reach was keeping in view the chances of spreading of subsurface flow. The solution has been found working well and till date there is no problem in the said length of the canal.

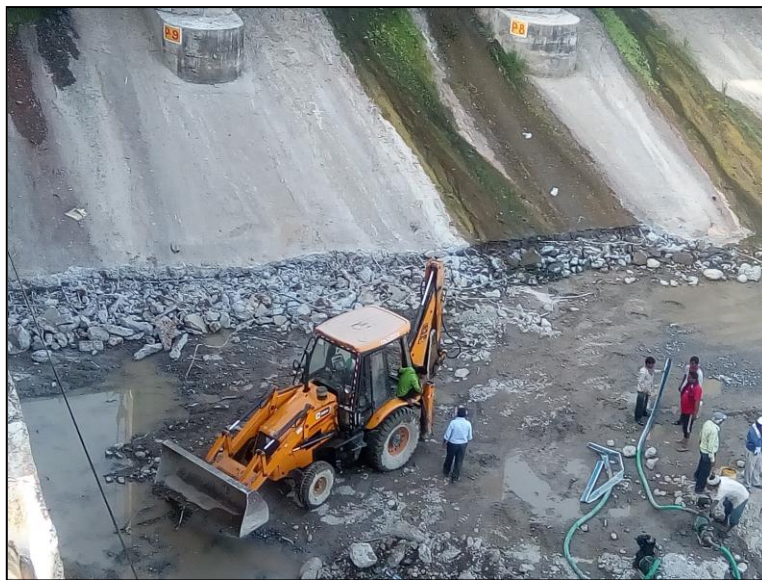
The Gorathiya dam manifested some signs of distress in only 2 years from its completion. The downstream glacis slope has been 1:3 whose toe got disintegrated and the reinforcements were pulled out as a sign of distress as shown in Photo-1. The next year the downstream apron got damaged but not in the entire length of the dam, only in the right half of the length i.e. river's half width as shown in Photo-2.

Photo – 1 Pullout of Reinforcement at Toe

Disintegration of concrete at toe of the downstream slope of the dam and pulling out of reinforcement in the entire length at the same location clearly suggested that it was not a construction flaw but it was due to cavity formation during release of water. This was because the glacis with 1:3 slope was insufficient to avoid cavity formation. There should have been a much flatter slope or an ogee. This part of the diagnosis was comparatively easy as it required only inspection and some knowledge of design.

reinforcements were welded with the reinforcements which were pulled out at the toe of the downstream slope of the dam. The concrete was cast for the apron such that at the toe of the dam was made a curved fillet to avoid pullout during the cavity formation. Strong foundation and strong apron with peripheral key checked the hydraulic path beneath the foundation and also assured impact resistance against the fall of water.

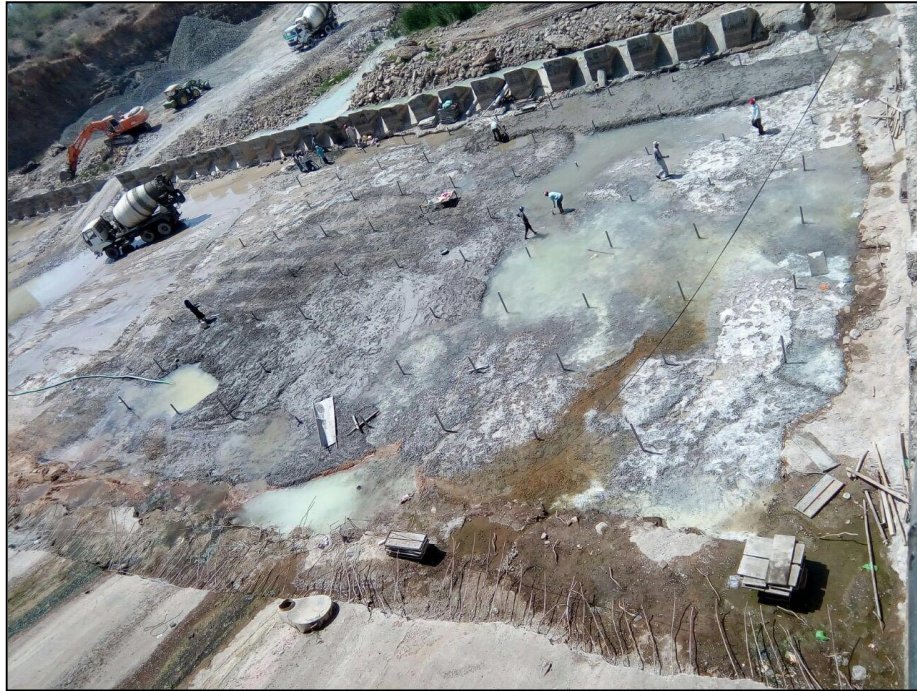
Photo – 2 Top View of Pulled Out Reinforcement at Toe and Damaged Apron

The reason for repeated damage in the half of the length of the apron was difficult to understand. If it were a design flaw, the damage would have been in the entire length of the dam. If it were a poor quality concrete in the apron, repeated failure could not be there as the repairs were done meticulously. The history of site investigation was thoroughly studied to commence with. There was some record that there was originally a basalt mine in the gorge of the river as the river was having good quality basalt in its bed. For preparation of the site, the design included lean concrete filling with large coarse aggregate i.e. plum concrete in the pit. The investigation began with identification of width and depth of the mine. Some other records with geological mapping suggested that the mine was only in the right half width of the river and the depth was about 9 meter. It was not a big mine but only some removal of basalt from this location which was advised to be filled up with plum concrete. The apron was removed and the

plum concrete beneath was investigated. It was learnt that the large coarse aggregates were there in place with mechanical locking and no compaction could be done but the cement and sand were in loose form and hence there was substantial amount of water beneath the apron in the voids of the aggregates. The dam was full up to crest level i.e. approximately 6 meter from the bed of the river. This gave a clue that the filling of the pit was aimed at plugging it but either the concrete was not allowed to set properly or the casting was not done properly and hence the concrete was not in a solid form and hence the voids between the large coarse aggregates were filled up with water which was not the groundwater; it was the water from the reservoir in the upstream of the dam. The water started flowing out after some hours which corroborated the said finding. This condition was extremely dangerous as at any time the subsurface flow could result in to undermining the foundation and collapse of the concrete dam itself.

The reason for damage to the apron in the right half length of the dam was then understood. When the gates were opened and water was released, the impact of the water fall was supposed to be taken up by the apron which required a solid foundation beneath which actually was not there and hence the concrete apron used to settle which caused sagging resulting in to damage at the bottom and top – bottom damage was not visible but the top was. Every time the gates were operated and the apron was found badly damaged due to this situation.

Removed portion of concrete apron in half of the length of the dam was provided with horizontal and vertical drainage embedded in to the concrete and the new construction of apron was done with properly compacted polymer concrete with reinforcement mesh at the top. These

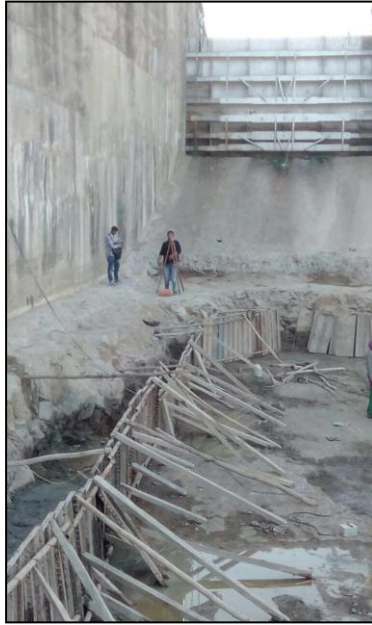
Photo – 3 Construction of Cut-off under Abutment

The apron was to be recast but it was decided to go for a 5 meter downstream cut-off to ensure checking the hydraulic path from the foundation. Additional cut-off was provided with the new apron. The right side abutment was also found vulnerable and hence the shuttering was made at its foundation after opening it and additional cut-off was also constructed there as shown in Photo-3. A peripheral cut-off was thus provided as shown in Photo-4. Entire construction activity required constant dewatering. Rapid hardening agents were added to concrete to ensure early setting of the concrete to reduce the construction time as the risk was very high.

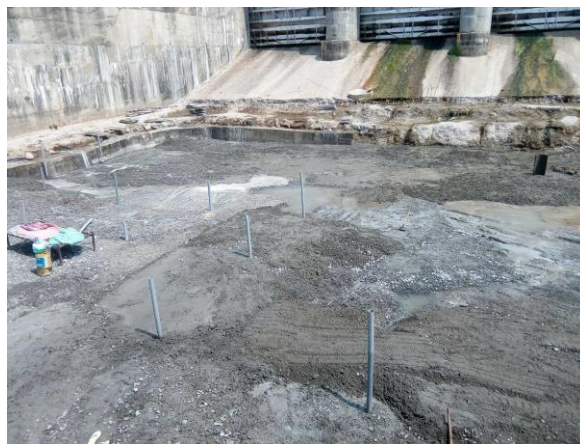
Photo – 4 Construction of Peripheral Cut-off

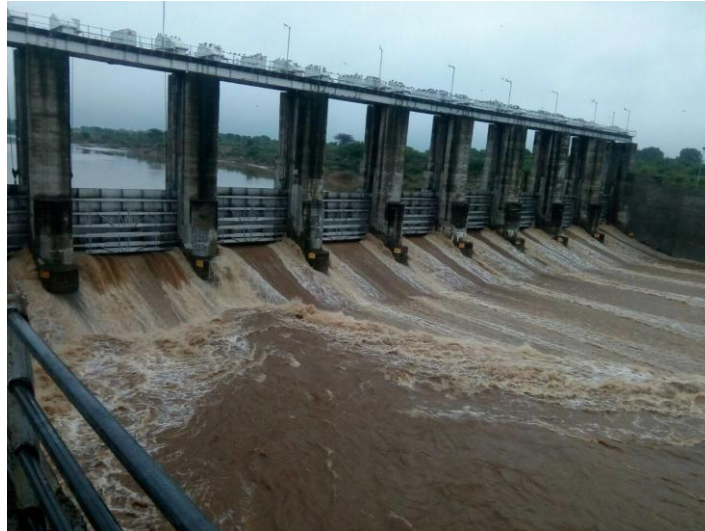
Photo – 5 Post-Repair Performance of Dam

The solution worked out was tested soon i.e. monsoon 2016 and there was full discharge released from the gates twice as shown in Photo-5 and it was found that the performance was as per expectations.
