# **Stabilization of Slope at Cabo Hill, Goa, India – A Case Study**

**S.D. Anitha Kumari<sup>1,3</sup>, B.R. Venkatesh<sup>1,2</sup>, M.V.Deepthi<sup>1</sup>**

## **ABSTRACT**

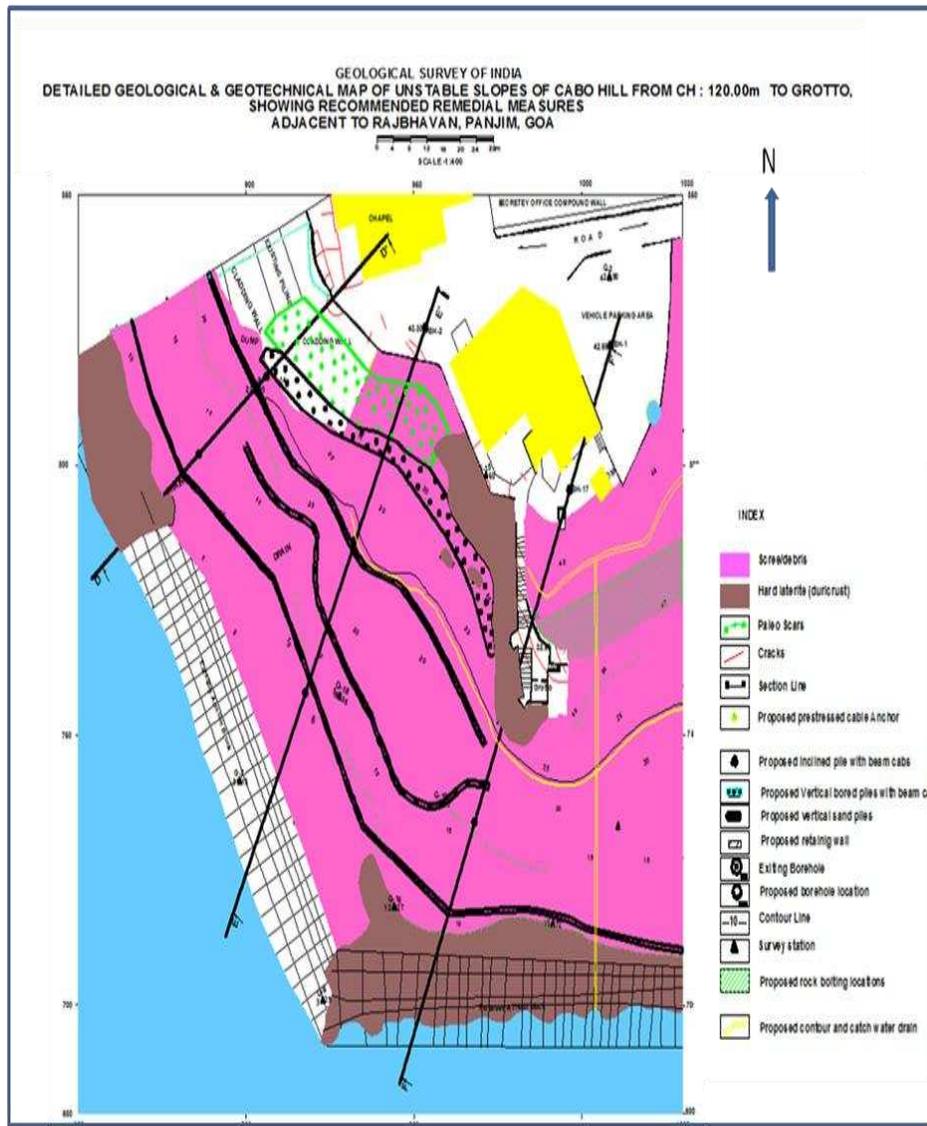
**Figure 5 Geotechnical Map of Cabo Hill (After GSI)**

The Geological Survey of India (GSI) commenced geotechnical investigation at the portion of the distressed slope in 2002 (Panduranga et al, 2008). A geotechnical map prepared on scale 1:500 showed the weak zones and distribution of scree and debris, duricrust, paleo-scars, cracks as well as appropriate borehole locations. Based on the investigations coupled with borehole analysis, the remedial measures suggested include pre-stressed anchor cables at selected weak zones, vertical and horizontal piles, retaining walls, weep holes etc. The geotechnical map of the Cabo Hill (after GSI) is shown in Fig 5.

When the GSI took up the investigation, cracks had already developed even on the pavement which was asphalted later, parapet wall, corner of verandah and the staircase of Grotto (a chapel at the Cabo Hill), buttress, cladding wall and seawall. This led to a conclusion that the protective measures carried out earlier were not effective. Even the south and south-eastern part, near Grotto, happened to be the continuation of the part of the slope that were once stabilized, found to experience distress. Besides the cracks in the building, five sets of joint planes within the laterite were open indicating clear dislocation.
