# Forensic Investigation of the Failure of a Marginally Stable Hill Slope

Priyanka Talukdar<sup>1</sup>, Ruplekha Bora<sup>2</sup> and Arindam Dey<sup>3</sup>

This paper presents the forensic study of the failure of an existing naturally stable stratified hill-slope, destabilized by seepage and sequential anthropogenic construction activities. The slope, located in the Umrangso region in the Dima Hasao district in the state of Assam, India, was initially in a stable state before any human intervention. However, the site had been chosen to establish various industrial manufacturing units which resulted in a massive mass movement of the slope where deformations were observed nearly approaching the toe of the slope with the progressive stages of construction. Concrete retaining walls constructed to arrest the mass movement did not serve the purpose of protecting the slope, rather added more weight leading to further destabilization of the slope. A forensic geotechnical investigation has been carried with the aid of field and laboratory investigations and subsequently aided by the development of a finite-element based numerical model. Field visits indicated multiple reasons related t

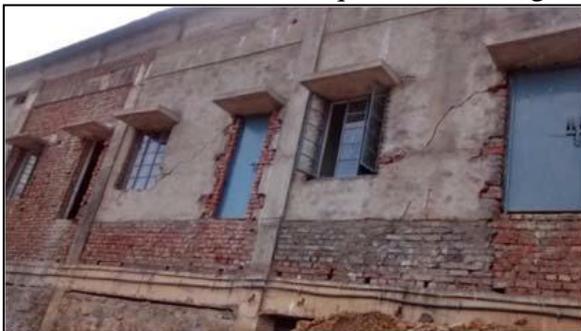
The sequence of distress was observed based on the site visits and preliminary enquiry at the site. The first slip was observed during July 2015. The foundation columns of the workshop building constructed on the hill slope were exposed due to the erosion of soil mass, resulting from the rainfall and subsequent landslide. The exposed columns of the workshop building were observed to be in distress condition as evident from the cracks in the walls of the building as shown in Fig. 3 and Fig. 4. As a preliminary preventive measure, rubble masonry retaining wall-I was constructed with subsequent backfilling during July-August 2015.

**Figure 3. Cracks in the walls of the workshop building**

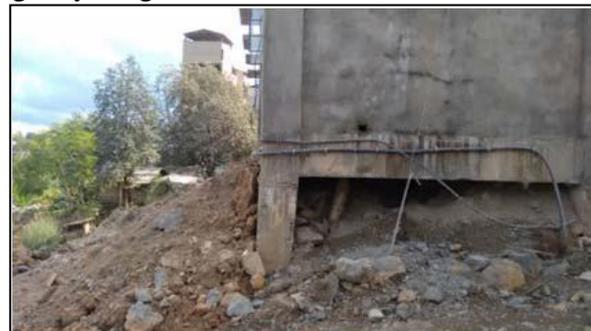
**Figure 4. Exposed building columns due to soil movement**

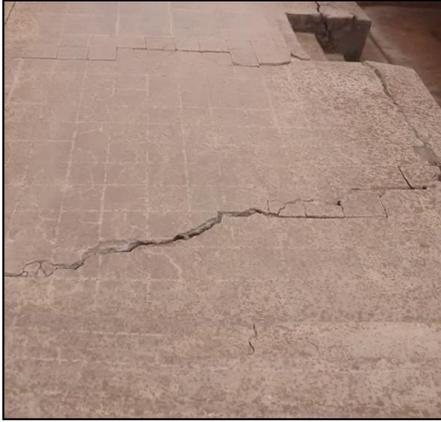
**Figure 5. Cracks in the floors of the colony building**

Further, during the period of September-October 2015, due to the continued land movement, moderate-to-severe distress was recorded in the buildings of a nearby colony area as shown in Fig. 5. This movement also resulted in the distortions, cracking, and disintegration of the retaining wall-I shown below in Fig. 6. In order to prevent further distress, rubble masonry retaining wall-II was constructed adjacent to the colony area during the month of September-October 2015. However, even with the above preventive measures, the soil movement continued, as a consequence of which retaining walls-III and IV was constructed during October 2015.

It can be well understood that this retaining wall, with its backfill, is actually floating on the moving soil mass, and would offer no benefit in arresting the slope movement, which is what exactly happened in the field, where no signs of the arrest of the movement was seen. Rather, after the construction of the retaining wall, large movements were seen even at a distance of 150 m from R1 in the field. Figure 15 exhibits the same in the numerical simulation. The construction of the retaining wall and its subsequent backfilling, in reality, added more load on the moving soil, thus generating additional movement as observed both in the field and in the numerical simulation. The extent of the lateral deformation encompassed the locations of R2 and R3, and hence, their construction was of no additional improvement to the stabilization of the moving slope. The extent of the deformation beyond the retaining walls R2 and R3 reached the colony area and caused a massive damage to the habitation (as shown in Fig. 5 and Fig. 6).

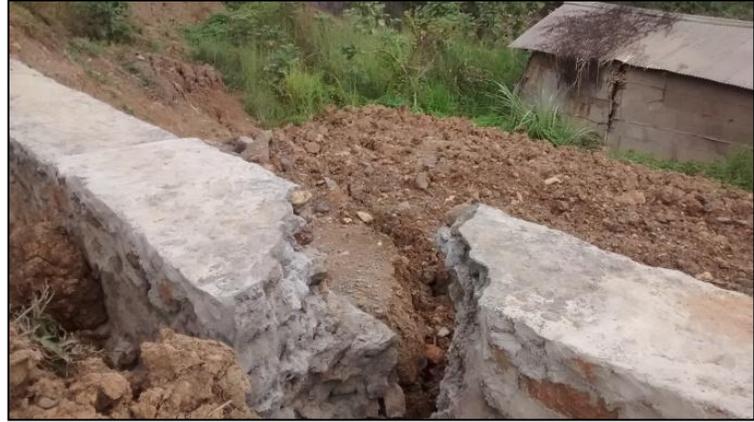
**Figure 6. Cracking in retaining wall-I**

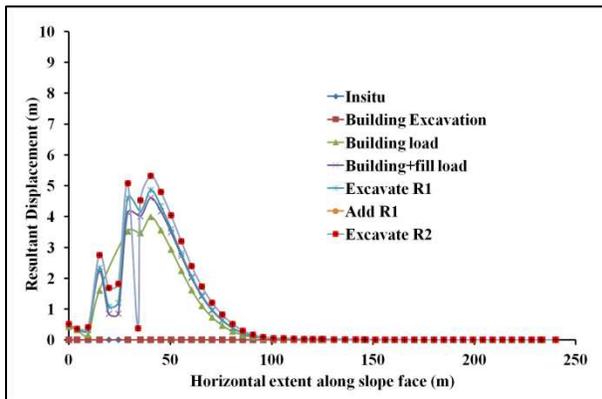
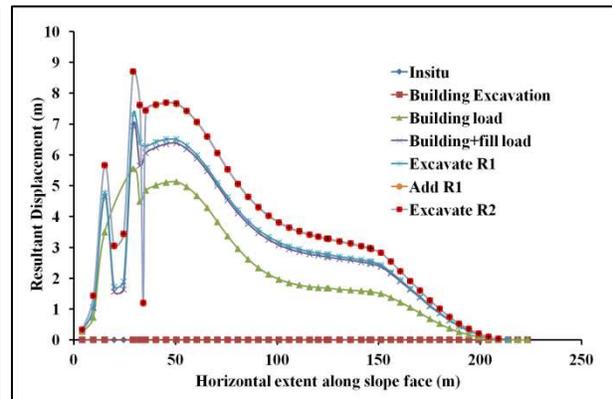
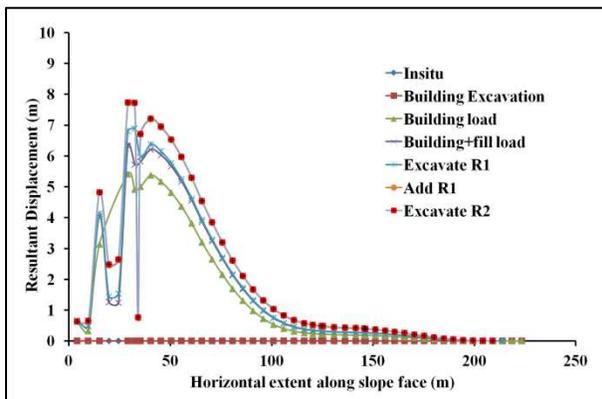
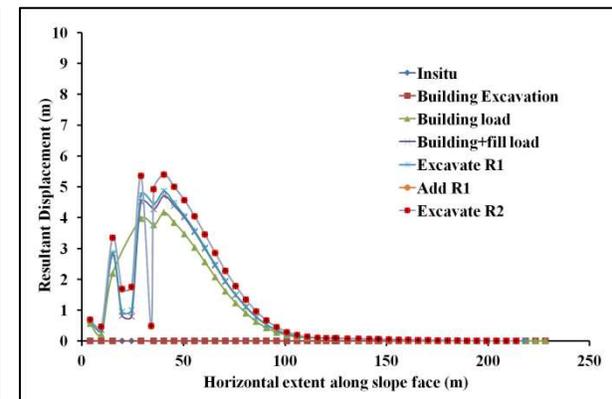
The displacement characteristics along the face of the slope for the critical stages of construction pertaining to the probable existing soil stratification in the field (Case II) is shown in Fig. 8 to Fig. 12 for dry and saturated conditions, respectively. Results from the analyses showed that for both dry and saturated conditions, the deformations in the first two stages of construction were negligible. The abrupt increase in deformations starts from the addition of the building load and its increment continues till the addition of the first retaining wall R1, after which no significant increase of deformation was observed for the rest of the stages of construction. Therefore, it can be clearly pointed out that the Stages 3-6 of the various construction sequences (as illustrated in Table 4 and Table 5) are the main triggering factors leading to the initiation and progression of deformation in the marginally stable hill-slope.

It can be noticed that saturation of the upper soil layers lead to higher degree of destabilization as illustrated from the larger values of displacement of the slope face. It can also be seen that different degrees of saturation result in different extents of deformation in the slope face. Seepage analyses conducted with varying levels of water heads yielded different phreatic surfaces and the water flux along the slope face was determined. The results of the simulations were compared with the field observation in terms of the location of water emanating out of the slope face after the monsoon period. Figure 12 shows the water flux along the slope face for Case II slope geometry fully saturated with water and the phreatic line is at its culmination in

**Figure 8. Displacement for the critical stages in dry condition**

**Figure 9. Displacement for the critical stages in saturated condition ( $W_1$ )**

**Figure 10. Displacement for the critical stages in saturated condition ( $W_2$ )**

**Figure 11. Displacement for the critical stages in saturated condition ( $W_3$ )**

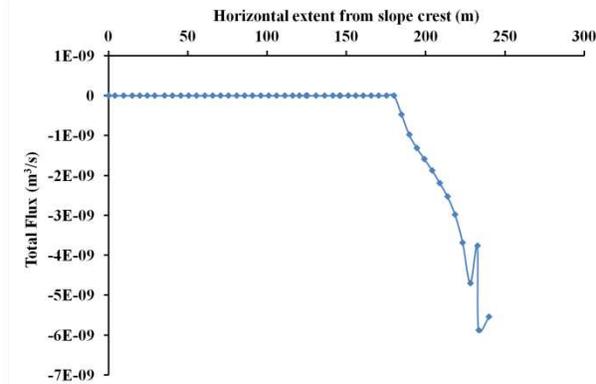
comparison to the other cases having different positions of water table. It can be observed that the Validating with the real field scenario the level of saturation with gave the maximum displacement can be adopted. A plot showing the variation of water flux along the face of the slope is shown below in Fig. 12. It can be observed that the water flux attains a negative value beyond a distance of 180 m from the crest of the slope. This signifies that water is emanating out from the slope face through this particular location, which is an outcome of the phreatic line intersecting the slope face at the said location. Visit to the distressed site also revealed water emanating out from the slope face as seeping spring at and around the said location (~ 150-200 m from the slope crest). Thus, it can be conclusively stated that the heavy monsoon season led to the saturation of the most parts of the slope and the rise of the phreatic lie towards the ground surface made the soil comparatively weakened (manifested by lower strength properties), and subsequently leading the massive mass movement of the soil. As shown in Fig. 7, retaining wall (R4) was constructed with the provision of weep-holes accompanied by an adjacent water-carrying nallah (open channel conduit) with the intention of releasing the water seeping through the slope. However, the phreatic line intersecting the slope at a much higher elevation had actually rendered R4 to be a dysfunctional one, and hence, resulted in a massive wetting of the toe of the slope, leading to the observed distress at the site.

**Figure 12: Variation of water flux along the slope face**

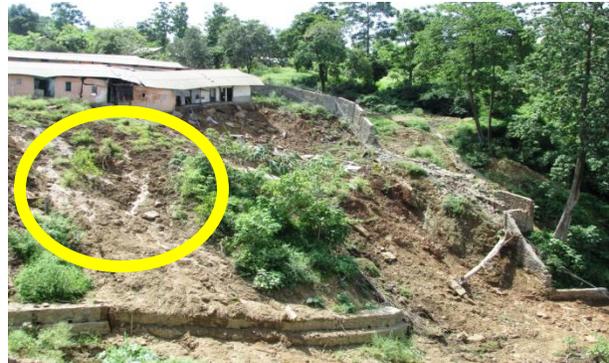
**Figure 13: Water emanating from slope face**

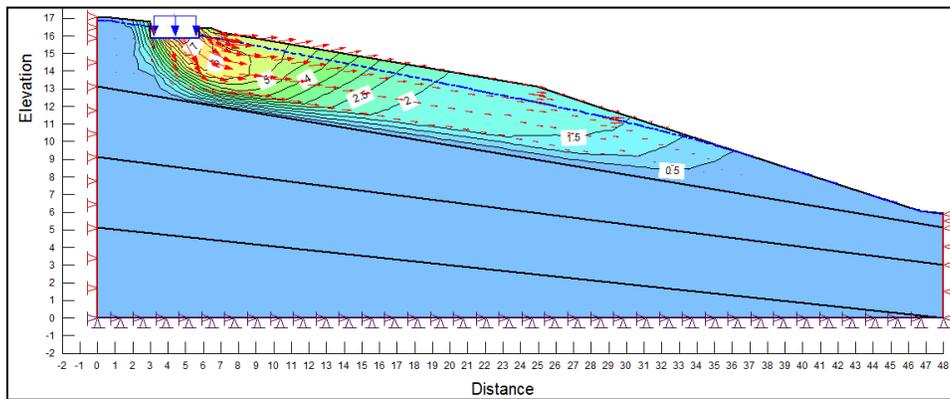
Figures 14 and 15 exhibit the deformation characteristics observed for the two most critical stages of construction (Stage 3 and Stage 6, respectively) with the identified slope geometry, soil stratification and the location of the phreatic surface and its intersection region in the slope. Supplement to Fig. 7, it can be observed from the deformation contours of Fig. 14 that a shallow slope movement with significant deformation extent has taken place at Stage 3 itself, when the building has been constructed. The deformation reached a depth of 4m below the ground surface and laterally extended up to 200 m from the building location towards the downhill of the slope. In order to arrest the movement originated due to the building construction, R1 was constructed with a foundation embedment depth of around 1 m from the ground surface.

**Figure 14. Deformation of the slope (Stage 3)**

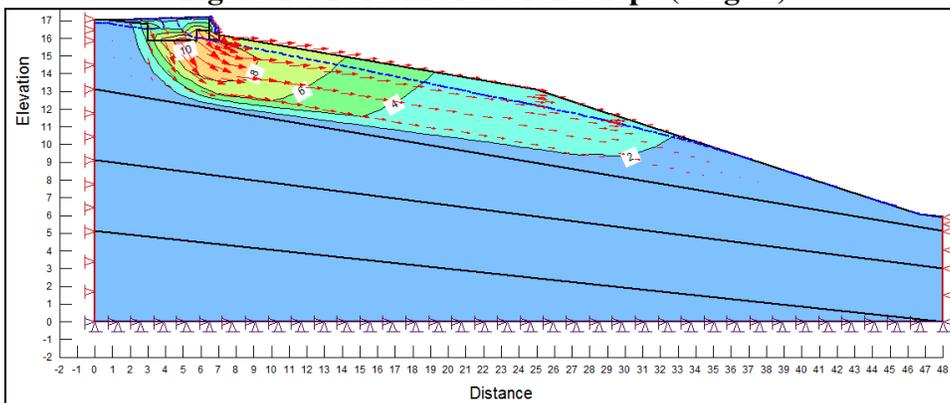
**Figure 15. Deformation of the slope (Stage 6)**
