# Geotechnical perspectives of Failure cases in Head walls of Hume pipe culverts and their Forensic Investigations

Amit Srivastava<sup>1</sup> and Dharmendra Kumar Srivastava<sup>2</sup>

The present study discuss and highlights the geotechnical aspects of failure cases observed in the head wall of Hume pipe culverts constructed at various locations on a bypass as apart work of ‘Four Laning & strengthening of a national highway in Haryana state’. Systematic Forensic investigation of the observed cracks developed in a head wall of Hume pipe culvert suggested construction as well as design deficiencies. From geotechnical perspectives, various aspects of failure, such as, suitability of soil as foundation material, inadequate compaction of the foundation soil, consolidation process and amount of settlement etc. were studied. Observed performance and development of crack at the location of stress concentration in the head wall were also verified through numerical analysis using finite element based numerical tool PLAXIS 2D. Upon investigation, it has been found that inadequate compaction of soil below headwall foundation was the primary reason for excessive settlement and development

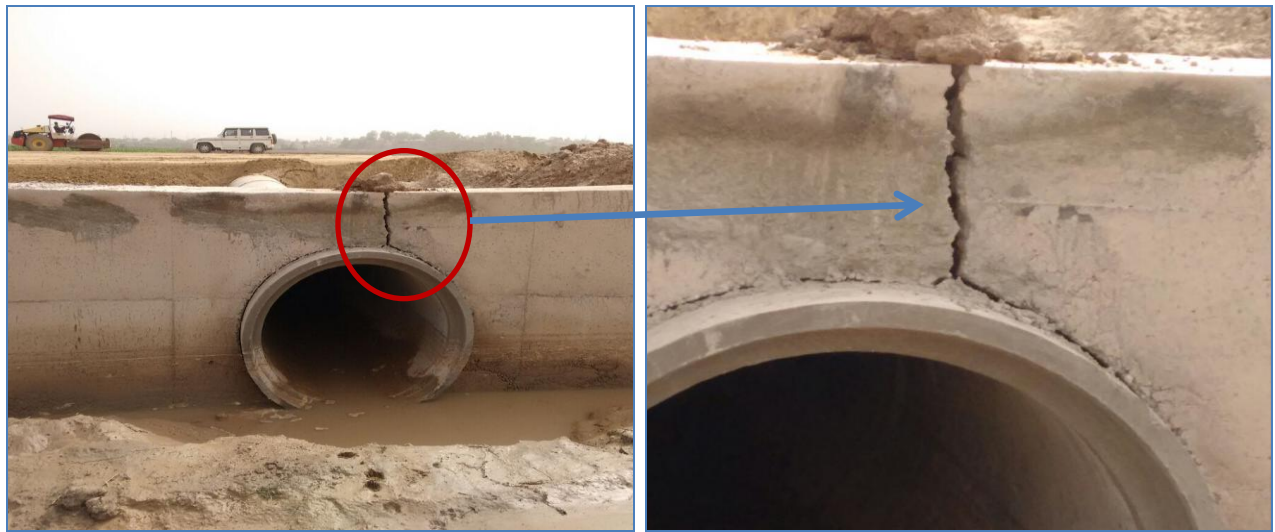
1200 mm diameter Hume pipe culvert was proposed on a bypass as a part work of “Four Laning & strengthening of one of the national highways (NH)”. Main function of provision of hume pipe culvert is for cross drainage of accumulated water from one side (U/S) to another side (D/S). Headwall is a part of HPC, generally, constructed to confine the road laterally at two ends of culvert and also serve as a retaining wall as protection against the scouring or undermining of fill or a flow diverting device. As per information and records, the construction of these culvert started in the month of June 2016 and was completed by the mid of July 2016. Soon after the construction, cracks were visible in the month of August 2016 during inspection. Similar observations were made at several other locations and severity of these cracks was on increase and with time, gradually, the crack was mostly 5mm to 10mm wide within a span of one month (Fig 2). This cause a serious concern to the concerned parties involved.

**Figure 2 Crack development in the head wall of a typical Hume pipe culvert**

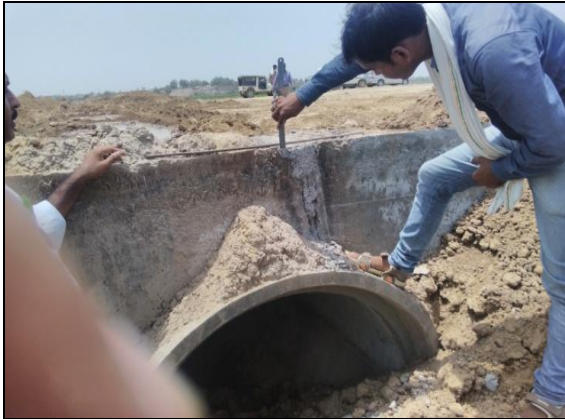
Settlement of both the head wall and pipe culvert was monitored during and after construction and it was observed that significant amount of settlement was noticed within a month of casting of head wall .It was also noted that there was intermittent rain soon after construction (within 15 days) of culvert and the foundation soil was submerged under water as it can be seen in Fig 2. As per drawing, the top R.L. of Head wall should be kept at 209.370 m (when head wall was casted). Following RLs at different locations of head wall were recorded (Fig 5a) and same has been reported in the following Table 1.

**Fig 5(a) Measurement of settlement of head wall and comparison with RLs**

It can be noted that RHS of head wall settles more than the LHS of headwall but the settlement is more or less uniform. On the LHS, the amount of differential settlement is 0.065 m and 0.042m on both side of the culvert. Similarly, on the RHS, the amount of differential settlement is 0.083 m and 0.053m on both side of the culvert. This must have caused stress concentration at the location in head wall where cracks are observed. Total amount of settlement from the original RL (209.37 m) of the head wall can be estimated as 0.063 m, i.e., 63 mm (LHS) and 0.230 m, i.e., 230 mm on the RHS.

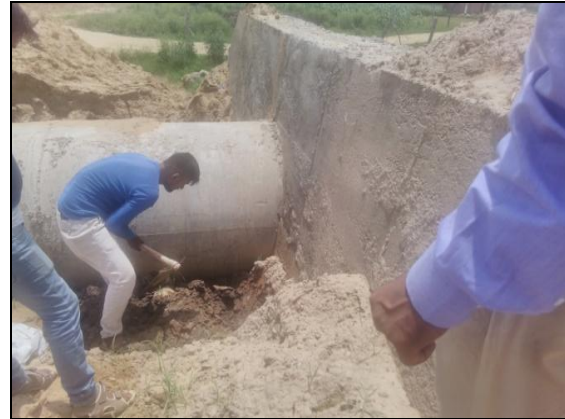
**Fig 5 (b) collection of soil samples for laboratory testing**

Soil samples were collected from the both side of Hume pipe culvert below head wall (Fig 5b) and its properties like grain size analysis, Atterberg's limit and free swell Index and compaction characteristics have been checked in site laboratory. Following Table 2 summarizes relevant geotechnical properties of the soil sample collected from the site:

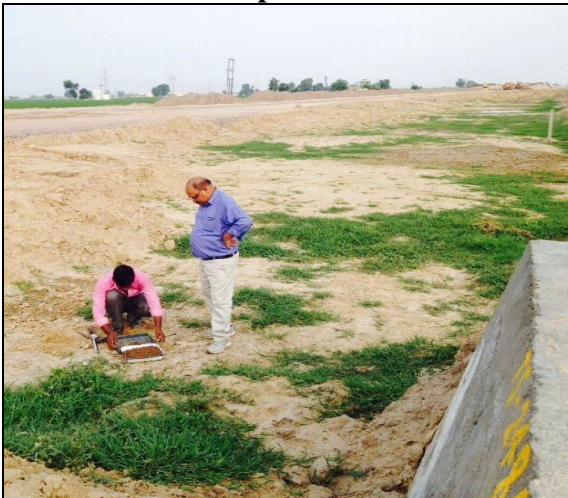
**Fig 5(c) In situ density measurement using sand replacement method**

It can be noted that the soil was very well compacted on the LHS of the culvert and the RC value achieved was more than 95%. This is the reason LHS of the culvert was not much settled. On the other hand, soil on the RHS of the culvert was poorly compacted and RC value was only 92%. This must have caused excessive settlement of the head wall.

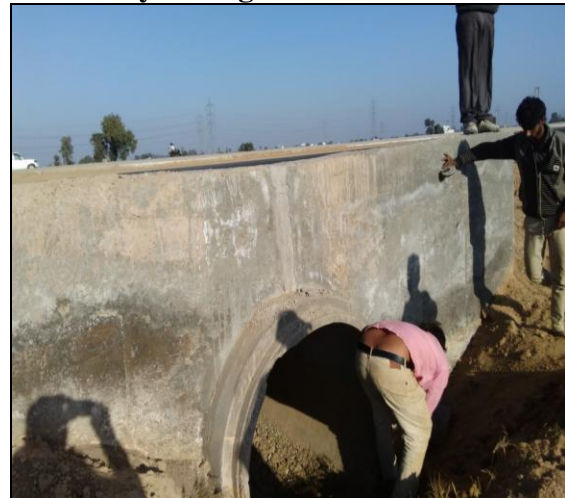
**Fig 5 (d) Investigation for construction deficiency**

- By eye witness interview, it has been brought to notice that there was no proper compaction below foundation of headwall and the construction of head wall was done in a hasty manner. There was no enough time gap between casting of leveling course (P.C.C.-M15) and raft of headwall. It was also noticed (Fig 5d) that P.C.C. below Hume pipe connecting to raft of head wall was also not laid with proper compaction.

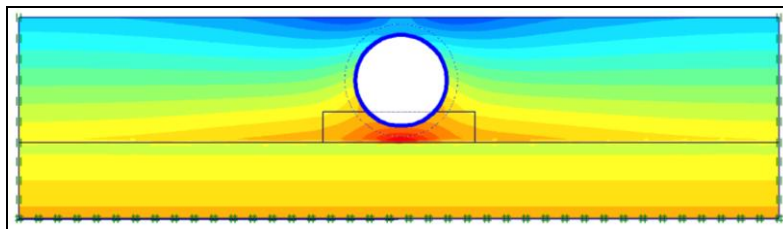
Fig 6 shows the step followed in the numerical analysis of the Hume pipe culvert. From results of the analysis, it can be noted that both compressive and tensile stresses are developed in the head wall. Blue shade shows tensile stresses developed and red shades indicates development of compressive stresses in the Head wall. It can be noted that the tensile stresses developed in the head wall is at the location of the crown of Hume pipe where the crack was developed. As we know that concrete cannot take tension, development of tensile stress ( $53 \text{ kN/m}^2$ ) has caused severe cracks in the head wall. Based on the study, provision of reinforcement can be suggested at the location of tensile stresses development in the head wall.

**Figure 6 (c) Stress concentration in Head Wall (blue shade for tensile stresses)**
