Analysis of Ground Distress Along a Busy Highway – A Case Study from Mumbai, India

Dasaka Murty¹, Vidyadhar Vengurlekar², Dharamveer Singh³ and Salil Upasham⁴

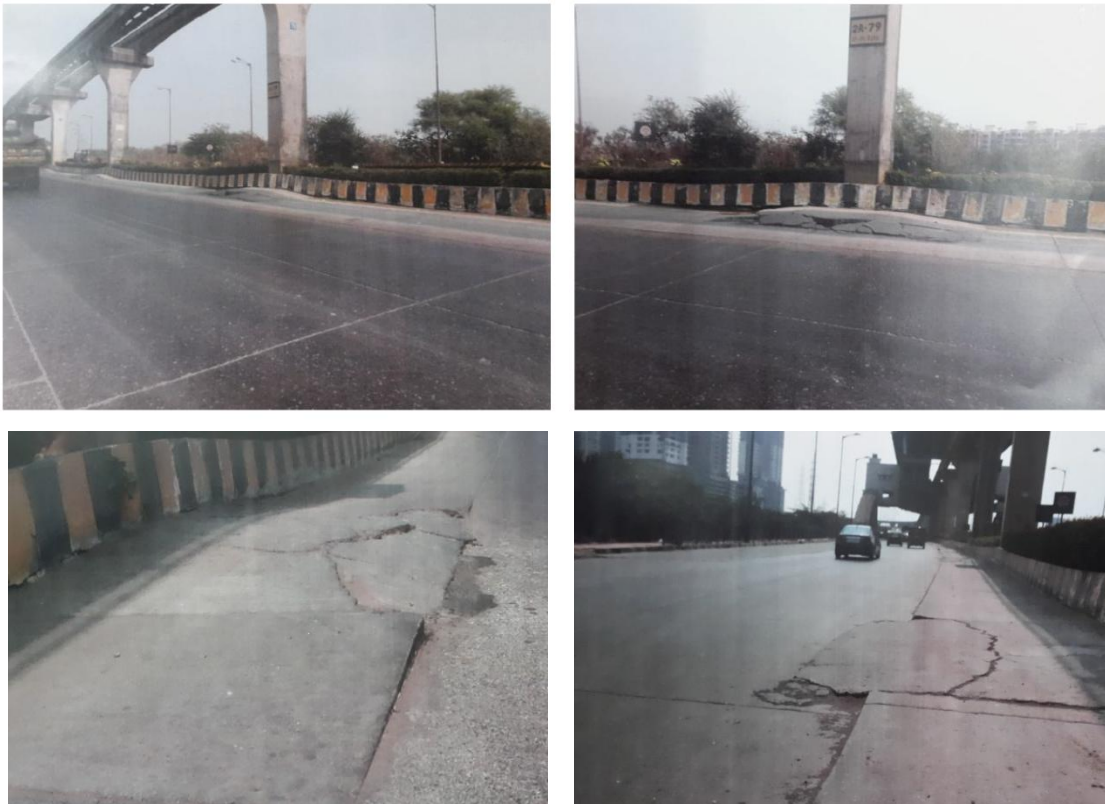
pillar of the monorail, after its construction, as shown in Figure 1. It is reported that this distress was smaller in magnitude initially and has been increasing with time, posing serious threat to the public safety, as several accidents have been reported in the last couple of years. Figure 1 also shows severe cracking of the pavement in addition to large differential settlement at several locations of the highway. To date, the monorail system is not affected by this uncontrolled volume changes, and a hazard may not be ruled out in near future, if the reasons for this distress is not understood properly and controlled forever. Such failure can be averted if through and systematic study of the ground profiles, geotechnical properties of the subsoil is done before planning and construction of any major structures. From the observed ground features, one of the following two causes for the ground distress can be thought of. They are (i) continuous settlement of the pavement due to consolidation of clay deposit, except in the zone surrounding each monorail pillar, which is supported by a strong piled raft foundation; and (ii) pavement distress due to ground heaving around each monorail pillar, probably due to buoyancy effect. If the second possibility is true, it should also be reflected in the upheaval (uplift) of the monorail pillar.

Figure 1: Pavement distress along Wadala-Sewri highway

upheaval of the monorail pillars, it can be safely concluded that the distress in the pavement is, in fact, due to the consolidation of the clay and subsequent settlement of the pavement, except around the monorail pillars, which is firmly supported.

Consolidation of thick soft to medium stiff clay layer is mainly responsible for the differential settlement of the pavement.

In order to prevent further settlements of the subgrade due to consolidation of the soft marine clay deposit, the ground should be substantially improved. Pre-consolidation of the clay deposit is a simple and effective method, and can be achieved by using prefabricated vertical drains with surcharge preloading. However, after installation of the PVD and placing the required surcharge, the ground should be left unattended for a minimum period of 3-6 months to achieve majority of the consolidation. However, owing to heavy and continuous vehicular traffic on the highway, being only access to some of the important establishments, such as Wadala truck terminal, Wadala RTO, and remote possibility of closing the highway even for a small duration, the conventional ground improvement techniques, such as surcharge preloading, sand columns, PVD assisted consolidation, vacuum consolidation, to accelerate the consolidation of the clay layer, may not be suitable at this site. Instead, one of the following alternative ground improvement strategies can be adopted at the site: (i) installation of stone columns extending into the poor subsoil, which can improve the load carrying capacity of the soft soil layer, and subsequently reduce the settlement due to working loads; (ii) placing in-filled geocell layer in base course or above the subgrade of the pavement, which can distribute the traffic loading on a wider area, and significantly reduce the intensity of vertical stresses transferred to the clay layer; (iii) compaction grouting extending into the poor subsoil; or (iv) a combination of stone columns underlying a reinforced in-filled geocell layer. In case of stone columns, a substantial loading needs to be applied on the stone columns and the surrounding area, in the form of embankment loading, in order to allow the stone columns to bulge and mobilize maximum passive resistance from the surrounding soft soil. Placing an additional fill of minimum 1-2 m over the stone columns to enhance the load carrying capacity of the reinforced ground, and substantially reduce the settlements under working loads, may not be possible in this project, and on the other hand increasing the replacement ratio of the stone columns, to control the settlements of the soft soil, proves very costly. In view of the above limitation, the more amenable alternative to improve the ground is to place a well-designed geocell reinforced soil layer overlying the stone columns. The geocell reinforced soil layer acts as a reinforcement layer, and dissipates the traffic loads on a wider area, and prevent overstressing of the soft clay layer. This hybrid reinforcing technique, involving both stone columns and geocell reinforced soil bed, can be effective in controlling the settlement of the pavement, and may prove economical. However, further studies are warranted to critically examine the geotechnical properties of the clay layer, and optimize the ground improvement strategy, in terms of choosing the spacing and depth of the stone columns, and type and thickness of the geocell reinforced soil bed overlying the stone columns.

A hybrid ground improvement strategy, involving installation of stone columns penetrating through the clay layers, overlying a well-designed in-filled geocell reinforced soil layer, can be a viable option for the site, which can prevent further settlement of the pavement.
