Causes of Cyclic Shear Failure at Lokanthali of Araniko Highway after Mw7.8 2015 Gorkha Earthquake

Binod Tiwari, Ph.D., P.E.¹ Beena Ajmera, Ph.D.², and Brian Yamashiro³

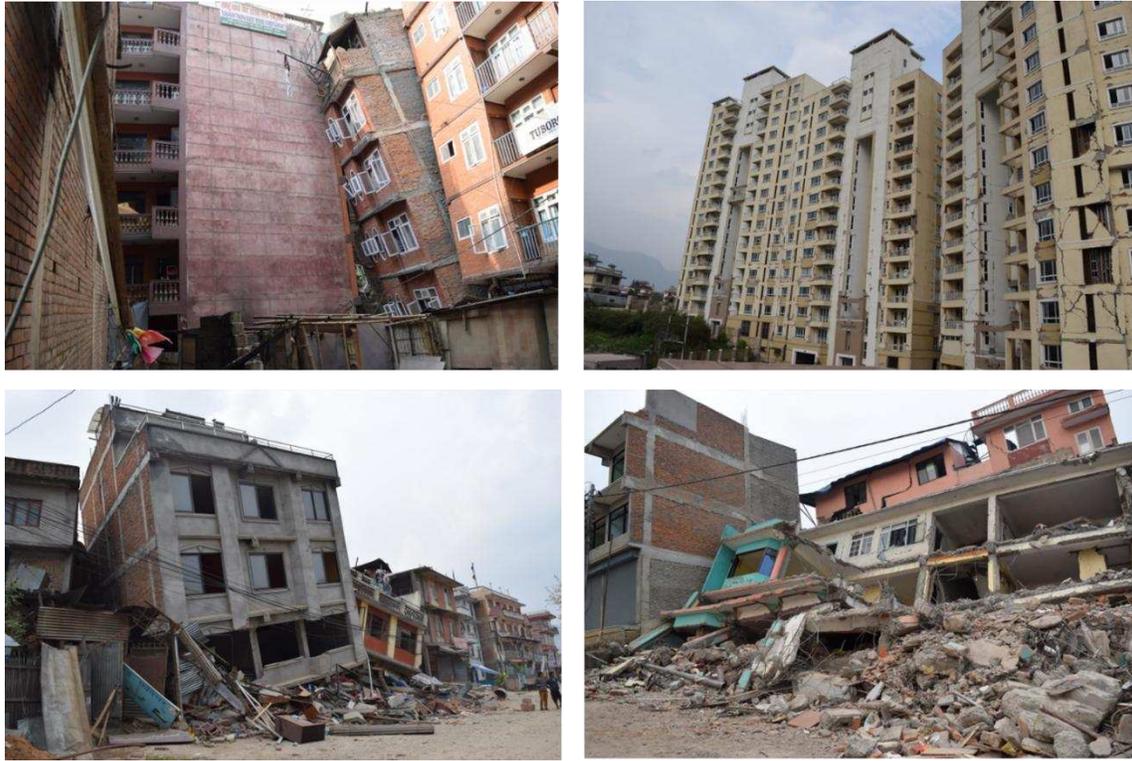
Figure 2. Extent of structural damage observed in Kathmandu Valley due to the 2015 Gorkha Earthquake. Majority of the damage were soft-story collapses.

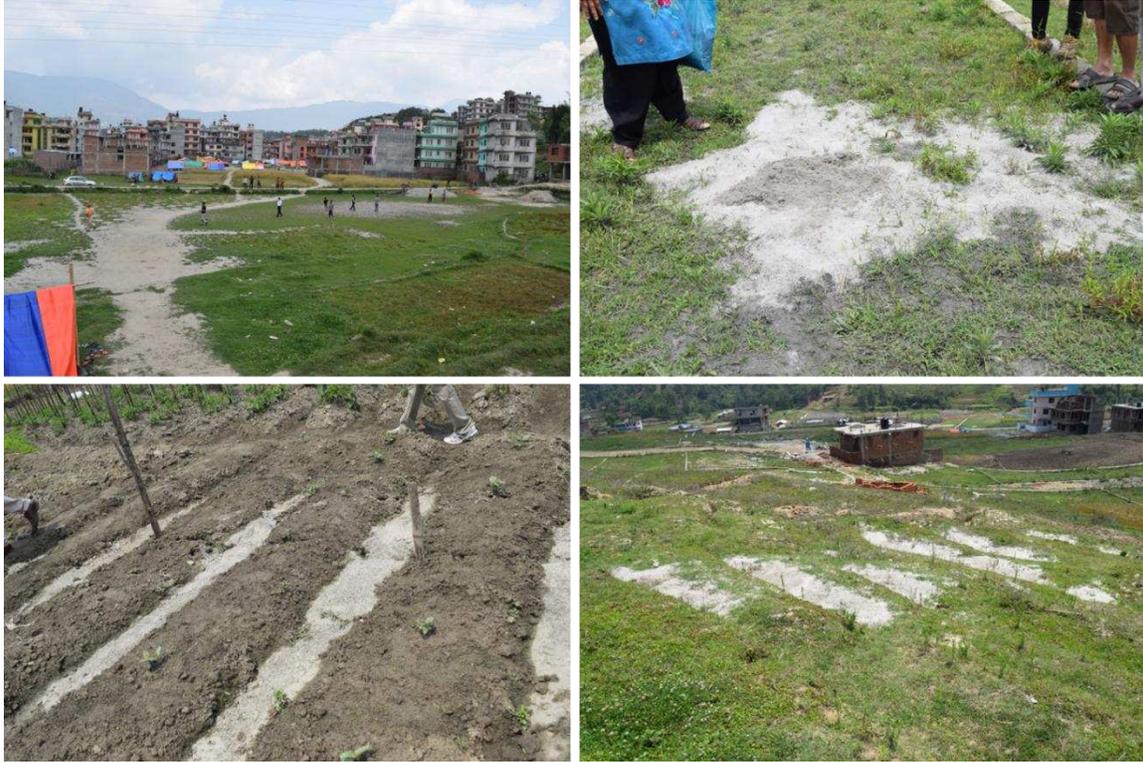
The 2015 Gorkha earthquake triggered liquefaction at more than 15 locations (Figure 3). At those locations, traces of liquefied sand ejecta were observed. Some of those ejecta were in significantly large in quantity and the others were clearly visible traces, but not in abundant quantity. The field observation showed that the earthquake shaking was just enough to liquefy the soil, but was not sufficient to cause a massive damage to structures.

Figure 3. Sand ejecta observed at the edges of Kathmandu Valley due to liquefaction. The liquefaction sites, although were wide spread, did not damage structures.

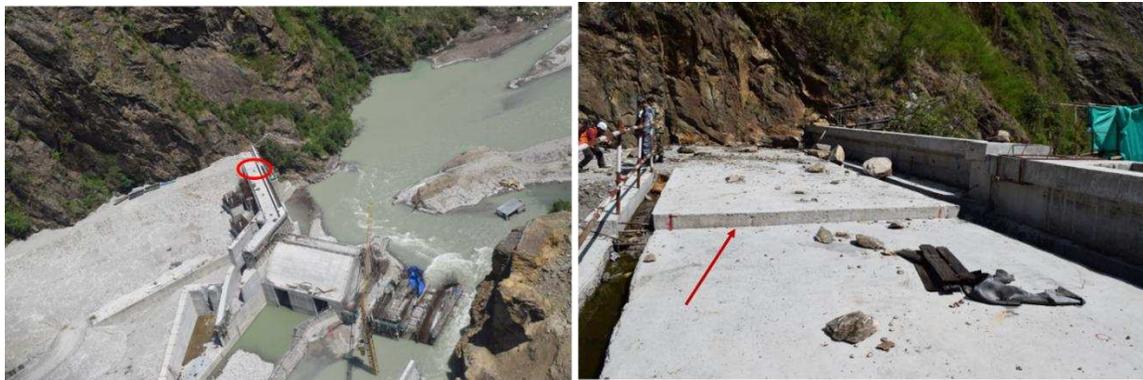
The 2015 Gorkha earthquake significantly affected the hydropower projects. While majority of the damage was observed in the dams, penstocks and powerhouses due to landslides and rock falls, 19 cm of seismically induced settlement was observed on the dam body of the Upper Tamakoshi Hydropower project, the largest Hydropower Project of the nation, which was under construction at the time of earthquake (Figure 4).

Figure 4. 19 cm settlement observed at the main dam of Upper Tamakoshi Hydropower project due to seismically induced settlement of the foundation material.

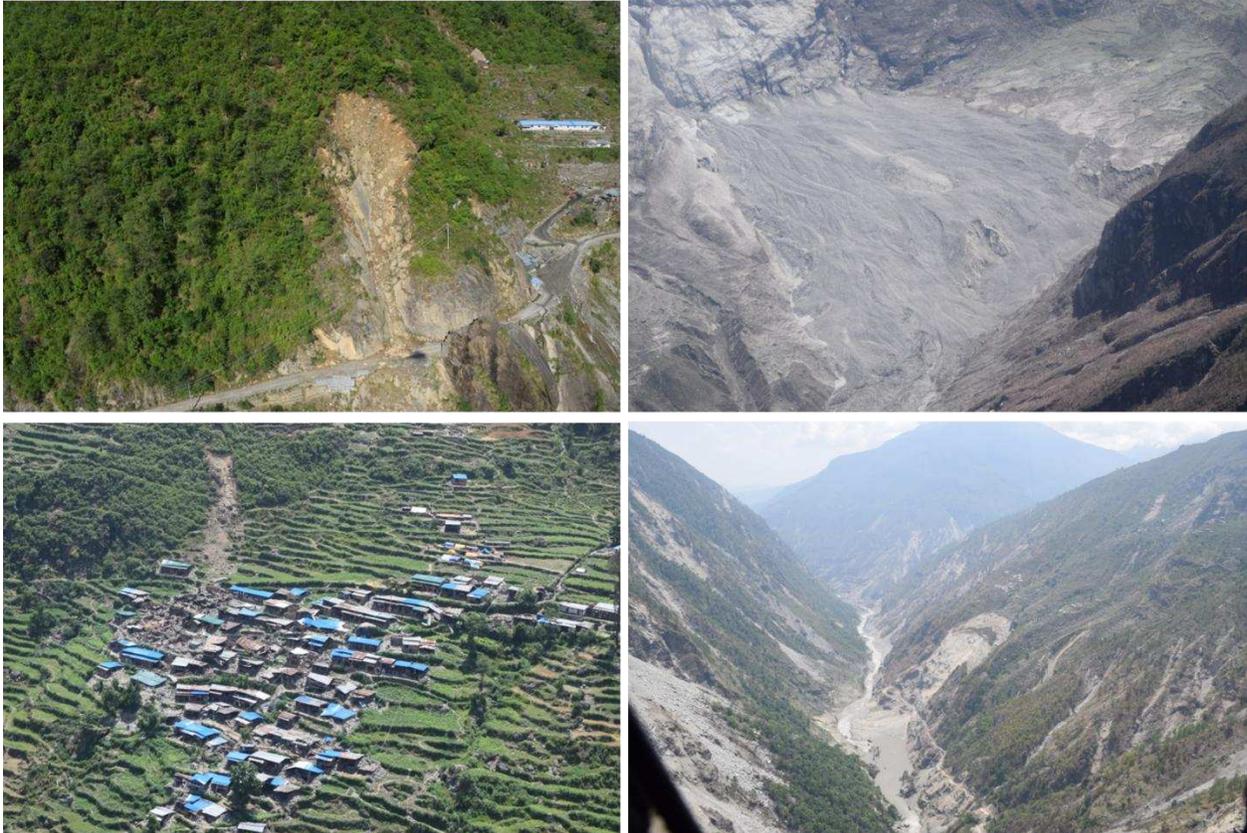
As expected, the 2015 Gorkha earthquake triggered approximately 15,000 co-seismic landslides (Figure 5). Approximately 3,500 of these landslides were larger than 100 m² in area. Tiwari et al. (2016) correlated those landslides with terrain slope, geology, and peak ground acceleration (PGA) and reported that slope inclination and PGA were the most influencing factor in triggering those landslides. More than 99% of those triggered landslides were disruptive landslides. Although very small in number, the coherent landslides triggered by the earthquake caused significant damage to structures and killed hundreds of people. Two among those landslides are Langtang Debris Avalanche and Lokanthali cyclic shear failure. Description of Langtang Debris Anavalche and other valley blocking landslides are available in Hashash et al. (2015), Moss et al. (2015) and Collins and Jibson (2015). This article discusses in detail about the Lokanthali cyclic shear failure site.

Figure 5. Typical co-seismic landslides observed in various parts of the country due to the 2015 Gorkha Earthquake.

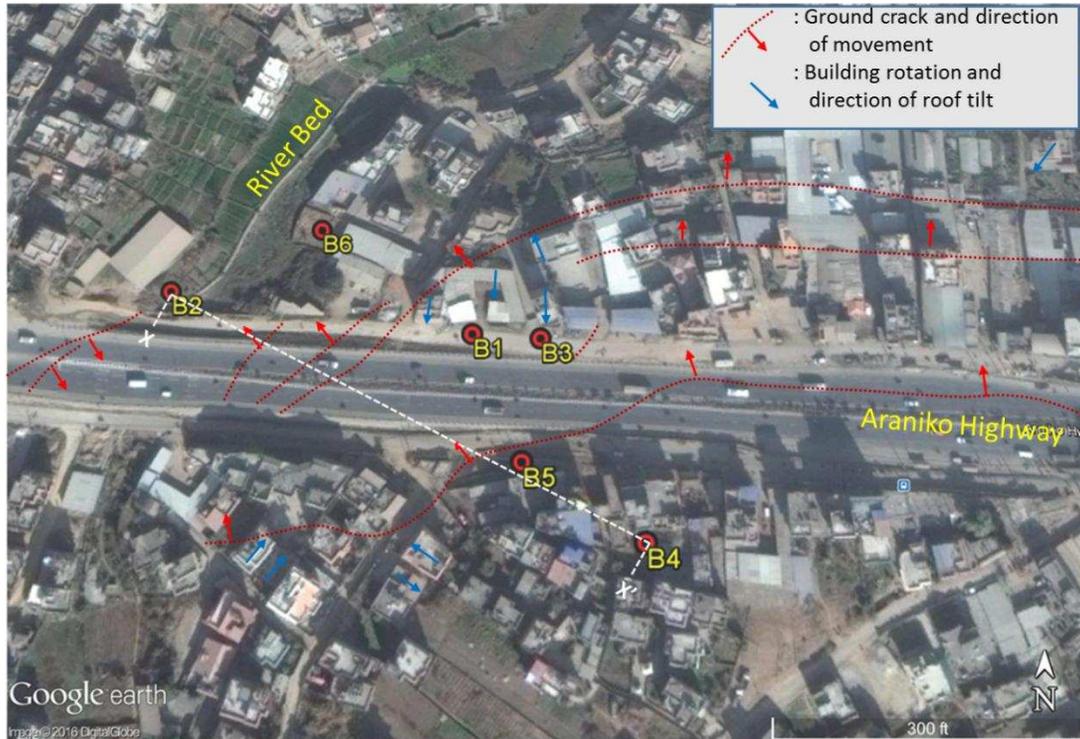
Figure 6. Observed main distress features at Lokanthali site and locations of in-situ investigation performed for this study (indicated by points “B”).

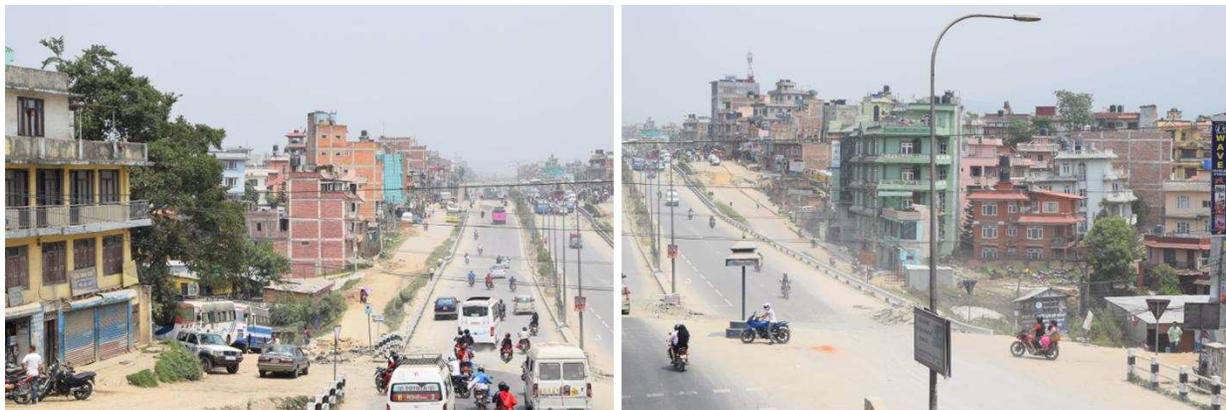
The authors conducted post-earthquake field investigation to evaluate the damage condition and potential cause of ground failure. The cyclic failure caused three major types of damage – a) partial collapse and major settlement of approximately 250 m length of Araniko Highway (Figure 7), b) partial or complete damage of many modern structures (Figure 8), c) development of tension cracks and settlement at 300 m x 300 m plan area (Figure 9).

Major portion of the settled highway is presented in Figure 7. This portion of the highway was constructed during the recent road improvement and includes an engineered fill within MSE walls (that can be seen in Figure 9). Figure 9 shows a few cracks observed along the eastern and western boundaries of the landslide. More than 1 m of vertical drop was observed at different locations within the residual area in the southeastern side of the distressed highway. Several buildings, located in the unstable side of the slope, were observed to have moved by 0.5-1.0 m along with their foundations without having a noticeable tilt in the building. Settlement occurred on both east and west sides of the highway ends near the creek, presented in Figure 10. This creek, which accumulates a large amount of surface run-off during the rainy season (that the authors observed during their field investigation during mid-monsoon period), is currently channelized with approximately 60 cm. diameter concrete pipes.

Figure 7. Overall view of distressed portion of Araniko Highway at Lokanthali, Left: North side of the highway; Right: South side of the highway.

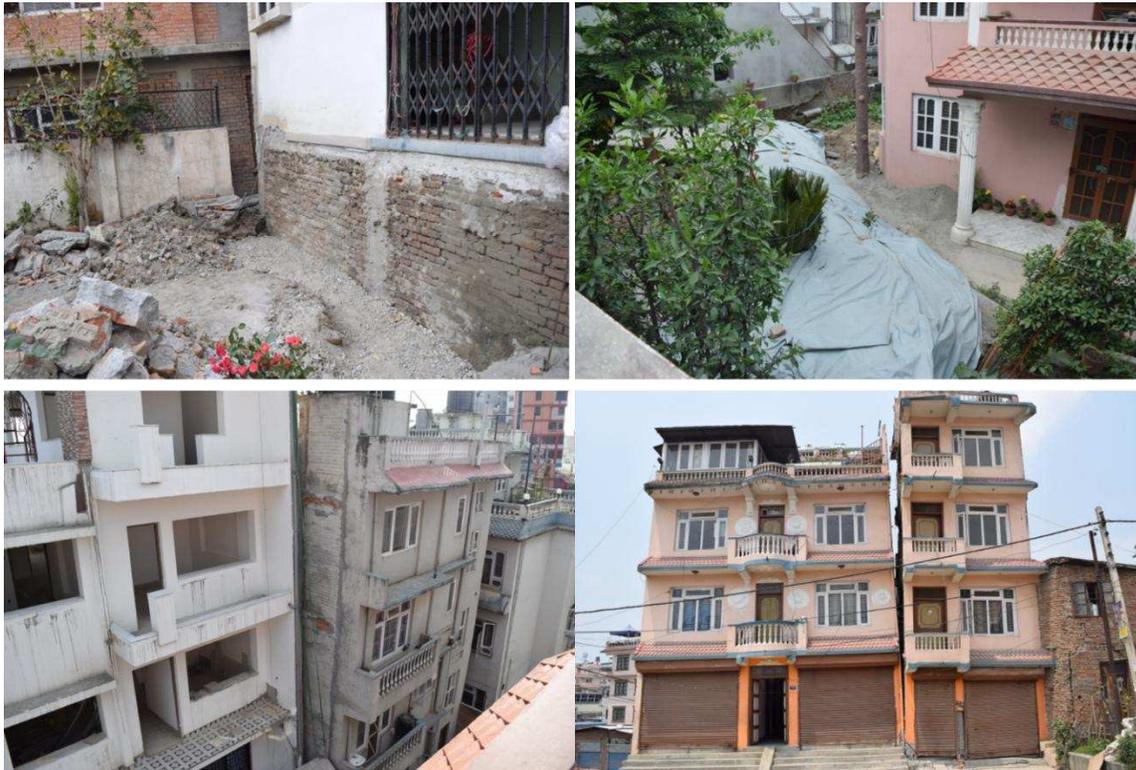
Figure 8. Typical structural damage observed during the field investigation.

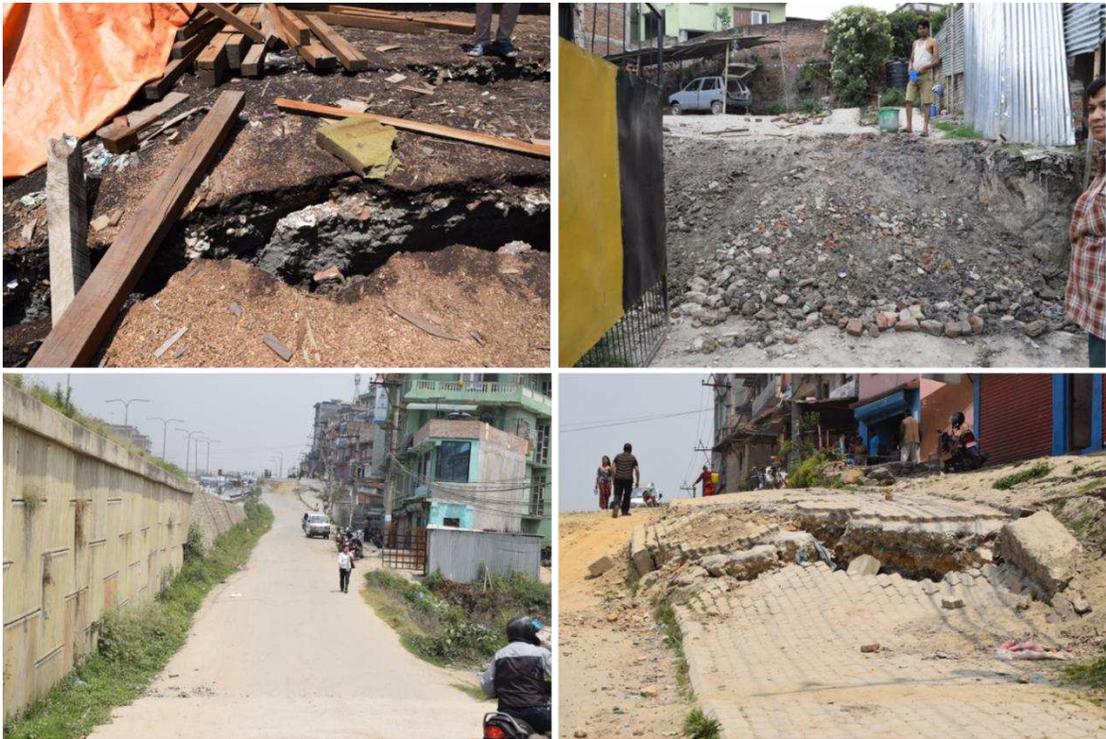
Figure 9. Left: Observed tension cracks and settlements throughout the study area.

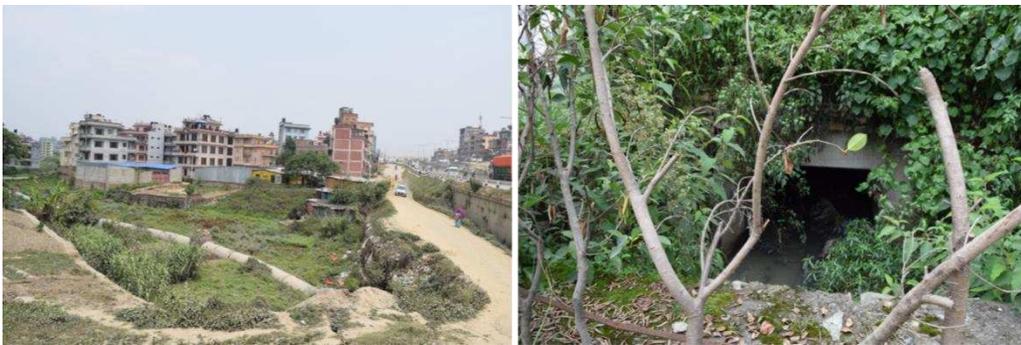
Figure 10. Concrete pipe and open culvert that used to drain the water from the study area.

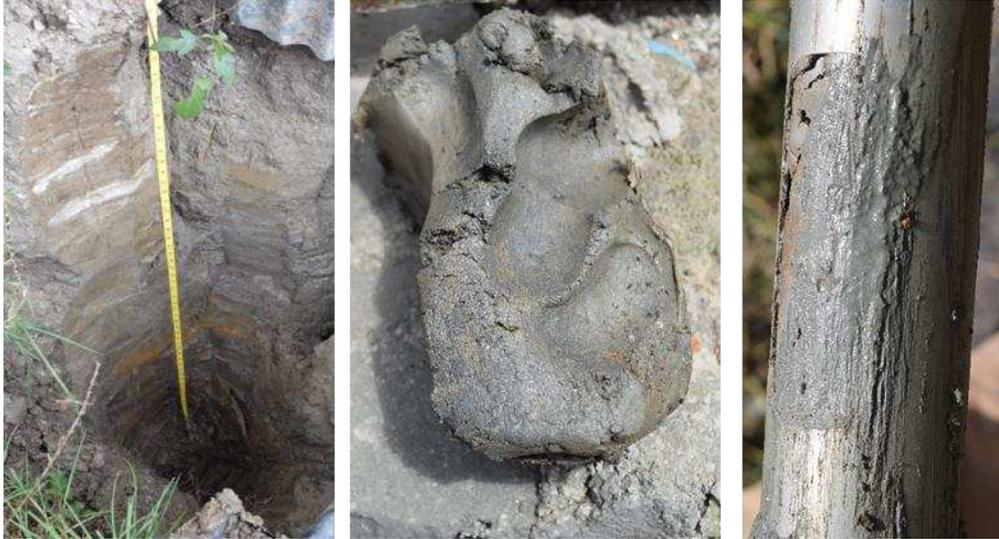
Figure 11 (Left). Left: Typical soil profile observed near the main scarp location; Center: Lacustrine deposits exposed along road cut (27°40'30.6"N, 85°21'42.4"E), composed of plastic clay beds separated by very thin sand layers (light grey in the photo); Right: Type of material observed during subsoil exploration.

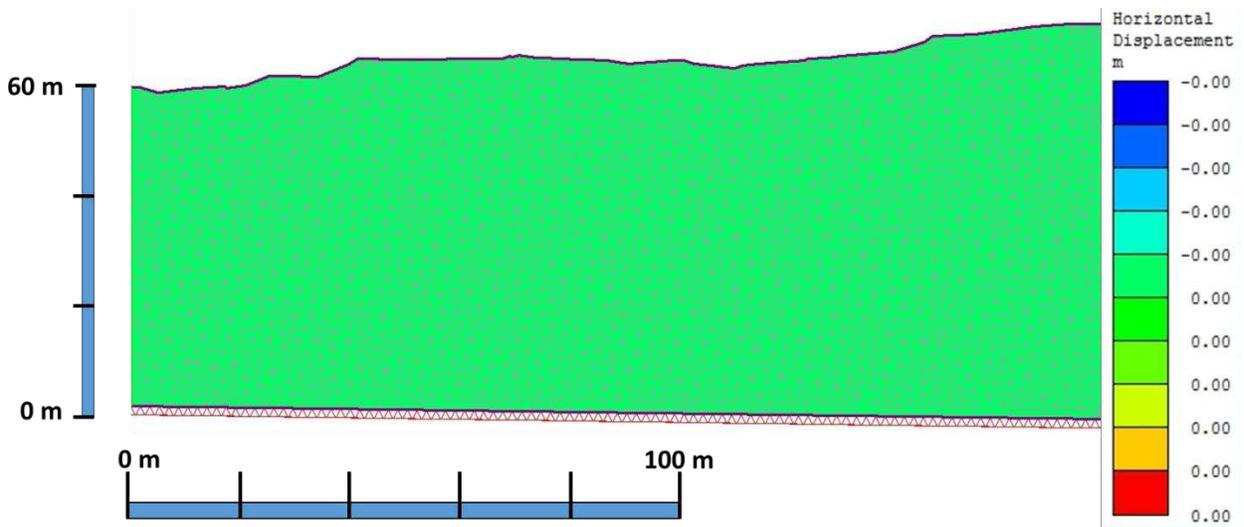
Results of the deformation analyses after the earthquake without and with strength degradation are presented in Figures 16 and 17, respectively. As can be observed from Figure 16, the slope was stable prior to the earthquake and after the earthquake considering the shear strength of soil prior to earthquake. When a strength degradation of 70% (which was obtained from the laboratory test) was applied, maximum horizontal displacements of approximately 1.2 m was observed. Magnitude and amount of those deformations are close to that observed in the field. When the ground motion after the major aftershock of Mw7.3 was applied, the slope did not show any additional deformation. The first author was at Lokanthali site at the time of the Mw 7.3 earthquake and confirmed that the earthquake did not trigger any further movements of the slope. The numerical study result shows that the shear strength degradation in combination with the seismic loading were responsible for the cyclic shear failure at Lokanthali.

Figure 16. Horizontal displacement of slope obtained after earthquake load without strength degradation, as calculated from numerical analysis

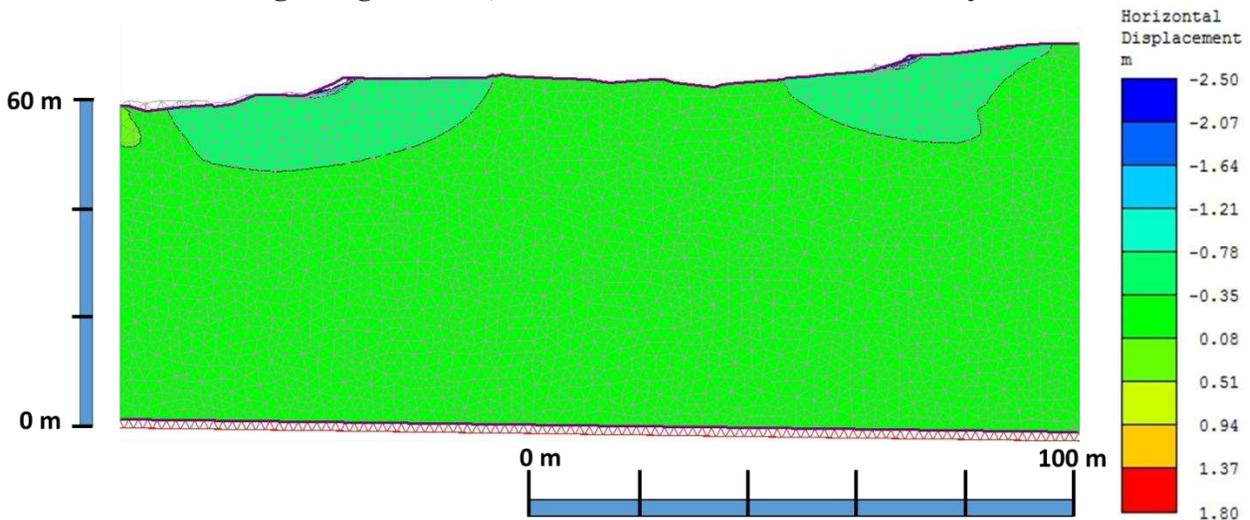
Figure 17. Horizontal displacement of slope obtained after earthquake load with strength degradation, as calculated from numerical analysis
