An investigation of effect of 2015 Gorkha Earthquake within the World Heritage monument zones of Kathmandu Valley

Ashutosh Kumar

ABSTRACT: On April 25, 2015, Kathmandu Valley was dramatically altered by the Gorkha Earthquake ($M_w=7.8$) causing huge damage to the UNESCO world heritage monuments. This study focuses on identifying the causes of collapse or damage in the ancient structures by investigating the geotechnical characteristics of the soil supporting them and also by collecting the associated damage evidence of the monuments. Geotechnical site investigation and structural damage pattern assessment were conducted at five heritage sites in Kathmandu during 2017-2018. The results of investigations revealed the presence of soft soil strata within the Hanuman Dhoka Durbar square which corroborated with the extensive damage recorded highlighting the importance of local site effect. The detailed laboratory testing results as shown for Jaisidewal temple site is required to study effect of dynamic soil-structure interaction on the heritage structure performance. Damaged evidence of structure pointed out that the age-related deterioration of the construction materials, loosening of

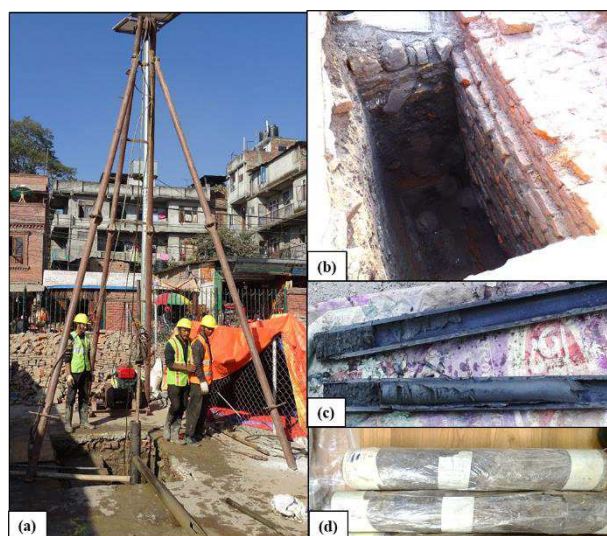
Figure 2. Pashupati location on December 10, 2017 (a) drilling operations, (b) removal of cultural materials (c) extracted disturbed sample and (d) undisturbed soil samples

At Pashupati site, soil was primarily sandy and SPT value ranged from 33-50 for the full depth of borehole indicating the presence of dense to very dense sand with a thin layer of medium dense sand at 8 m depth (SPT-N= 15). The soils were primarily non-plastic. Bhaktapur site showed nearly increasing penetration resistance ranged from 2-35 having very loose strata present at the shallow depth to very dense layer present at deeper depth. The soil was primarily clayey silt with plasticity index ranged from 4-12. Changu Narayan showed the presence of dense clayey silt having SPT-N ranged from 35-50 and plasticity index ranged from 6-12. At Jaisidewal location, SPT-N ranged from 8-50 indicating the presence of soft to stiff soil. The plasticity index of the soil ranged from 6-22 indicating the presence of clayey strata. Hanuman Dhoka revealed the presence of loose to medium dense to very dense sand strata where SPT-N ranged from 9-50 with a very thin layer of very loose strata at 7.5 m depth (SPT-N= 3). The specific gravity of the soil ranged from 2.55-2.72 indicating the absence of organic matter. More details about the geotechnical properties of sites can be found in Kumar et al. 2019 and 2020. During the drilling operation, the ground water table was only recorded at Pashupati at a depth of 7 m from the ground level. The drilling location at Pashupati was very close to the Bagmati river. It has to be pointed out that the drilling was carried out during the dry season. Also, the evidence of liquefaction was not observed at any of the surveyed heritage sites. Gautam et al. (2017) presented the evidence of soil

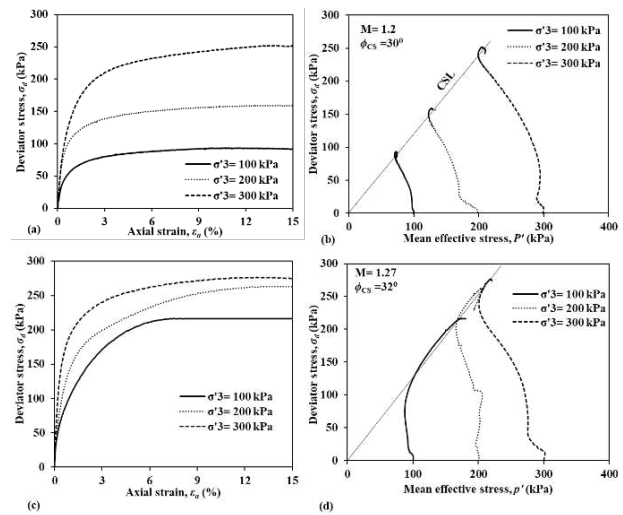
Figure 3. Results of monotonic triaxial testing (a) Deviator stress–strain response for silty sand at 9 m depth (b) Stress path and critical state envelope for silty sand at 9 m depth (c) Deviator stress–strain response for silty sand at 12 m depth (d) Stress path and critical state envelope for silty sand at 12 m depth.

Figures 3b & 3d shows the plots of deviator stress q and mean effective stress p' ($p' = \sigma_1' + 2\sigma_3'/3$) on q - p' space which was then used to obtain the critical state parameter M , the slope of deviator stress and mean effective stress. The critical state friction angle ϕ_{cs} was obtained using $M = 6 \text{Sin} \phi_{cs} / (3 - \text{Sin} \phi_{cs})$. The critical state shear strength friction angle for clay sample was obtained as 33° , for silty sand at 9 m depth was 30° and for silty sand at 12 m depth was 32° . It was observed that the critical state shear strength friction angle obtained for different depths were comparable with shear strength parameters corresponding to SPT-values recorded during the drilling operation (Kumar et al. 2020).

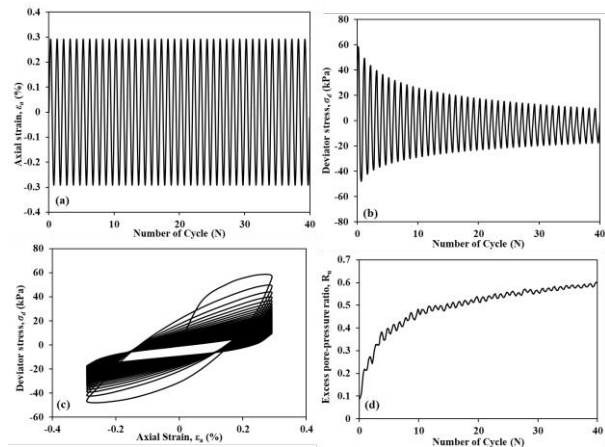
strain i.e. hysteresis loop that depicts the degradation of the stiffness of soil with an increase in the number of loading cycles. Figure 5d indicates the gradual increase in the excess pore water pressure ratio, r_u (ratio of excess pore pressure induced during shearing to an effective confining pressure, 100 kPa) where r_u reaches to a value of 0.65 at the end of 40 cycles of loading. Such increase in the pore-water pressure ratio was responsible for successive reduction in the deviator stress. The details about the modulus reduction and damping ratio curve of the soil can be obtained from Kumar et al. (2020).

Figure 5. Cyclic triaxial test results: (a) Axial strain $\epsilon_a = 0.3\%$, $f=1$ Hz, $\sigma'_3=100$ kPa; (b) Deviator stress versus N ; (c) Deviator stress versus axial strain ϵ_a ; (d) PWP ratio r_u versus N .

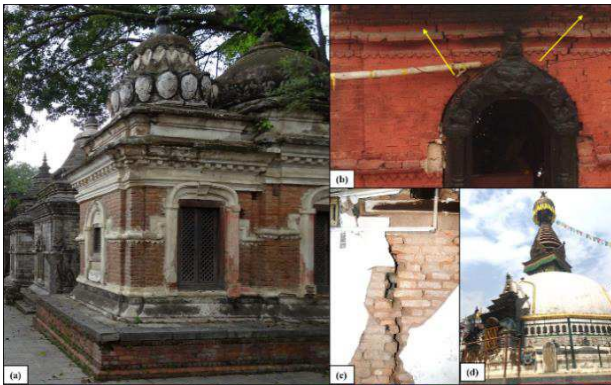
During post-earthquake reconnaissance surveys conducted in 2017 and 2018, minor to serious levels of damage were identified in most of the structures surveyed. Figure 7 illustrates the typical symmetrical temple structures made of stone and brick masonry (Figure 7a) and the damage patterns within the arch of the brick masonry temple and a wide visible cracks within the walls (Figure 7c) and the view of dome shaped or stupa style temple structures (Figure 7d). Similar crack patterns were identified in many temples with similar geometrical configurations also constructed using brick masonry walls. This damage pattern is attributed to stress concentration near the crown portion of the temples and their inability to bear bending stress induced during seismic shaking.

Figure 7. Temple structures common typologies and crack propagation (a) View of symmetrical temple structures 3 years after the 2015 Gorkha earthquake (b) Crack propagation in the crown portion of a typical temple (c) cracks in the wall panel (d) Dome shaped temple structure.

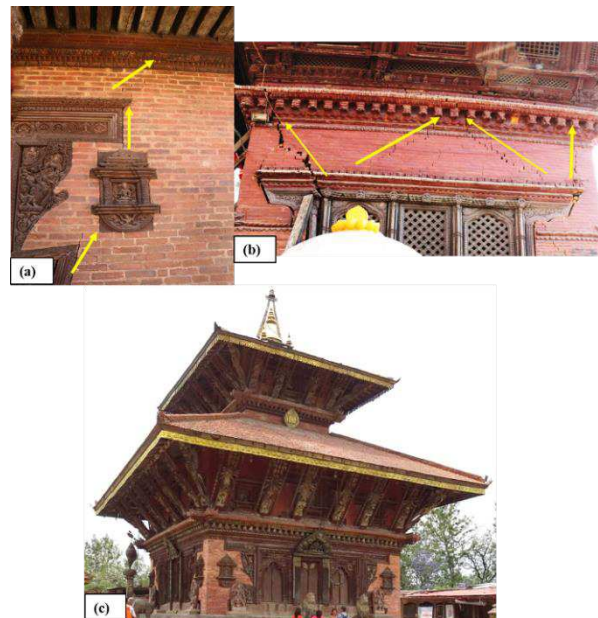
Figure 8 show the distribution of crack within the temple structures where diagonal and vertical crack propagation can be observed in one of the temple structures of Bhaktapur and Hanuman Dhoka, and also the view of Changu Narayan temple showing no noticeable damage. It has to be pointed out that Changu Narayan Temple structure did not suffer damage even during the 1934 Nepal-Bihar earthquake. This may also be due to the location of the Changu Narayan on the hill top and the presence of very dense soil strata. However, some of the structures which has shown damaged evidence in the Hanuman Dhoka and Bhaktapur monument zones have wooden sculptures embedded within the masonry walls which has provided a zone of stiffness incompatibility and the zones of crack opening (Figure 8a). Such insertion of sculptures within the walls should be avoided in terms of seismic standpoints. In addition, the diagonal and vertical crack originating from the walls may be due to the inability of the walls to withstand the shearing action arising during the earthquake (Figure 8b). This may also be due to the inability of the mud-mortar present in the masonry walls to resist the lateral forces induced by 2015 Gorkha Earthquake. However, other portions of the building appeared to be intact from outside and the wooden support system are fixed and repair process were undergoing. Inspection within some of the heritage structures revealed flexure crack propagating from the timber

connection points. In some of the structures, wide cracks ranged from 50 mm – 200 mm were observed which is difficult to repair. The survey noted minor level damage in the structure made of stone masonry and stupa or dome shaped structures. One storied temples performed relatively well compared to the multi-storied temples. This was probably due to the fact that small temples developed good box action between all the elements of the building and in particular that of the roof and walls.

Figure 8. Masonry temple structure performance observed during the survey (a) Crack distribution in one of temple of Bhaktapur, (a) Crack distribution in one of the temple of Hanuman Dhoka, (c) view of Changu Narayan temple where no noticeable damages observed.

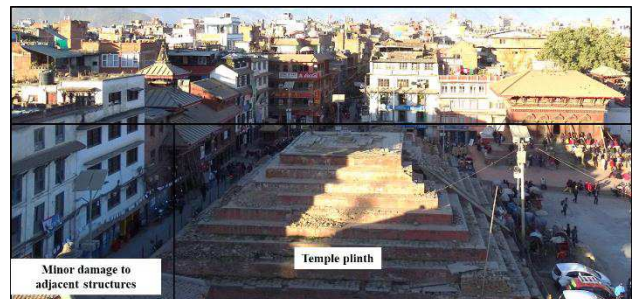
Figure 9 shows the view of the complete collapse of a temple structure within the Hanuman Dhoka Durbar square zone and the adjacent structures. It can clearly be observed that the adjacent structures made of modern construction materials performed very well compared to the masonry structures. Survey also noted that that the heritage structures were more affected as compared to modern reinforced concrete structures. Damaged evidence pointed out that the age-related deterioration of the construction materials, loosening of the bonding of the masonry units, poor connection within the composite structures and discontinuous loading distribution pattern along with local site effect might be responsible for the cultural catastrophe observed in the Kathmandu Valley.

Figure 9. Complete collapse of heritage temple structure and minor level damage to adjacent structures made of modern construction materials.
