Rawene Reserve landslips emergency response and stabilisation

Simon Farquhar

Tonkin and Taylor Ltd, New Zealand, sfarquhar@tonkintaylor.co.nz

KEYWORDS: landslide, ground stabilisation, debris flow, anchored palisade wall, strainmeter

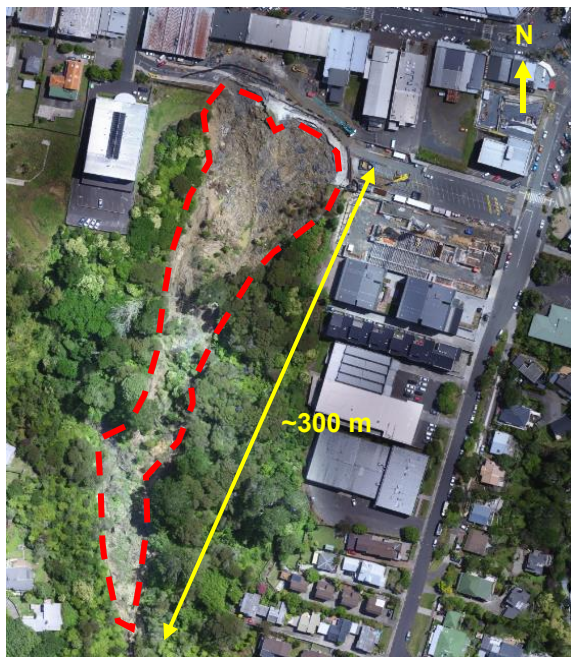
Rawene Reserve is located behind the Mokoia Road shops in the suburb of Birkenhead on Auckland's North Shore (Figure 1). The reserve consisted of an asphalted carpark for the shopping area and a densely vegetated gully. Cracking was first identified in the carpark asphalt by Auckland Transport in 2015. A geotechnical investigation was undertaken identifying a slow-moving deep-seated landslide (GHD 2015). The cracks were sealed and the carpark visually monitored for further signs of instability. Creeping movement of the landslide was observed in August 2017. Auckland Transport closed a section of the carpark on 20 September 2017 for safety reasons. On 9 October 2017 significant movement of the landslide occurred over a period of approximately 5 hours. A 5 m high headscarp formed with a debris flow extending up to 300 m down the Rawene Gully, coming to rest in privately owned land (Figures 2 & 3). The debris flow dammed streams and destroyed a wastewater pipe bridge, causing sewage to overflow into the reserve.

Figure 2. Landslip and debris flow extents (in red dashed line).

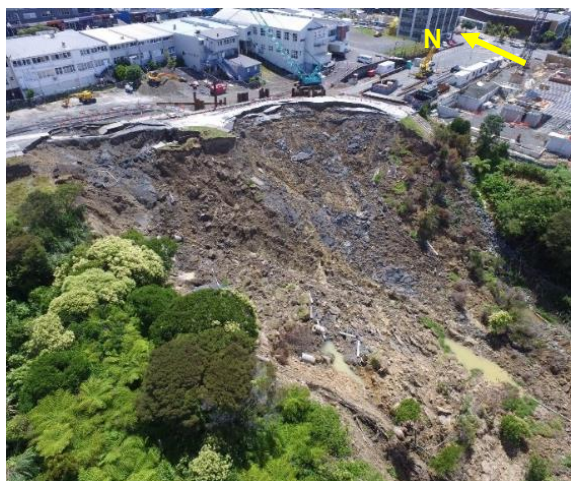
immediately to the west of the initial failure (eastern failure). The western failure occurred during installation of the jet-grouted columns, resulting in the loss of the grouting rig in the landslide debris, as well as further loss of the carpark and the access road. In early January 2018, the western failure headscarp regressed causing loss of a footpath, which had previously been undermined. A sheet piled wall was installed 5 to 10 m behind the eastern and western headscarps to prevent further regression of the landslide towards the buildings at Mokoia Road. The sheet piles were driven 10 to 13 m below ground level, in 3 m wide groups in a 'hit and miss' pattern to prevent creating a groundwater dam. The landslide movement appeared to stabilise following the January 2018 regression with only minor surficial movement of the debris observed.

Figure 3. Aerial oblique photograph of landslide headscarp taken 7 January 2018.

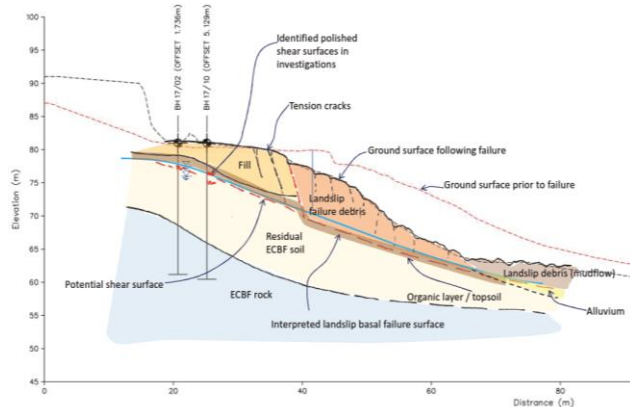
remoulded landslide debris materials up to 5 m thick were deposited over the alluvial and residual soils in the base of the gully. The soft debris presented challenges for construction. The subsoil model is presented in Figure 4.

The landslides are considered to have occurred due to one of, or a combination of, the following failure mechanisms: uncontrolled fill placement resulting in poorly compacted fill over soft soil layers (paleosols); oversteepened slopes; saturation of the fill (due to surface infiltration and inadequate drainage in the fill); failure through saturated and softened zones in the fill and ECBF soil; failure on the organic layer / buried topsoil at the base of the fill; failure on pre-sheared defects in the residual ECBF soil (Figure 4).

Figure 4. Geological model of site following the landslide with inferred translation failure mechanism.

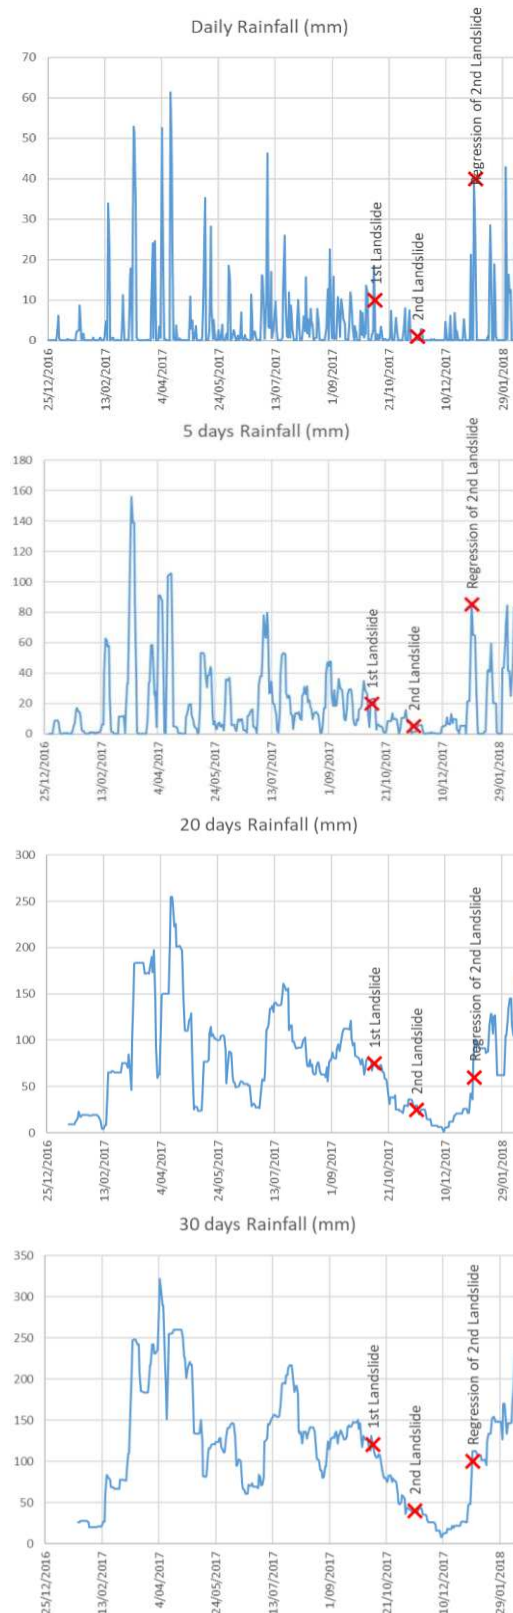
A review of rainfall data collected from a monitoring station 1 km from the site indicated that the rainfall in the month prior to the October and November 2017 landslides was not significantly higher than in earlier months (Figure 5). Daily (24 hour) rainfall data was first assessed. Glade (1997), notes that there are limitations when looking at daily rainfall data only. A prolonged rainfall event may occur over a number of days. Pore-water pressure may take days to infiltrate and dissipate from a slope. As such, 5, 20 and 30 day cumulative rainfall values were also compared.

The first ground movement was observed in 2015 and following this, softened zones and sheared surfaces may have begun to develop. As such, the main landslide was not thought to be caused by extreme short term weather conditions. However, long term rainfall may have contributed to increased saturation of the fill. Short term rainfall may have triggered subsequent smaller failures (i.e. the January 2018 regression).

Figure 5. Cumulative rainfall data from 26 Miraka Place, located approximately 1km away from Rawene Reserve (red crosses note landslide events). From top to bottom: a) 1 day, b) 5 days, c) 20 days, d) 30 days.

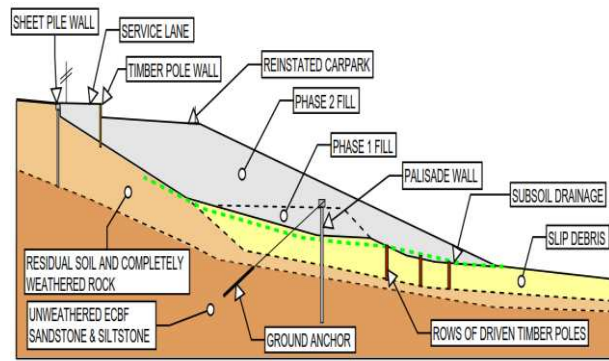
Figure 6. Typical section down slope showing Phase 2 design elements (approximate only)

Phase 2 works focussed on re-establishing the carpark and ensuring the site, and supported buildings met adequate long term stability requirements. The design (Figure 6) primarily consisted of:

- An anchored in-ground reinforced concrete pile palisade wall.
- Placement of up to 27,000 m³ of imported SPR fill above and below the palisade wall to reform the carpark and slope.
- Rows of driven timber poles to stabilise landslide debris down-slope of the palisade wall.
- Construction of a timber pole retaining wall to support a new service lane behind the Mokoia Road shops on the uphill side of the carpark.
- Civil works and services including pavements, stormwater

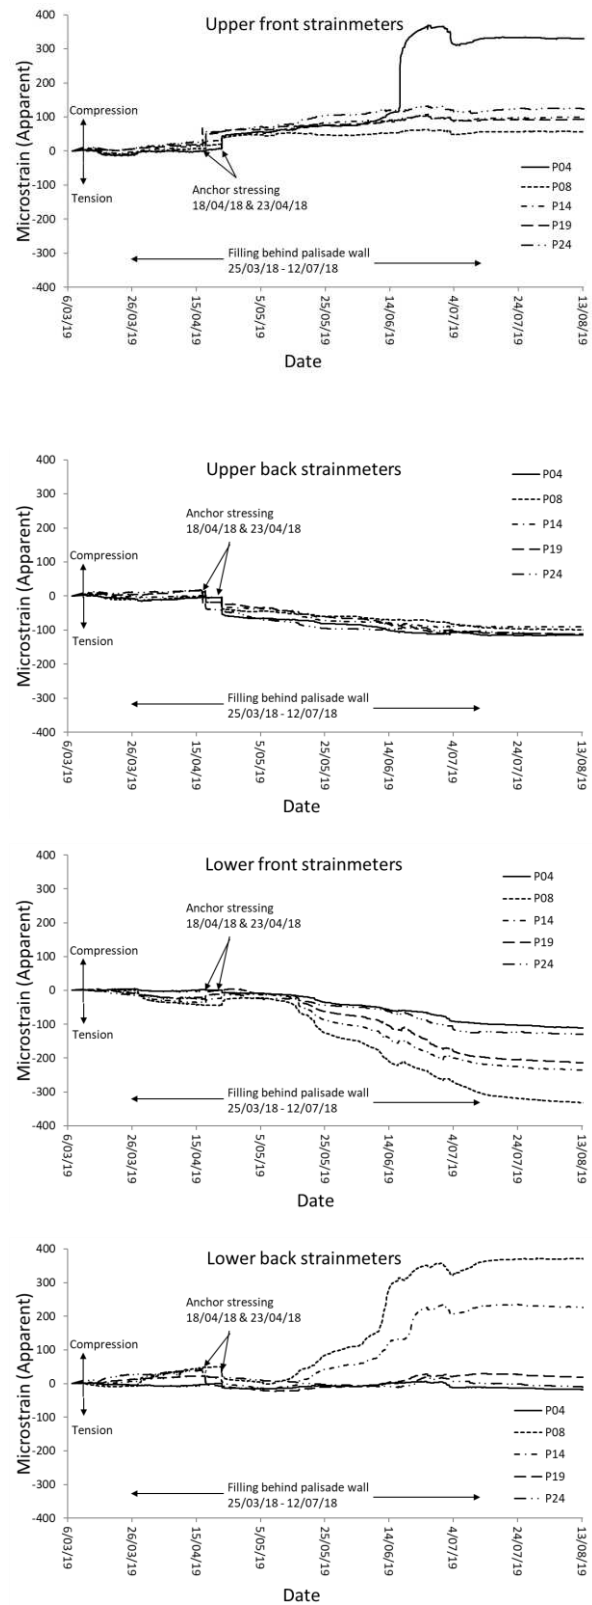
The strainmeters typically show for the upper pairs (located 1 m below the top of the pile) a positive bending moment of approximately 175 kNm is measured (25% of the calculated design action). For the lower pair of strainmeters (located 8 m below the top of the pile) a negative bending moment of 415 kNm is measured (30% of the calculated design action). The ULS design load for the wall was determined using limit equilibrium analysis targeting a factor of safety of 1.5. For large failure surface areas this can result in very high stabilisation forces being required. The monitoring indicated that the actual (working) loads in the piles are significantly smaller than the design loads. Additional strainmeter pairs would have helped to confirm the full bending moment profile along the length of the piles. However, this would have added significant cost to the project.

Figure 8. Palisade wall pile rebar strainmeter comparison. Note spike in strain during anchor stressing. Strain increased during filling, negligible change in strain following earthworks indicates that movement of the palisade wall is not occurring. From top to bottom: a) upper front, b) upper back, c) lower front, d) lower back.

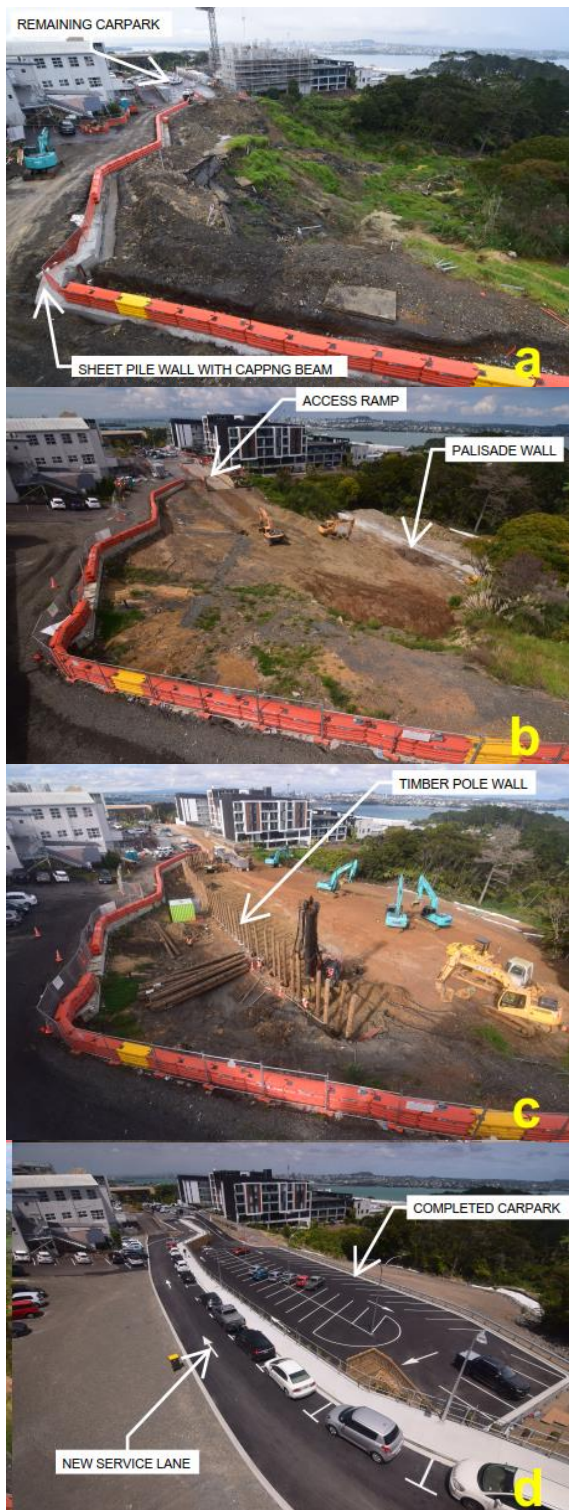
Figure 9. Photos of site from time-lapse camera: a) 28 June 2018 – Phase 1, prior to earthworks, b) 3 March 2019 – Phase 2, palisade wall completion, c) 5 July 2019 – Phase 2, fill 90% complete, timber pole wall construction, d) 22 November 2019 – carpark completion.

Placement of the fill, up to 15 m thick, took place quickly during winter months with the aim of opening the carpark as soon as possible. The fill was placed over top of the 5 m thick layer of saturated landslide debris and alluvial materials, with characteristic undrained shear strength of 30 kPa (measured from in-situ and core barrel hand-held shear vanes). Photos of the works at different design stages are shown in Figure 9.
