The paper was published in the proceedings of the 7th International Young Geotechnical Engineers Conference and was edited by Brendan Scott. The conference was held from April 29th to May 1st 2022 in Sydney, Australia.

Horizontal directional drilling ground heave during watermain installation beneath a dike

Steven Harms

TREK Geotechnical Inc., Canada, sharms@trekgeotechnical.ca

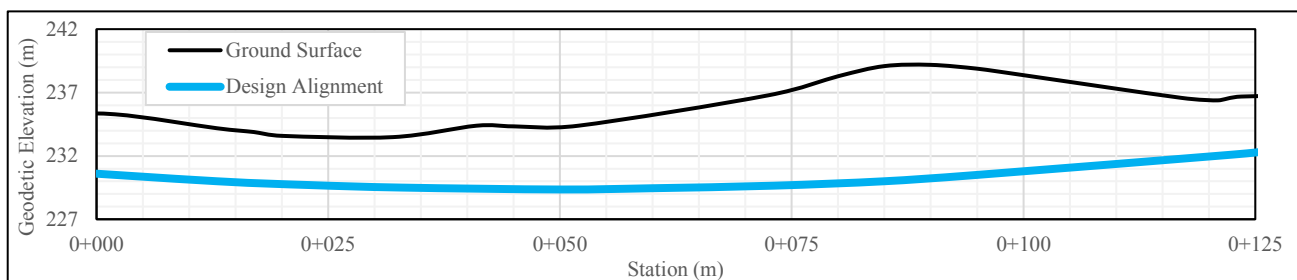
Figure 1. Installation cross-section

The sending and receiving pits were 125 m apart, and for reference have been assigned stationing of 0+000 (upstream side of dike) and 0+125 m (downstream side of dike), respectively. The dike footprint lies between Sta. 0+063 and 0+113 m. The design installation depth varied along the alignment from as shallow as approximately 3.5 m at Sta. 0+025 up to approximately 9 m below the dike. Figure 1 shows a cross-sectional view of the project area between the sending and

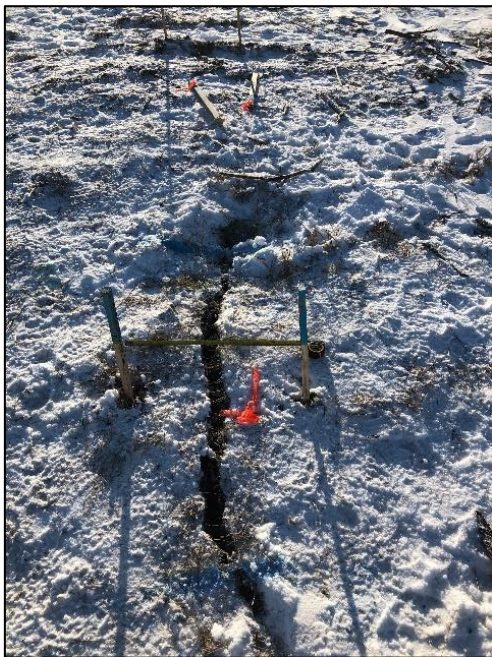
Figure 2. Original crack approximately 75 mm at its widest point

On December 4, the crack was about 15 m long and approximately 75 mm wide at its widest point near the center (Figure 2). According to the contractor, when the cracking occurred the pipe was being pulled through at a rate of approximately 1.5 m per hour, and there was no notable loss of drill fluid or changes in fluid pressure during the installation, and no drill fluid was observed in the cracks.

The primary concern at this time was related to the extent and severity of the disturbed ground due to the installation, and the impact it may have on the performance of the dike; specifically, the potential for increased seepage within the disturbed ground, or worse, the potential for a hydraulic connection between the reamed hole and the outside of the encasement pipe (open flow).

Recommendations were provided to closely monitor the crack and fluid pressure for the remainder of the installation to prevent further disturbance and identify and address the cause of further disturbance (if observed).

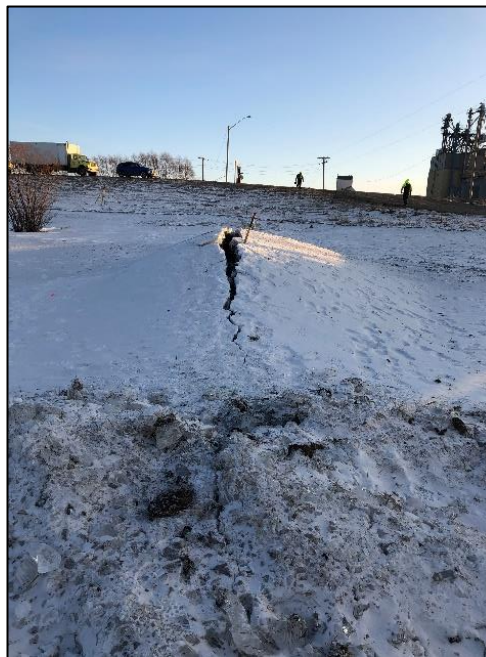
Figure 3. 0.9 m high heaved area after installation attempt 2 with the dike in the background.

This time, the encasement pipe was fully installed at a rate of approximately 50 m per hour, and additional ground disturbance occurred beyond the initial surficial cracked area. The ground heaved forming a 13 m long, 0.9 m tall hump between Sta. 0+034 and 0+047 and the surficial cracking spread from Sta. 0+026 to 0+075 (Figure 3).

However, one measurable deviation from the design is the installation depth, which was observed to be 1.3 m shallower than designed where the ground heaved at Sta. 0+040. While it is unclear whether a greater embedment depth would have prevented ground disturbance entirely, the shallow installation

depth was undoubtedly a contributing factor.

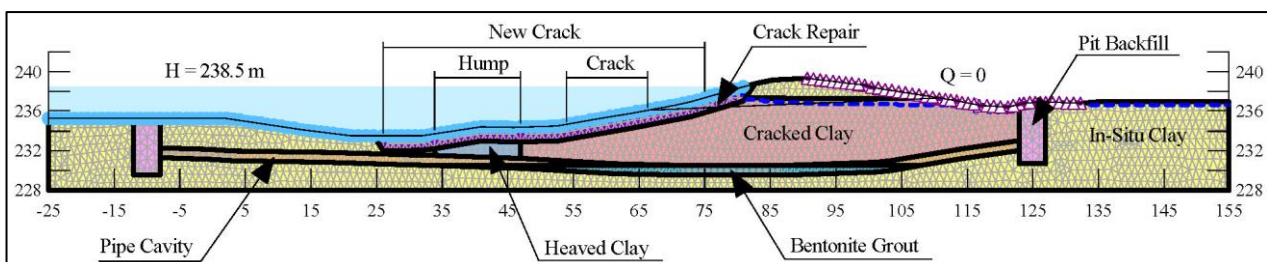
Figure 4. Model Setup

Flux boundaries were drawn within the dike and from the dike crest to the bottom of the model domain to determine the flow per metre through and under the dike. Figure 4 shows the model regions, boundary conditions and mesh of 1 m triangular elements.

A 1.5 m thick clay blanket was modelled at ground surface to seal off the zones of cracked and heaved clay at surface. At the time of the analysis, there was uncertainty relative to whether the repair would be undertaken in the winter (before the spring flood) or summer, and therefore uncertainty relative to the level of compaction that could be achieved. Cases 4, 5 and 6 model clay blankets with hydraulic conductivities of 1×10^{-8} , 1×10^{-9} and 1×10^{-10} m/s, respectively to explore the potential effectiveness of a poorly to well-compacted clay blanket. The drill fluid in the pipe cavity was modelled with a hydraulic conductivity of 1×10^{-8} m/s for cases 4-6.

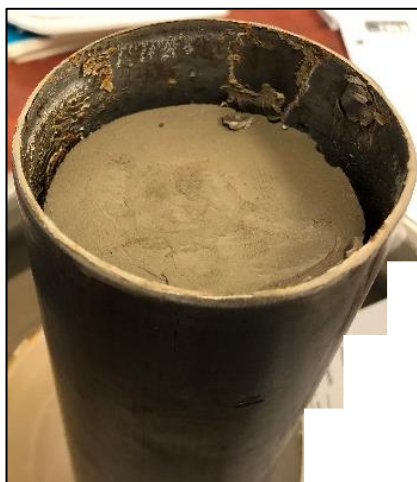
Figure 6. Cured grout sample showing a reduction in volume occurs during curing.

A sample of the drill fluid that was allowed to cure in open air conditions was also tested, and yielded a hydraulic conductivity, $k = 4.96 \times 10^{-10}$ m/s, which is lower than the modelled drill fluid hydraulic conductivity. As shown in Figure 6, the sample which had originally filled the Shelby tube, experienced shrinkage upon curing; this likely represents an upper bound of shrinkage because it cured in an open-air environment. The hydraulic conductivity was not altered in the model to account for the possibility that some shrinkage in the field may result in a higher hydraulic conductivity; this potential reduction was deemed to have already been captured by the limited extent of bentonite grout within the pipe cavity.
