Management of high wall failure at Dubbo Quarry, NSW

Jason Hellmuth

GHD Pty Ltd, Australia, jason.hellmuth@ghd.com

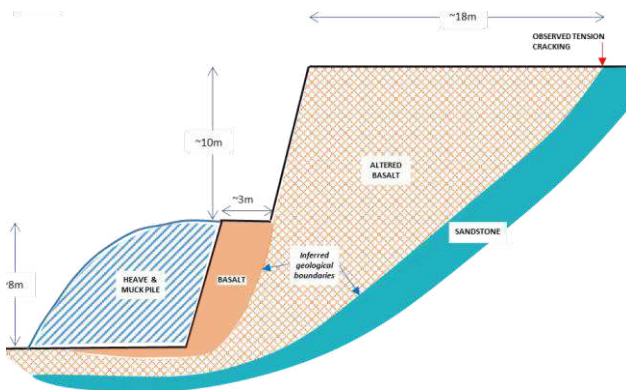
Figure 2. Typical section through the eastern high wall.

The eastern high wall of the quarry has been developed as two benches. The first bench was approximately 8 to 12 m in height and was blasted in mid-2018. Mining was completed in two production shots; first the northern half and then the southern half of the quarry. The second bench, approximately 8 m in height and 15 m wide, was then blasted in November 2018. The high wall design also included a 3 to 5 metre wide, mid-height catch berm at the level of the second bench. This second bench was blasted in a single production shot and mining began at the southern end of the quarry. This second bench was expected to be the final cut along this eastern high wall, as a consequence of reaching the limit of the target resource. A typical section through the eastern high wall is presented in Figure 2.

The failure spanned the full width of the former quarry access road (which had been closed to vehicles after the first signs of failure). The back scarp of the failure did not reveal the lithic sandstone of the footwall, but observations of the failed material supported the theory that it was due to rotational failure through the altered basalt, initiated at the sandstone-altered basalt contact (Figure 2). At this stage, nearly two-thirds of the accessible blasted material had been recovered.

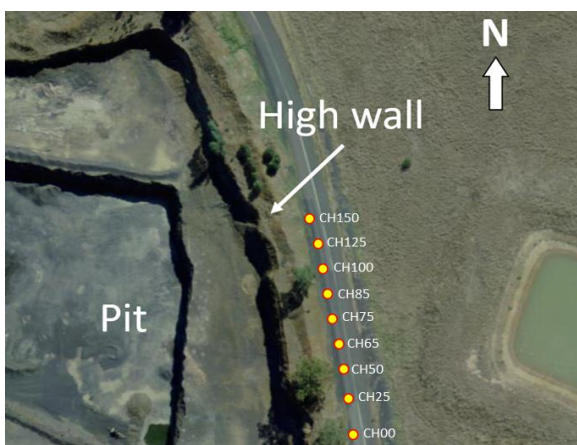
Figure 3. General arrangement of prisms on the eastern high wall.

As discussed in Section 3, a prism monitoring regime was established at the first signs of cracking. Nine prisms and three backsights were set up in total. The general location of the prism monitoring setup is shown in Figure 3. The prisms were surveyed regularly, with the current Easting, Northing and height above datum (in metres) recorded. The data gathered were then plotted against time for each prism. This resulted in a series of graphs which displayed absolute movement over time and could provide an indication of acceleration in any particular direction.

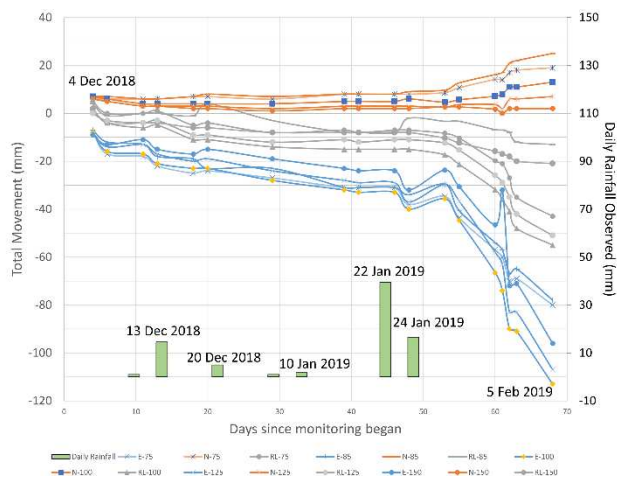
Five of the nine prisms displayed a significant displacement to the west, which accelerated over time. A smaller magnitude of movement was also noted downwards for these prisms. The recorded total movements from some select prisms are presented in Figure 4, where acceleration towards the west (in blue) can be clearly seen.

As noted above, on January 21 and 23 the recorded daily rainfall was 39.4 mm and 16.6 mm, respectively (or 56 mm over approximately 72 hours). This correlates to apparent acceleration of prism movement. In response to the acceleration to the west seen around 24 January, more frequent prism monitoring was undertaken, becoming daily for a short period of time. The consequences of the acceleration (i.e. likelihood of failure) were discussed as part of morning pre-shift safety talks.

Figure 4. Recorded total movements for the five prisms which experienced the greatest magnitude of movement. Orange lines represent movement relative to Northing, blue lines relative to Easting, and grey lines relative to RL. Daily rainfall (mm) is displayed in green on the secondary axis.

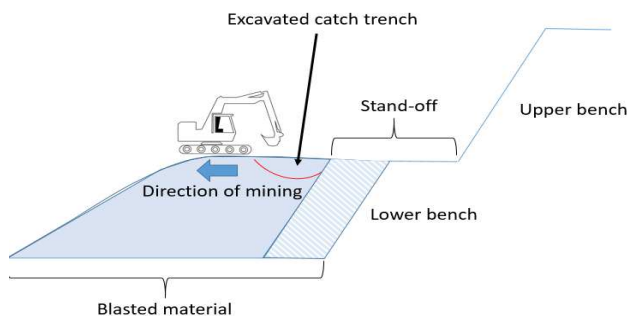
Figure 5. Cartoon of mining sequence of blasted material at toe of failure.

The mining sequence and final high wall geometry were also modified to manage the predicted consequence of a worst-case failure under the TARP. Specifically, a 3 m width of blasted material was selected to be left against the 3 to 5 m wide catch berm to allow for extra stand-off from the upper bench. The remaining blasted material outside of this selected zone was then used to create a bench for the excavator to sit upon.

Following this creation of a bench, the excavator mined the remaining blasted material by reaching towards the high wall and excavating the material from outside the stand-off area, thus creating a catch trench between the high wall and the excavator (Figure 5). Mining otherwise progressed as normal, though the mining direction was always from the catch trench back towards the open edge of the blasted material. This mining campaign was expected to take approximately three weeks.

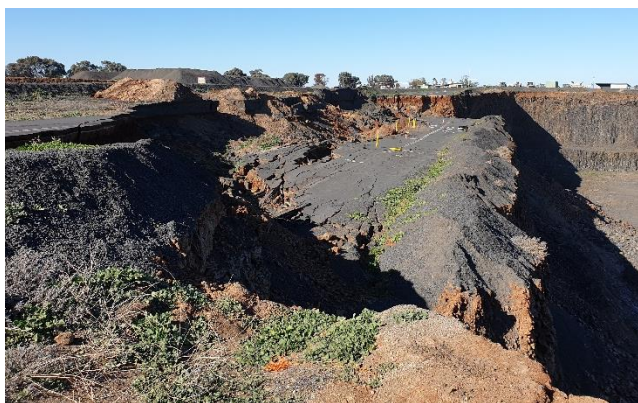
In February 2019 the eastern high wall failure slid down approximately four metres and outwards by approximately 3 metres (Figure 6). The area of failure was roughly 80 m in length, and up to 20 m in width, located between prisms #75 and 175. The prisms within this area (#85, 100, 125 and 150) had recorded the greatest movement to the west during the period of monitoring and had also shown an acceleration in westerly movement in the 10 days beforehand. The failure occurred almost immediately after a rain event of 12.2 mm on 8 February, and soon after the above-mentioned rain events in January.

The failed material was almost entirely captured by the extra stand-off and catch trench, with the exception of the southern end of the failure where a small amount of material associated with a slight overhang in the face fell onto the quarry floor. There was no interaction between fallen material and personnel or plant.

Figure 6. The eastern high wall following occurrence of the failure. The deep shadow to the right of the picture is the high wall into the pit, and the deep shadow to the left is the back scarp of the failure. The grey material in the middle of the photograph is the asphalt of the now inaccessible access road.
