Tailings dam breach analysis: Lessons learned from released volumes of recent environmental catastrophes.

Diego Inzunza

Engineering, Knight Piésold, Chile, dinzunza@knightpiesold.com

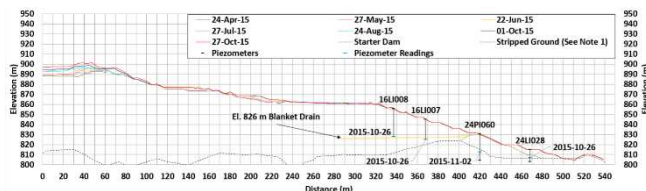
Figure 2. Typical section Fundao TSF (Morgenstern et al., 2016)

The Fundao TSF began construction in 2008, with an upstream raise method using compacted sand material and an overall slope in its final configuration of 7H:1V. Upstream and downstream of the middle plateau it is characterized by two embankments with overall slopes of 2.0H:1.0V (see Figure 2). The dam reached a maximum height of 110 m (its crest had reached El. 900 m) and a crest length was approximately 600 m long (considering a setback that increased the initial total length). At the time of failure in November 2015, the impounded volume reached 56.4 Mm³, and discharging 43.7 Mm³ (<http://www.csp2.org/tsf-failures-from-1915>) in a time period of 0,42 hr. (from seismic records Agurto-Detzel et al., 2016). The flood wave reached the downstream town of Bento Rodriguez and subsequently the Gualaxo do Norte river.

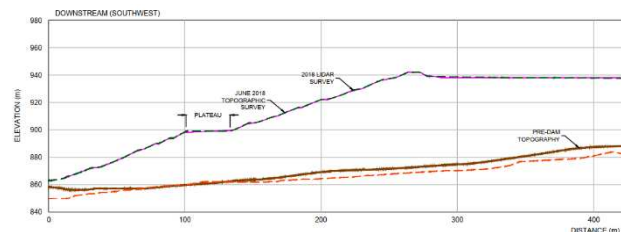
Figure 3. Typical section DAM I, Feijao (Robertson et al., 2019)

Feijao was a TSF that began construction in 1976. The design embraced 10 stages of raise using the upstream method. The overall slope was 2.0H:1.0V, with compacted material consisting of fine residual soils (clays or silts) and tailings (see Figure 3). At the time of the failure, the embankment reached a maximum height of 86 meters (crest El. 942 m) and a length of the crest of approximately 700 m. The impounded volume was 12.0 Mm³ and 9.57 Mm³ was discharged (<http://www.csp2.org/tsf-failures-from-1915>); the video coverage showed that the release of materials occurred in about 5 minutes (Lumbroso et al., 2020).

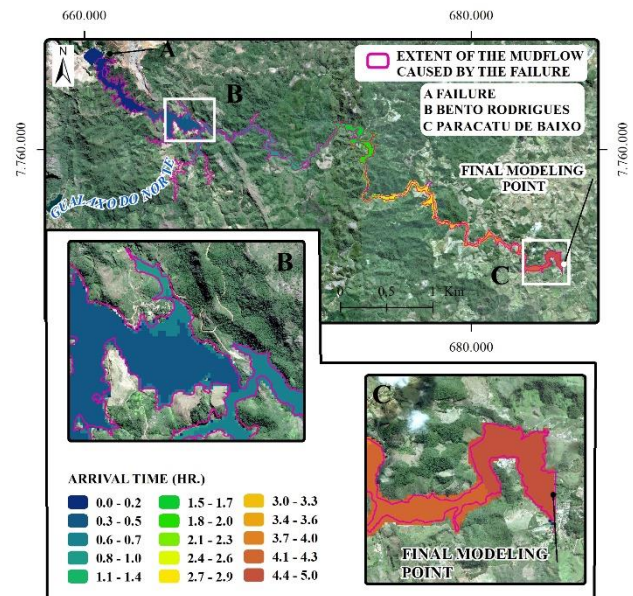
Figure 6. Fundao mudflooding modeling

The modeling results are shown in Figure 6 and Table 2 for Fundao and in Figure 7 and Table 3 for Feijao. At key points of interest both models were compared with arrival times and final flow heights. The Fundao modeling covered almost 35 km downstream of the embankment. Modeling results show a good relationship between flooded area and official arrival time. The Feijao model results show consistency of the flooded area compared to the official area. Some differences are observed in the area near the embankment, which can be attributed to the fact that the model utilizes the topography without consideration of the erosion generated by the downstream flow.

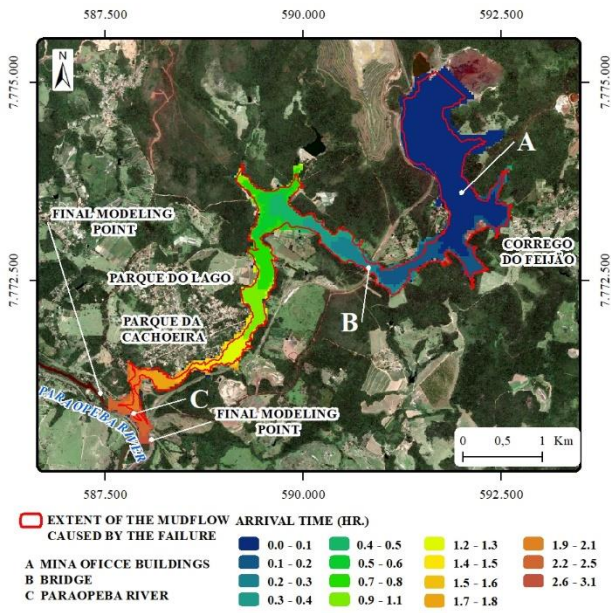
Figure 7. Feijao mudflooding modeling

Feijao is the first dam break where the failure is documented on video footage; therefore, the duration time of the failure generates great consensus. This information helps characterize the duration of the outflow hydrograph and is the reason why the modeling required little effort for parameter calibration unlike Fundao. This water input affects the concentration of the mud that continues to travel downstream. The maximum solids content (Cv) of the release hydrograph had to be corrected to 47% to observe arrival times at the Paracatu location as indicated by the information collected.

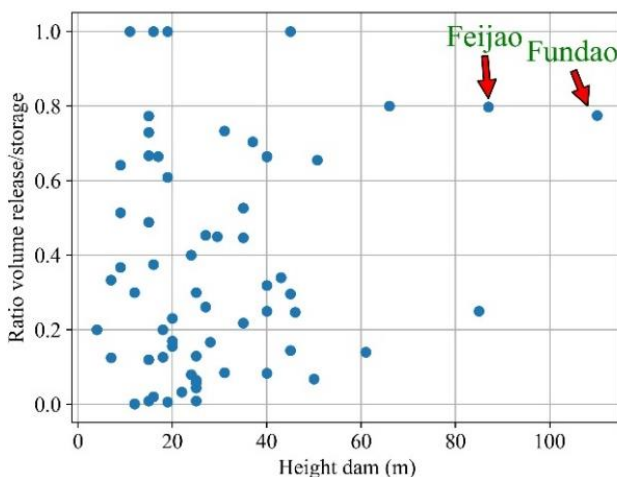
Figure 8. Comparison data base failure dam tailings

By looking at the failure database at <http://www.csp2.org/tsf-failures-from-1915>, and filtering the tailings deposit failures where the embankment height was reported, the volume storage and the release volume can be plotted as shown in Figure 8. The ratio of volume released to storage volume has been plotted on the vertical axis. The dams that failed in Brazil appear as outliers in these cases. This reflects that Fundao and Feijao do not have close proximity to the previous failures and that the estimation of release volume is a more complex issue.
