## Proposed methods and considerations to allocate damages for deficient mechanically stabilized earth walls

**Ashley Loyola (nee MacMillan)**

### 3 A CASE STUDY: THE COLONY AT WHITE PINE CANYON

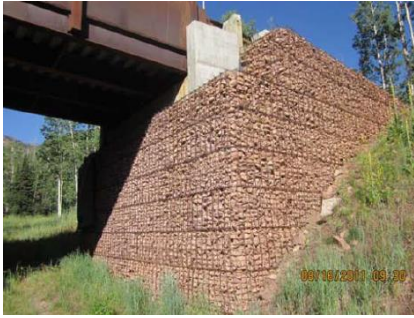
Figure 1: Typical MSE structure (bridge abutment) at the Colony Project.
