## Research into pile toe failure in Amazonehaven

Reza Nejad

**ABSTRACT:** Extreme folding damage of open-ended tubular piles could occur during piling in onshore practices. The Amazonehaven unique quay wall removal provided the opportunity to study pile toe failure. The quay wall had a combined-wall system with open-ended tubular piles as its primary elements exposed to both static and dynamic load. The static load regards the asset's technical lifetime, whereas the dynamic load regards the hammer-induced load during installation. In Amazonehaven, the mysterious pile toe failure is argued to be caused by the hammer-induced stresses due to uniaxial direction of the extreme deformations close to pile toe. However, research into pile toe failure in Amazonehaven shows that the stresses close to the pile toe are significantly lower than the material's yield stress. Therefore, the pile toe integrity is not solely influenced by dynamic load. The main reasons for pile toe failure are discussed to be (1) the initial dent close to pile toe and (2) the pile inclination.

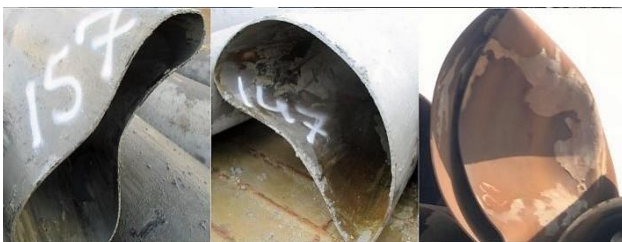
After removal of Amazonehaven quay wall in Maasvlakte II Rotterdam, it was observed that the open-ended piles, the primary elements in a combined wall system, were significantly damaged. The open-ended piles were damaged close to the pile toe, as depicted in Figure 1. This paper aims to study both technical- and management-aspects of pile toe failure.

Figure 1. Extreme folding damage

could be identified as (1) extreme folding of pile toe, (2) completely closed pile toe, ovalisation at pile toe. The damage in axial direction is estimated to be about 15% to 20% of the total numbers of primary elements. For secondary elements, the damage is estimated to be about 50% of the total numbers (Broos & de Gijt 2014). Moreover, scorched sand at pile toe was observed which reveals the occurrence of an Extremely High Temperature of about 400<sup>0</sup>-500<sup>0</sup> (Broos & de Gijt 2014). The heat is possibly generated by the high friction between soil and pile which could only occur during (pile) driving activity.

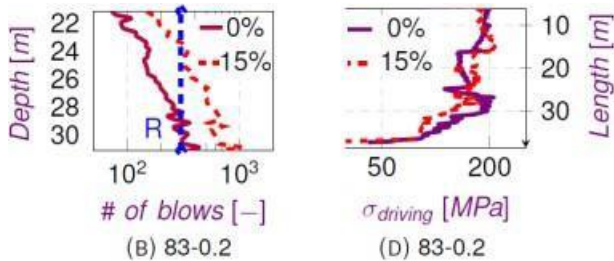
(a) soil compaction due vibration; more soil resistance to pile driving is generated, which reduces the downward wave stresses. Therefore, the hammer-induced driving stresses close to pile toe are less than material's yield stress. Figure 4 shows (B) the number of blows over the entire driving depth, given the threshold (R), for both virgin or compacted (15%) soil. The Fatigue Factor (FF) due piling, degradation of the soil resistance, is 0.2. Due to compaction, the piling becomes troublesome (heavy piling), if not impossible.

Figure 4. Piling prediction for a D/t-83, Fatigue Factor-0.2

Figure 4 shows (D) the hammer-induced driving stresses over the entire length of the pile. The compaction does not affect stress- development along the pile, significantly.

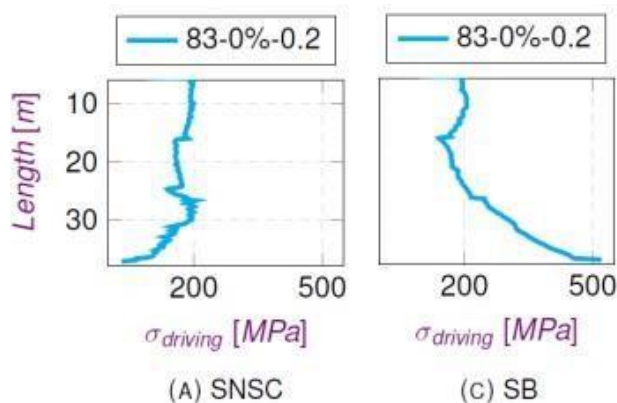
- (b) pile inclination could cause unequal load distribution due to eccentric impact force at pile head. Therefore, another stress-development is to be expected along the pile.
- (c) Zero Shaft Friction (ZSF) simulates piling while shaft friction is completely eliminated. A ZSF circumstance could happen in case of (pile) stagnation & continuous driving.
- (d) Hammer selection is quite important to ensure sustained driving. For Amazonehaven, a D62 hammer did not comply within the ranges of minimum and maximum hammer energy (Tara 2016).
- (e) Driving stresses are about 60% lower than the material's yield stress (483 MPa) close to pile toe, for Amazonehaven Standard to Normal Soil Condition (SNSC). However, in case of Medium to Hard Soil Condition (MHSC), the stresses are extremely high close to pile toe as depicted in Figure 5.

Figure 5. Piling prediction for a D/t-83, Fatigue Factor-0.2

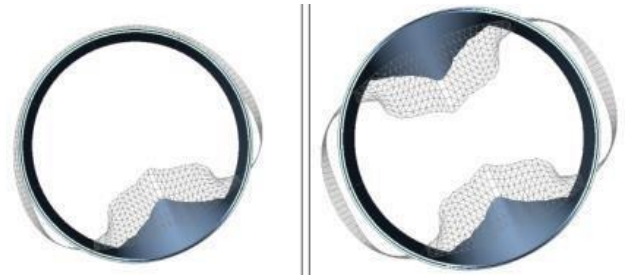
- (f) Temperature reduces both strength and stiffness of the steel which makes it less resilient to folding. The temperature elevation is argued to be caused by a high friction between soil and pile. A local Temperature Elevation (TE) together with, e.g., an initial imperfection will be detrimental to maintain pile toe integrity during piling.
- (g) Initial imperfection leads to pile toe failure, in terms of extreme folding damage when it is accompanied with a Locally Extremely Hard Spot (LEHS). In case of sustained driving, unequal soil distribution inside & outside occurs, which leads to a gradual inwards deformation due to clamped solid soil next to pile toe. Figure 6 shows, the imperfection as modeled in SCIA and its final deformation.

Figure 6. Top view pile, initial dent and its final deformation

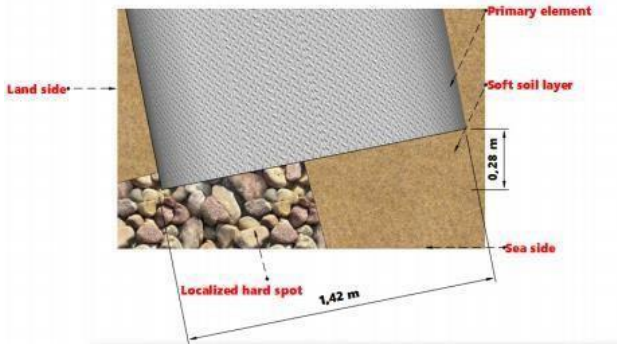
- (p) Locally Extremely Hard Spot (LEHS) is detrimental to pile toe and could have caused pile toe failure. A combination of LEHS and initial (dent) imperfection will worsen the extent in which pile toe failure occurs.
- (q) Pile inclination refers to a non-uniform soil property (stiff and weak) at the toe as depicted in Figure 7. Pile inclination is assumed to exacerbate the occurrence of such non-uniform soil properties. Therefore, pile toe experiences at one edge higher stresses whereas at the other edge the stresses are limited to impact stresses at the head.

Figure 7. Pile inclination, non-uniform bed

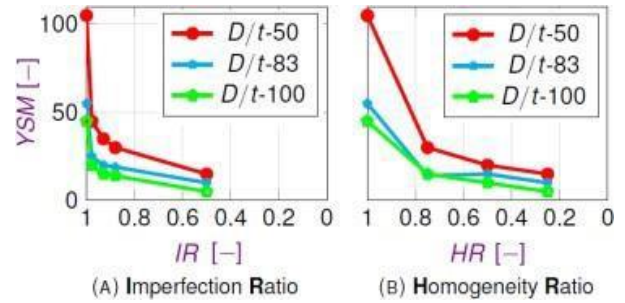
The main reasons to pile toe failure in Amazonehaven are shown to be: initial imperfection and pile inclination. The pile is modeled in SCIA to carry a sensitivity analysis regarding the above mentioned causes to pile toe failure. Figure 8 and 9 show the Yield Stress Momentum (YSM) with (A) increasing initial dent and (B) a decreasing soil homogeneity at pile toe, given various  $D/t$  ratios, for respectively centric and eccentric loading. The Yield Stress Momentum (YSM) is the point in which the material's yield stress reaches for the first time. Therefore, it could be argued that a pile with a lower YSM-value be locally more prone to extreme folding damage.

The YSM decreases drastically in case of decreasing Imperfection Ratio (IR), where  $IR = 1$  means a perfectly rounded pile. However, it decreases less drastically for Homogeneity Ratio (HR) at pile toe, where a  $HR = 1$  means a uniform (stiff) soil-bed. A decreasing HR means a non-uniform (stiff and weak) soil-bed.

Figure 8. Yield Stress Momentum for centric loading

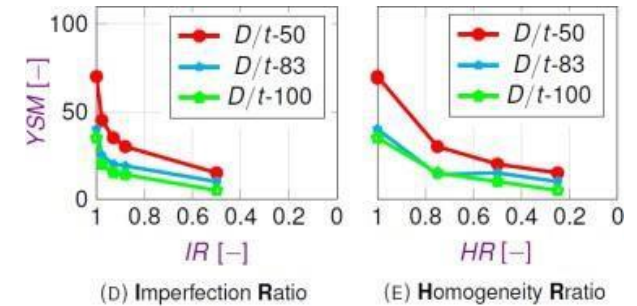
Also, due to eccentric loading, YSM-value is lower which pinpoints inclined piling could be detrimental for maintaining pile toe integrity during piling.

Figure 9. Yield Stress Momentum for eccentric loading
