Transpennine Route Upgrade: Geotechnical engineering solutions to replace failed structures caused by peat and dissolution hazards

For the Transpennine Route Upgrade East (TRUe), SYSTRA and the TRUe Alliance delivered three new flood balancing structures as a replacement to a failed culvert on the Normanton and Colton Junction Line. Geotechnical research into the cause of the culvert failure and geological investigations into this region of North Yorkshire, identified that dissolution of gypsiferous material and the presence of peat deposits had been causing the rail embankment (through which the culvert was constructed) to displace.

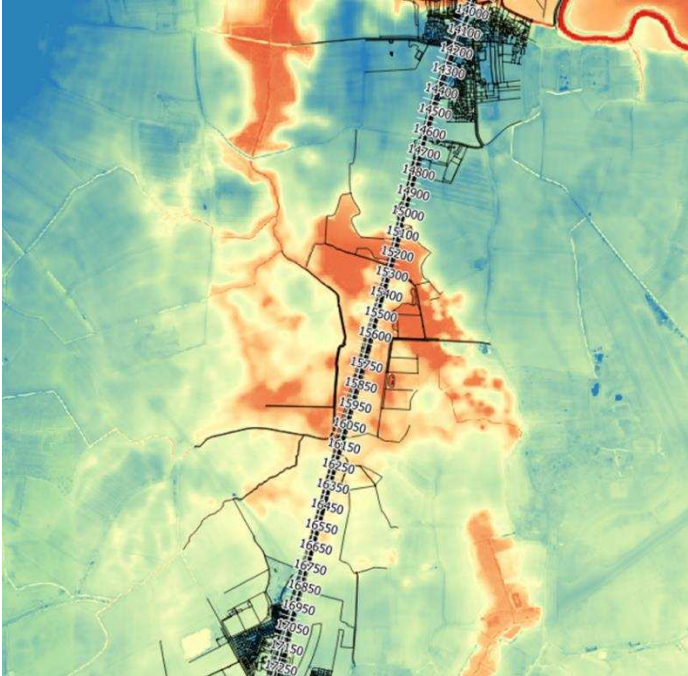
Figure 2: 1m LiDAR DTM dataset of Ulleskelf Mires, North Yorkshire (reproduced from the EA dataset, UK GOV)

Based upon the above, dissolution of the Sherburn Gypsum is considered to be widespread, however is likely concealed (Cooper 1986) as a result of infilling of cavities and pipes with superficial soils. It was therefore considered a critical risk to the NOC/23 site and a potential cause of the failure of the structure. Given that the existing structure is located within Ulleskelf Mires, a particularly boggy region, the upward rising of groundwater was considered likely to be occurring at the Site.

The revised 1:10,000 Scale BGS map SE53NW, compiled by Cooper (2000) shows large areas of Alluvium and Peats (see Figure 1) that are likely gypsum subsidence features. The Department of the Environment gypsum subsidence study (Thompson et al. 1996) maps subsidence features from air photographs, illustrating sinkholes in the area north of Church Fenton. Based upon the Environment Agency Open-Source LiDAR datasets, mapping provided at Figure 2 shows the region of NOC/23 to be generally flat, however shows a depression, likely attributed to subsidence (orange), at NOC/23 and Ulleskelf Mires. Cooper (1986) identifies a similar pattern of hollows in subsidence surface patterns as a result of confirmed dissolution locations at Ripon. They are interpreted as amalgamated hollows, whereby subsidence occurs as a result of the first hollow collapsing the underlying cave,

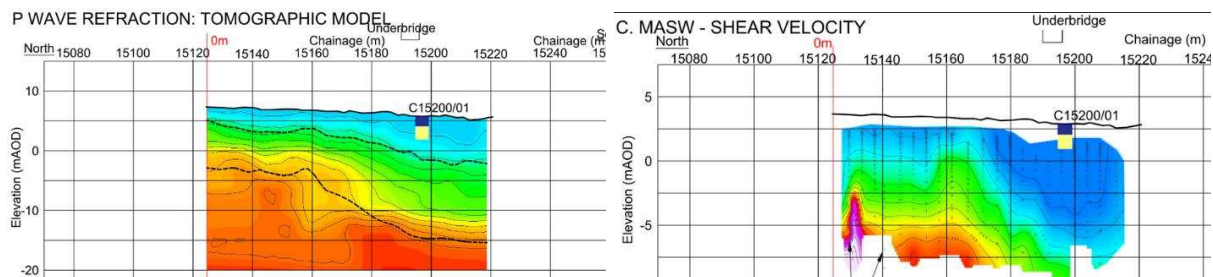
Figure 3: P Wave Refraction Tomographic Model (Left) and S Wave Velocity Model (Right), reproduced from integrated results of geophysical survey for TRU East of Leeds

Seismic surveys were undertaken by P Wave and Shear Wave, and individually plotted (see Figures 3 and 4). The P Wave tomographic model indicates that from approximately chainage 15,160m, a gradually deepening zone of lower P Wave velocity, compared with the subsurface profile to the north (down chainage). A similar, but clearer trend is shown in Figure 4, whereby S Wave velocity is considerably lower in a conical shape around the location of NOC/23 (labelled as an underbridge on Figures 3 and 4).

The conical shape of the structure identified within both P Wave and S Wave plots align with the shape of an expected brecciated pipe that would occur as a result of dissolution of Gypsum within the Roxby Formation. These surveys supplemented research to provide evidence that the site is the location of a dissolution hazard. Based upon the above, gypsum is thought to have dissolved at depth, below -10mAOD, and has been infilled by overlying superficial stratum. This superficial stratum is thought likely to be softened further by subartesian water flow, responsible for the lower velocity of seismic waves. It would appear, based upon the seismic profiles that the northern boundary of the brecciated pipe is between 15,140m and 15,180m, with the southern boundary not established by the survey.

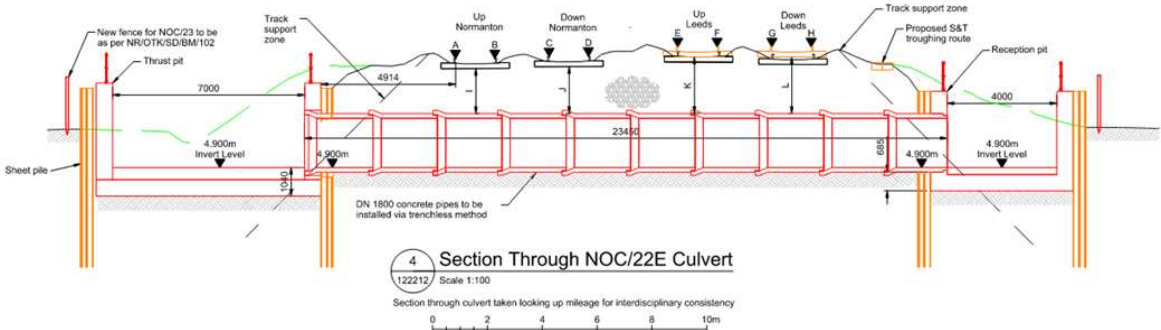
Figure 4: Extract of cross section, showing one of the proposed culverts (NOC/22E), against natural ground levels and existing embankment setting

With a proposed invert level of 4.9m AOD, proposed drainage channels/pits on either side of the embankment would require excavation from natural ground levels by approximately 3.5m. As the embankment was wider than the proposed culvert length of 23.45m, excavation of channels and pits would result in dig out of the toe of the embankments on both sides. It was noted that, when accounting for overdig in the worst-case, this would mean that sheet piles in the temporary case would need to retain 5m of railway embankment and underlying natural ground. In the temporary case, propping was required to support excavations during tunnel installation and channel formation.

As the existing rail embankments are of Victorian Era age and are life expired, global stability checks in the permanent and temporary cases were required to determine that change in use would not have a detrimental impact. Findings of the stability assessment advised that not only was propping necessary in both the permanent and temporary cases to keep pits and channels open, but also that sheet piles would need to be of necessary length to prevent failure planes generating as a result of unloading of slope toes whilst excavating channels.
