Improvements in emergency responses for geotechnical failures – a case study from the 2015 Boxing Day floods

R. Spence

Mott MacDonald Infrastructure Ltd, Sheffield

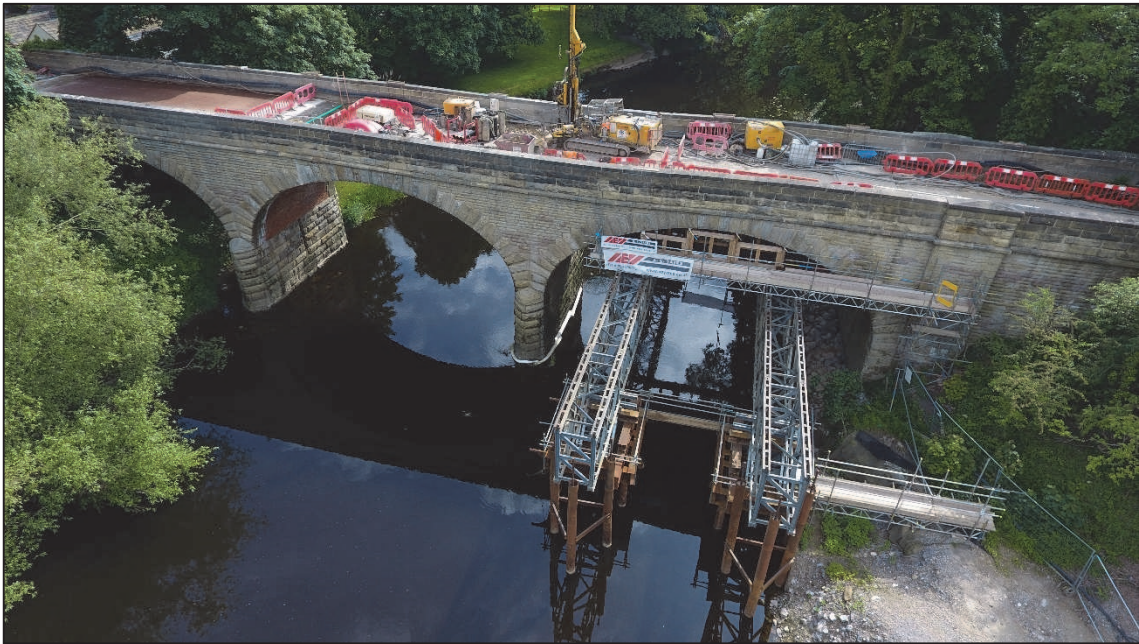
On the night of 26th December 2015, the south pier of Linton Bridge was undermined by scour and suffered 200mm settlement and minor rotation, which in turn caused cracks to form through the arch barrels which continued to the top of the keystones, indicating a loss of compression in the arch and a risk of bridge collapse.

Fig. 3: Temporary support scaffolding and permanent piling works at Linton Bridge

Remedial works comprised emergency underpinning, temporary piled scaffold to support the south arch for permanent construction works, as illustrated in Figure 3 above, and the design and construction of a new integral bridge deck with mini piles through each abutment and pier. This achieved a strengthened bridge, with lower maintenance liability without compromising the original character of the listed structure.

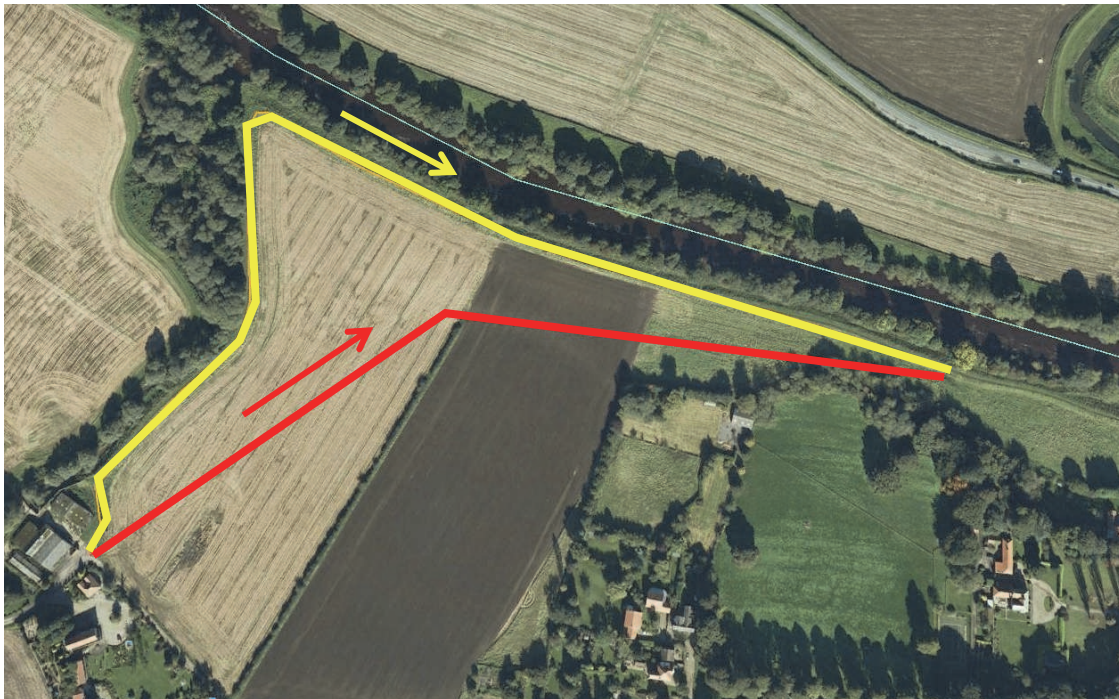
Environment Agency flood defence inspections revealed a new depression 8m wide and 8m high in the upper river bank and riverside face of a flood berm near the village of Croft on Tees. BMMJV carried out a walkover survey in April 2016 to assess this feature, which was indicative of an early stage rotation slip, and consider the requirements for further investigation, design, and construction. This revealed that a 500m long haul road (illustrated in Fig 4) would be required to get plant and materials to site for a typical shear key and counterfort drain repair and an alternative solution of a mini piled wall was developed in which very small plant could access the bridge via the public footpath, as in indicated in Fig 4.

The cause of the instability was thought to be a combination of the surcharge load of the flood bund on the crest of the river bank, positive pore water pressure in the slope after rapid drawdown and a localised occurrence in 1 bore hole of soft alluvium. Back analysis of the slope was carried out on the slope which confirmed a Factor of Safety (FoS) less than 1 was likely during rapid draw down conditions with water pressure in the alluvium above river level.

The location of the slip plane was indicated by the presence of a toe bulge and by small movements detected within inclinometers installed beneath the depression.

Fig. 4: Proposed temporary haul road (bottom) and actual route used on embankment crest for access by mini piling rig (top).

The design method was based on an approach described by J.P. Davies for the stabilization of a landslide on the M25 (Davies et al. 2003). The analysis method took the back analysis with a FoS 0.951 and applied a shear force working to resist the slip at the position where the slip plane crossed the proposed bored pile wall until a FoS of 1.25 was reached. This indicated that a new embedded wall through the middle of the depression, designed to provide a resistance of 25kN/m shear at the level of the slip plane would provide the ULS margin of safety required by Eurocode 7. The solution comprised 15No. 450mm diameter piles at 1.2m centres so that soil arching would occur between the piles preventing further soil movements.

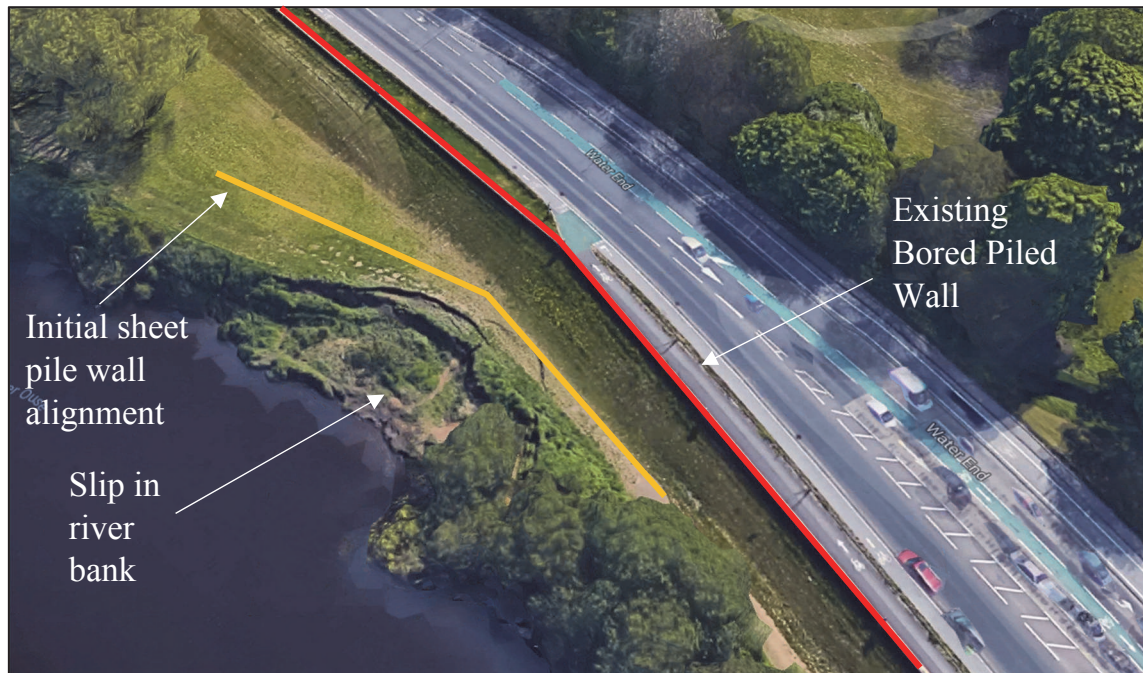
Water End is a modern flood wall (constructed in 2011) sitting on top of 600mm diameter bored piles at 2m centres at the crest of a road embankment behind a river bank. A slip occurred immediately after Storm Eva peaked, during rapid drawdown conditions. The slip threatened the stability of the road side flood wall and the integrity of several buried services. BMMJV designed and constructed a sheet piled wall and counterfort drains on the foreshore in November 2016.

Fig. 5: Water End river bank failure

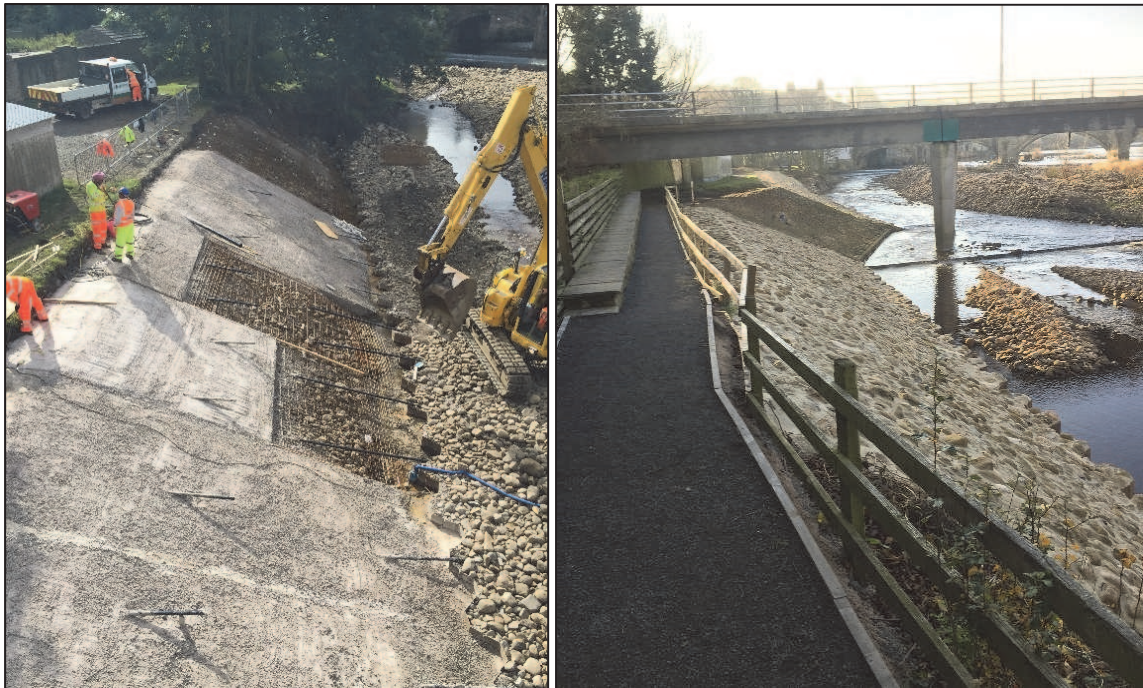
Fig. 6: Haydon Bridge reinforced concrete stone pitching revetment with sheet piles at toe.

The main works at Haydon Bridge comprised an extension of the stone pitching currently under the main highway bridge to repair the scour damage downstream of this 'hard' defence which threatened to undermine the flood wall. Care was taken to mitigate the risk of future scour causing the same problem immediately downstream of the new stone pitching, and a transition detail was included to return the toe of the sheet piles up the bank with a taper.

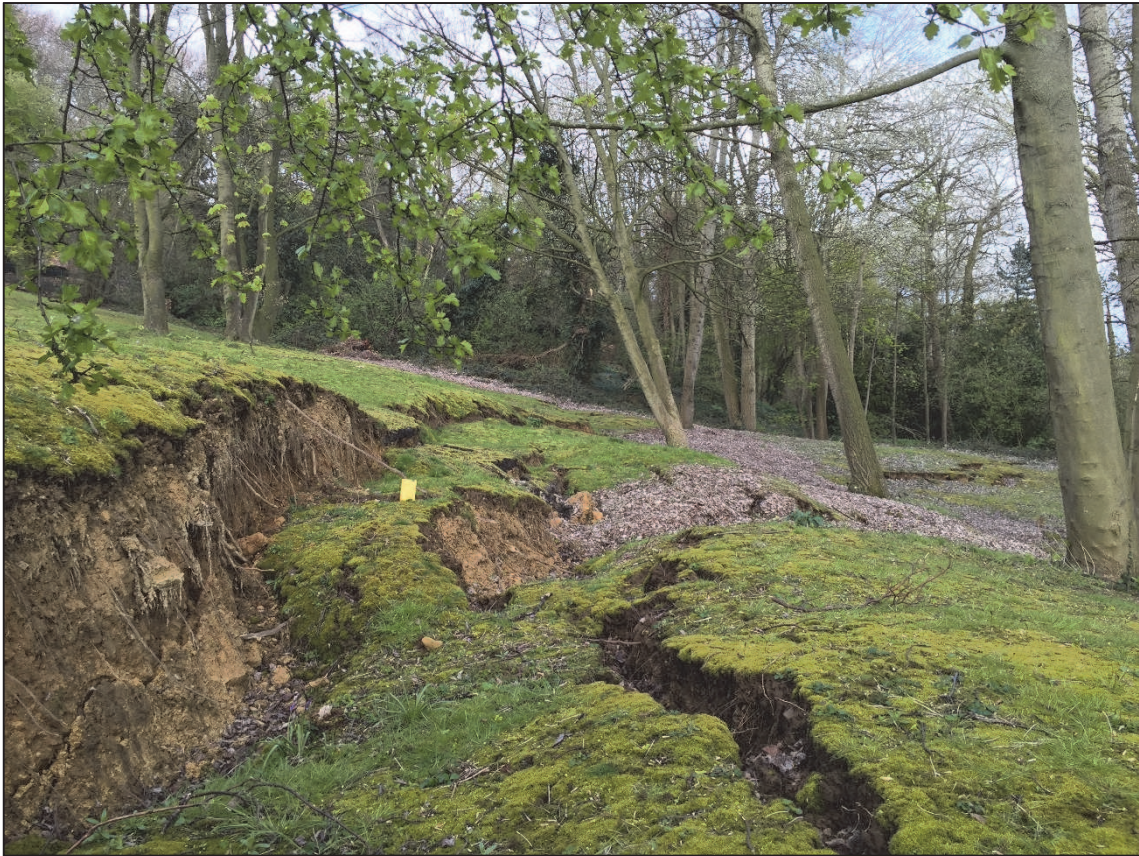
Fig. 7: Eastern half of Collingham bank slip

A series of large scale slope failures resulted from the Boxing Day flood event. The largest of these were at Collingham and Knaresborough. These were assessed during a site inspection with the client and JV present, agreeing the probable remedial measures and timescales for ground investigation and reporting. Stability assessments were undertaken and lifetime cost/risk analysis, alongside flood modelling, led to a managed retreat for some of the landslides.

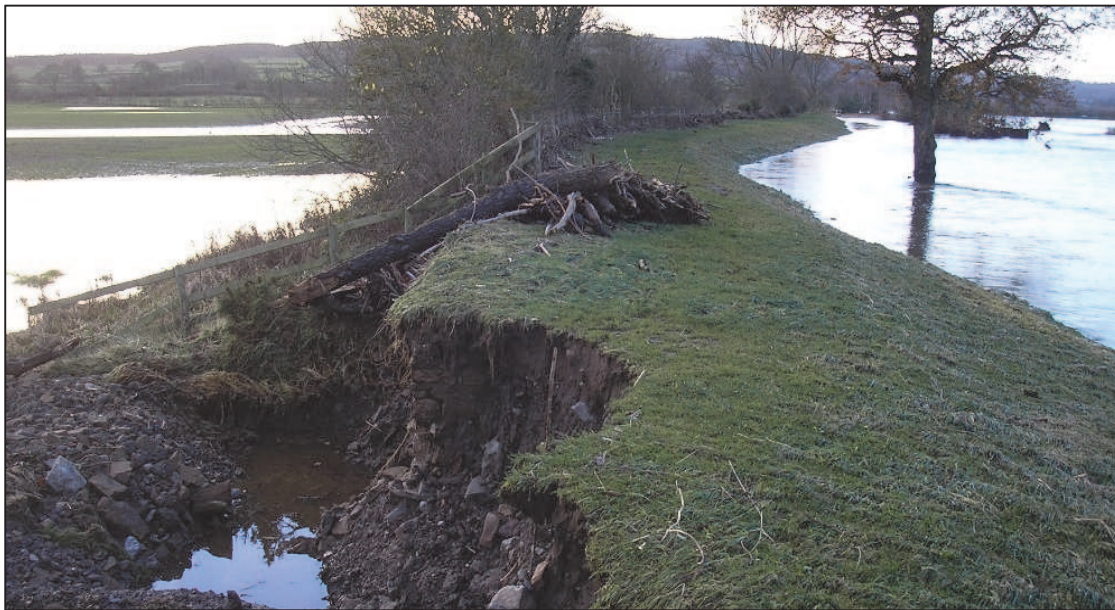
Corbridge flood embankment was one of many flood bunds which were damaged and subsequently repaired on tight timescales. At Corbridge the river overtopped the flood bund at a transition point where a masonry wall inside the bund terminated and scoured a large hole landside of the earthwork.

Damage at Corbridge can be seen in Figure 8 below. The image shows the flood waters still high two days after the flooding occurred on site.

Fig. 8: Damage to Corbridge flood bund
