Geotechnical risk assessment on Albanian historical bridges

M. Gega

Polis University, Department of Architecture and Civil Engineering, Tirana

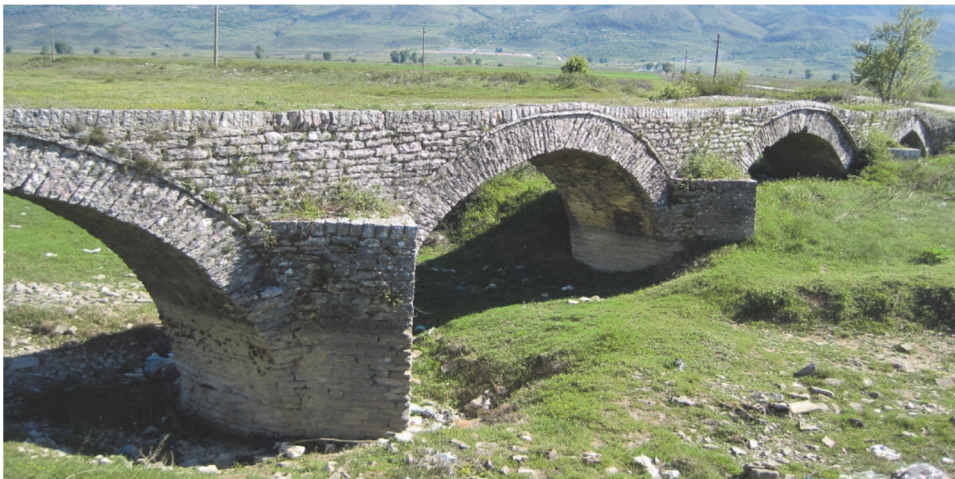
Fig. 1: Kollorcka Bridge pier scour in the dry period of the year

Resulting from Drino river flow velocity change the presence of pier scour Bozo & Muceku (2002) is investigated that causes serious damage in two of its piers. This hydrological conditions change has uncovered the wood piles in 2 of the piers but in one of them has also eroded the cohesive clays of the river bed. During the construction phase for improving soil structure interaction a pile cap with lintel beams is used to avoid wood pile foundation erosion (IMK) .It is thought that the main factors leading to this critical situation are decreases of groundwater level and total stop of river flow in summer time. While the level of the groundwater reaches to the soil surface in autumn and spring and river flow comes to its maximum by causing flooding activities such as the one of year 2014.

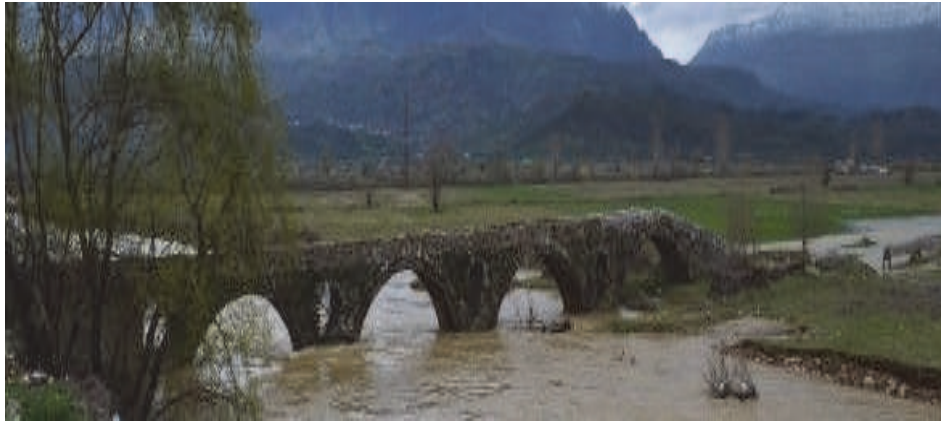
Fig. 2: Kollorcka Brige in 2014 flooding (IMK)

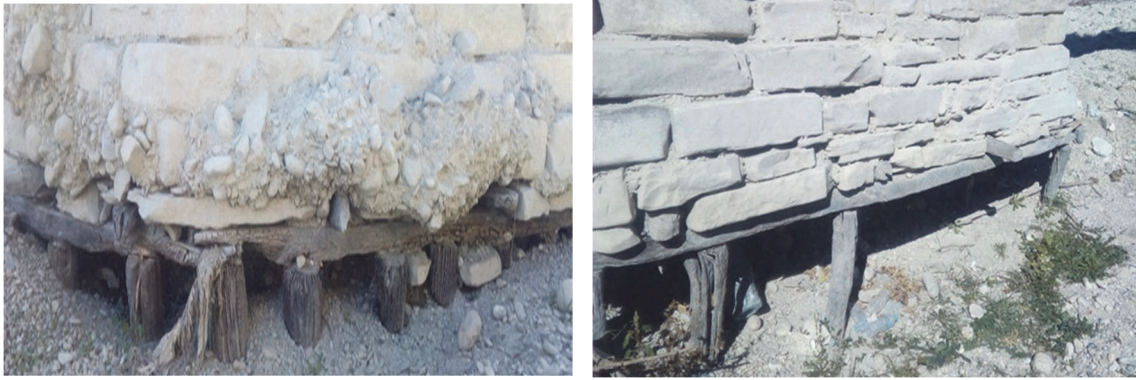
Fig. 4: Exposed wood piles of diameter 12-18 cm (IMK)

This exposition deteriorates wood because it loses stiffness and all the stresses are transferred to the soil. If the interventions are not performed in time Kollorcka bridge wood loose its protection guaranteed by wood piles and it will be prone to lateral erosion and further displacement that can bring the total collapse of its two piers and finally the bridge itself. How harmful is the effect of wood deterioration depends on pile dimensions, spacing, and geological conditions. Also the interventions are immediate as bacteria can accelerate wood deterioration (Bettiol, et al. 2016).

Kollorca Bridge is in high risk because of its wood pile foundations damage on 2 of its central piers. Geotechnical assessment is performed and as a result immediate interventions on foundation reinforcement and total replacement are crucial for the bridge stability.

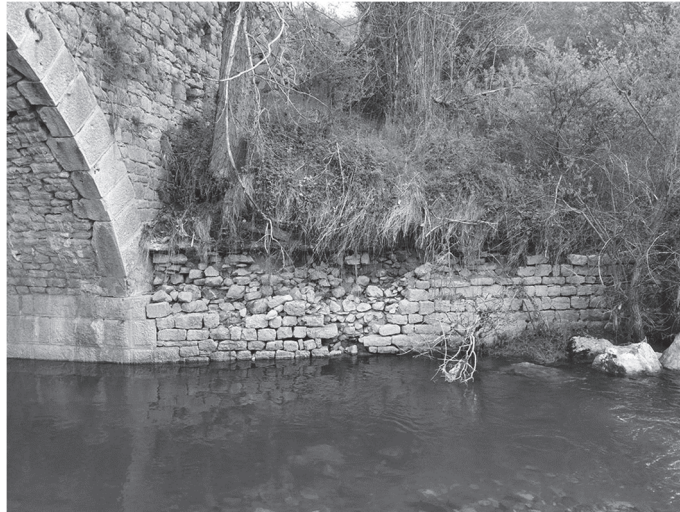
the foundation damage in the other side a retaining wall is constructed. As shown in the bridge plan in the part where maximum spring flow occurs it hits the retaining wall. As shown in fig. 7 the wall is considerably damaged up to 50 %. This leads to monitoring requirement on deteriorating factors affecting this retaining wall. Mainly the presence of erosion has created a dynamic load on the retaining wall structure by eroding underwater parts of the mortar and the wall stone in the same time. This wall requires immediate interventions as it also serves as a protection for the foundations of the Shen Prodhomi bridge.

Fig. 7: Shen Prodhomi Brige, retaining wall (IMK)

Shen Prodhomi Bridge doesn't show geotechnical risks. The resisting parameters of basal sedimentary rock have kept bridge shallow foundations in good conditions. Meanwhile human activity and hydrological conditions have seriously damaged the bridge structure and the retaining wall next to it. Restoration of the retaining wall is important for keeping the foundations in the current state.
