Ground treatment and stabilization of a railway embankment in failure state

M. Chludziński

Keller Poland

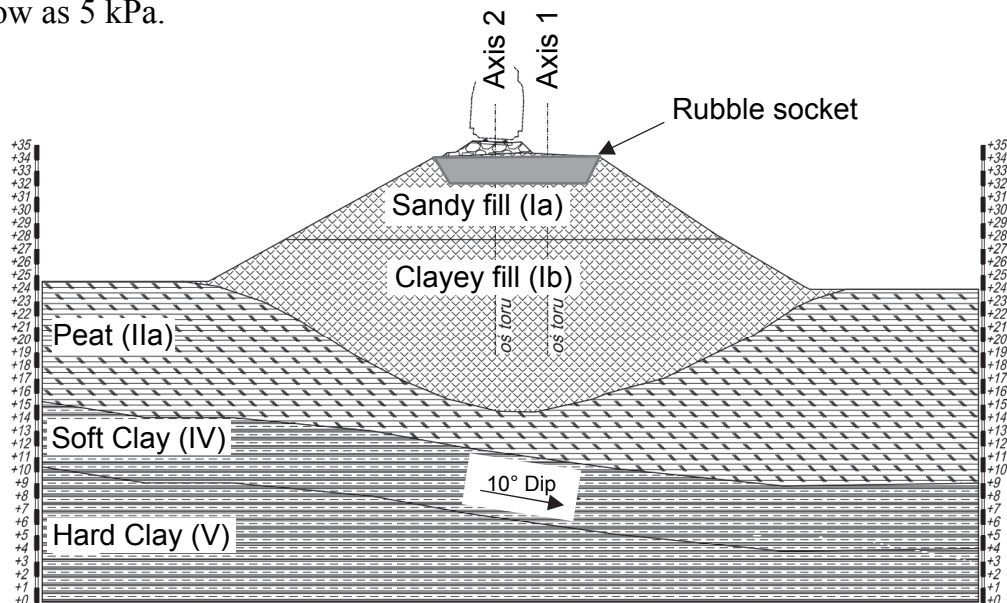
Ground investigation on the site, before planned works, revealed non-bearing soils up to 10 m depth under the left side and up to 17 m under the right side of the embankment (see Fig. 2), forming a natural 10° dip of sensitive layers, which corresponded with the direction of future landslide. The thickness of the organic soils – especially muds and peat – suggested that the embankment was built in an old river bed. Beneath the layer of organic soils (stratum IIa) there was an

approximately 5 m thick layer of soft and firm clays (stratum IV and V). Several decades of overloading the ground with the 8 – 10 m high embankment resulted in the creation of a natural basin from anthropogenic soils and a partial displacement of underneath organic soils. The thickness of organic layers underlying the embankment, determined in field tests, reached up to 4 m. The process of consolidation had a significant impact on the strength parameters of the soils located beneath the embankment, which were increased comparing to the characteristics of layers situated outside the embankment. The undrained shear strength of the organic layer ranged from 10 to 35 kPa, but locally the strength was as low as 5 kPa.

Fig. 2: Typical cross – section of the embankment in critical chainage 266+300 (initial state, before the landslide)

It should be mentioned that during works the 3 m layer of rubble pressed into the embankment was found, suggesting that running track was regularly underpinned due to progression of embankment’s settlement over the years (see Fig. 2).

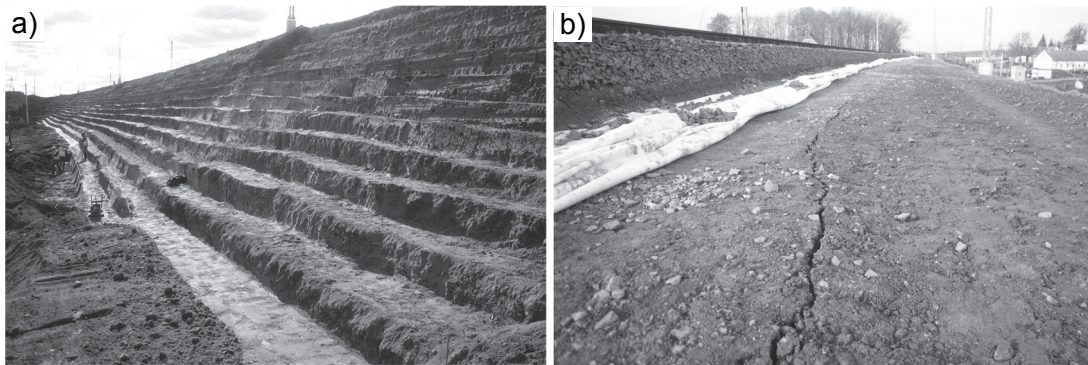
The early stability issue was noticed on site, following the modernization works, which included a 1 m embankment widening on its right slope (see Fig. 3a). Before placing a protective layer in the axis of track no. 1, the top of the embankment subsided, showing a 50 mm crack (see Fig. 3b). The observable crack took the shape of a 130 m long curve, from chainage 266+210 to 266+340 (see Fig. 4), with settlements of up to 300 mm.

Fig. 3: a) Shelves formed to widen the embankment 1 m to the right side
 b) Crack on the top of embankment under the track no.1

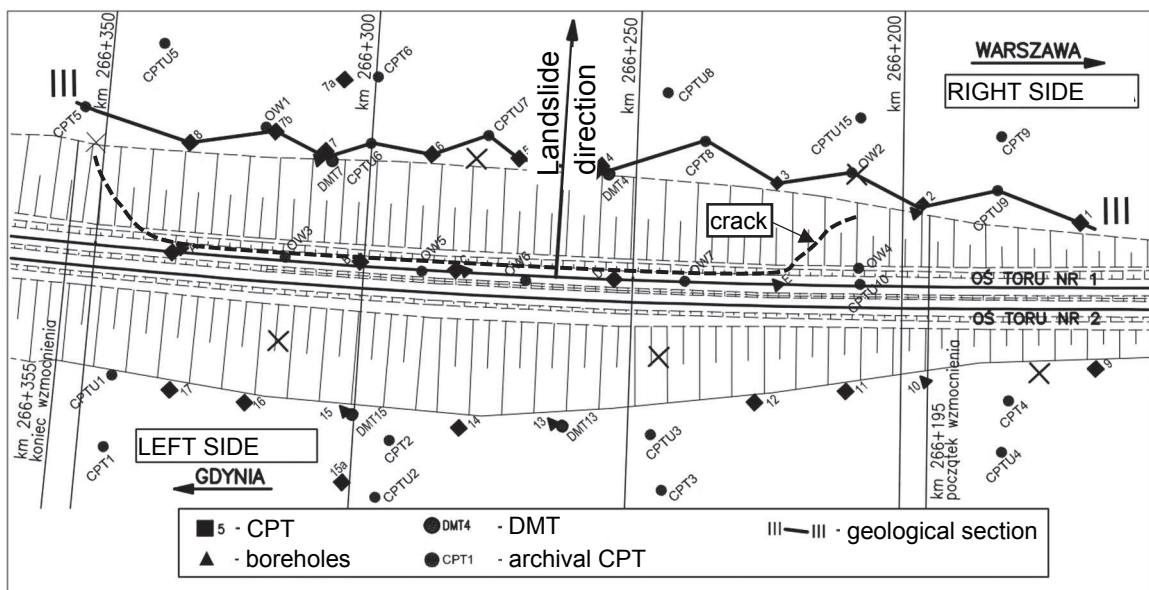
Fig. 4: Layout of the field tests and the observed crack curve on the right side of the embankment

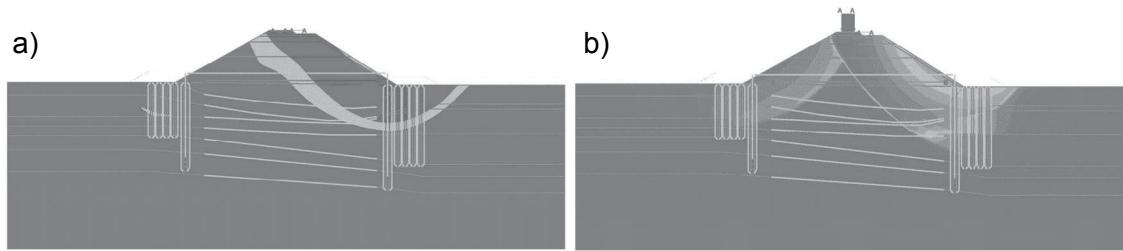
The geometry and character of instable slope indicated that the embankment was failing and had been set in motion as a result of earlier formed deep-seated shear failure. The back analysis of this state proved that the overall stability of the embankment was unsafe (see Fig. 5).

Fig. 5: a) Stability for the initial state without soil improvement, FOS=1.1 without traffic load applied
 b) Stability with long term traffic load applied on a single track, FOS \approx 1.0

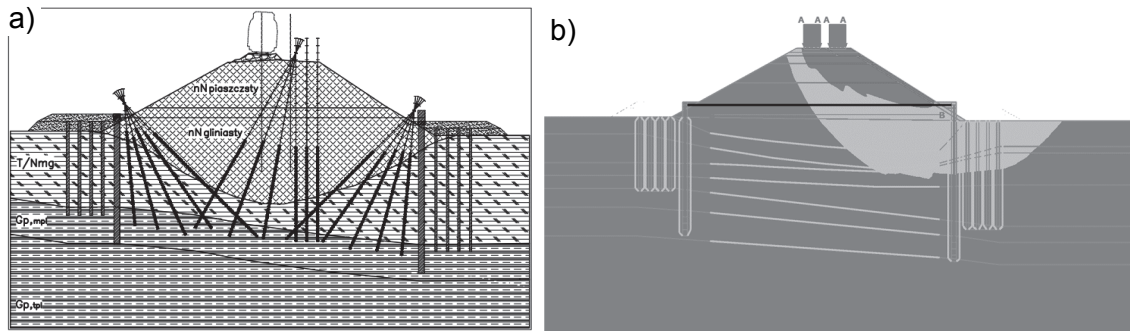
Fig. 6: a) The first geotechnical solution
 b) Stability with soil improvement, $FOS_{min}=1.5$ with a long term traffic load applied on a double track

In order to provide slope stability during the main repair works, the construction of a soil buttresses on both sides of the embankment was performed at first. The soil buttresses were used as working platforms for specialist machinery used on site. Due to very low soil strength parameters at the bottom of the embankment, it was decided to strengthen the buttresses with concrete columns. Then a CFA pile wall with a diameter of 80 cm in axial spacing of 1 m was constructed. The structure wall, embedded in the bearing layer at necessary depth, ensured unconstrained flow of groundwater, preventing the problems connected with water damming. In the next phase of works, it has been planned to top the pile walls with capping beams and to tie them up with post-tensioning system strands, performed in leading pipes, installed in horizontal drillings at the embankment's foundation. In the last stage of repair works, the execution of compaction grouting was planned in the embankment and its underlying layers of low bearing soils, providing a deep compaction of the soil that had been loosened during the creation of the landslide.

The stable construction, performed in that way, cuts through a deeply developed slip surface, preventing the further vertical movement of the embankment during its exploitation. It additionally prevents from the appearance of potential landslides on the other side of the embankment, which is in a state of unstable balance FOS \approx 1.0, according to calculations (see Fig. 5b).

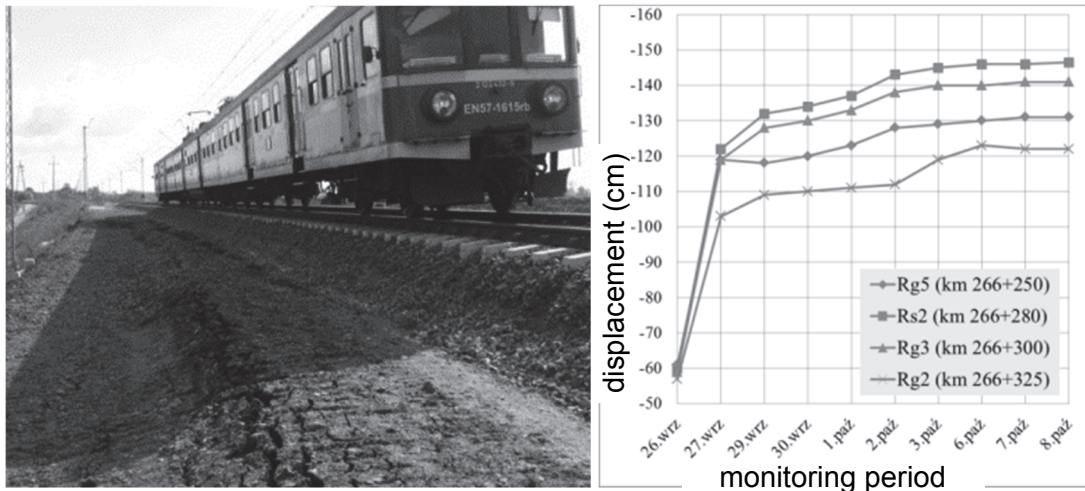
Once the stabilization design was finished and the work was already planned, torrential downpour activated the landslide and caused the embankment to fail. During the time of rain the slope became unstable with the reduction of the soil suction. Due to rain infiltration, suction pressure in the soil decreased, and thus, the effective shear strength of a slope significantly reduced, resulting in reduction of the factor of safety (FOS). The potential mechanism of rain-triggered slope failure of the railway embankment was widely discussed and reported by Raj and Sengupta (2014).

Fig. 7: a) Top right side of the embankment (~60 cm of settlement) – day after downpour
 b) Time – displacement curves of active landslide

The right side of the embankment was immediately covered with a PVC foil, preventing from further destruction that could be caused by changeable weather conditions. Additionally, 6 inclinometers were installed at the bottom right side of the embankment to measure the horizontal deformation, and precise geodetic survey was done. In order to estimate the compaction state of existing embankment on the landslide side, a number of dynamic penetration tests were performed. As shown on Fig. 7b, displacement of the landslide was up to 1.5 m in two weeks and

began to stay constant after this time. It suggested that the landslide was stabilized and repair works can be resumed.

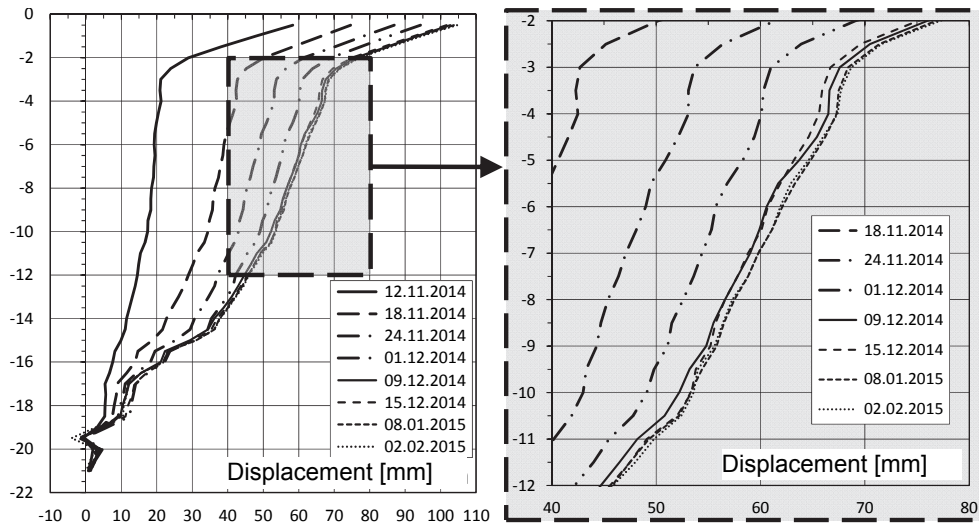
After the completion of the repairing works, regularly performed Quality Control results (measuring vertical and horizontal displacements) indicated stabilization of the settlements, which proves the adopted solution to be safe and effective (see Fig. 9) (Mitrosz 2015).

Fig. 9: Horizontal displacements of the embankment measured by inclinometers. Base measurement performed on 12.11.2014 (after finishing CSC), reference measurement on 15.12.2014 (end of strands stressing)
