Coastal erosion process at Calhetas parish, São Miguel island, Azores

F. Marques*, A.M. Malheiro, P. Amaral, A. Santos, L. Cunha

Laboratório Regional de Engenharia Civil (LREC), Ponta Delgada, Açores - Portugal

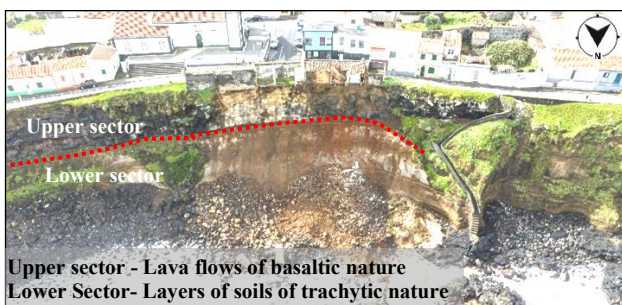
The cliff under analysis in this study delimits the parish of Calhetas to the north and is around 20 m high, with a sub-vertical slope, with some of the strata partially suspended. The lower half of the cliff, geologically, is made up of soft formations, namely a level of pumice of trachytic nature, with interspersed ash of the same nature with variable thickness. The upper half is formed by lava flows of a basaltic nature (s.l.) with clinker intercalations. Finally, a small layer of surface soil (vegetable soil and/or landfill) can be seen. All these formations have varying thicknesses along the length of the cliff (Figure 1).

Figure 1. Geological constitution of the cliff at Calhetas.

Geologically, this cliff has a high propensity for the occurrence of these instability processes, considering that the base of the cliff is made up of material that is easily erodible by the action of the sea. So, periodically, the overlying basalt flows stay in cantilever. Furthermore, the alternation of basaltic flows with clinker levels, which are also quite erodible, leads to situations where the overlying strata also stay unsupported.

To avoid the continued retreat of the cliff, it will be necessary to protect its base, which is made up of soft strata, as well as the stabilization of the overlying basalt flows that are fractured. For the lower sector, a rockfill prism adhering to the cliff can be done, which could serve as a base or foundation for the stabilization solution in the upper sector. Therefore, two possible solutions are proposed for the upper sector: one involves constructing an embankment along with small containment structures, while the other entails the installation of a reinforced concrete curtain anchored and nailed to the cliff.

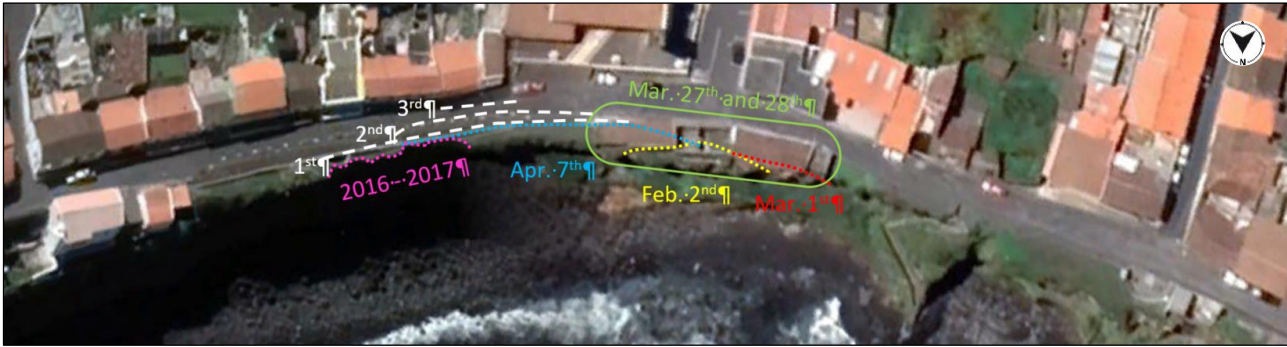
The current crisis began on February 2, 2023, at 8:00 pm, having destabilized an extension of the cliff measuring around 30 m and causing a retreat, which, in some places, reached 5 m (Figure 2).

In this episode, one of the affected buildings lost its back façade. It is important to note that the affected buildings were already vacant since the 2016-2017 crisis, except the structure located further west, which remained in use once it was a small warehouse.

After the first episode, the cliff became unstable again on March 1st, this time in a sector immediately to the west of the previous one, reaching a length of around 16 m and causing a retreat of around 2 m.

Figure 2. Affected areas on the Calhetas cliff: the alignment of existing cracks (dashed), the unstabilised areas (dotted) and the demarcation of demolished buildings / those affected by this crisis (continuous). Google Earth image (June 2022).

A few days before the demolitions began, it was found that the first and second alignment of cracks parallel to the coastline, already identified in 2016-2017, reactivated on the sidewalk and in the street pavement, resulting in an increase in the opening and the extension to the west of cracks. Furthermore, a new alignment of cracks further back was detected, the third (3rd) (Figure 2).

In March, the 2nd alignment (Figure 2) was located between 4.2 m and 6.2 m from the cliff crest, and the 3rd alignment was 1.6 m further back, thus compromising around 2/3 of the traffic lane.

After this reactive phase, following a recommendation previously made by the Regional Laboratory for Civil Engineering, the four buildings located in the affected sector were demolished on the 24th, 27th, and 28th of March. This operation was done to relieve the load over the cliff and reduce the mass expected to become unstable once the cracks between the buildings and the adjacent sidewalk continued to evolve.

During the current crisis, and after the reactivation of the 2nd alignment and the emergence of the 3rd, it was recommended to increase the extension of the prohibited area for car traffic. This closure was extended to the west around 100 m, and in width, besides the entire sidewalk, 2/3 of the traffic lane was closed in the most critical area.

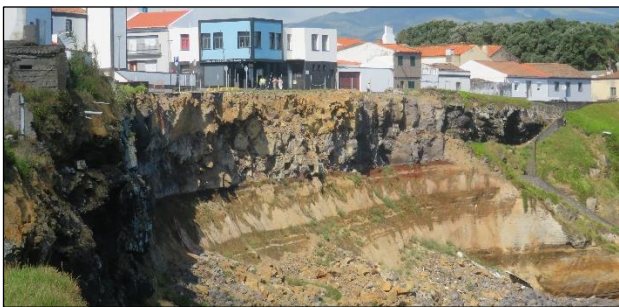
On the night of April 7th, a few days after the demolitions had concluded, the cliff became unstable again. The sector now unstable was located immediately east of the initial one. With a length of around 50 m, it reached a retreat of 5 m in the sector of the demolished buildings (Figure 3).

Figure 3. The cliff after the instability of April 7.

After the instability of April 7th, the crest of the cliff retreated to the 1st alignment, becoming the 2nd alignment 2 to 3 m from the crest.

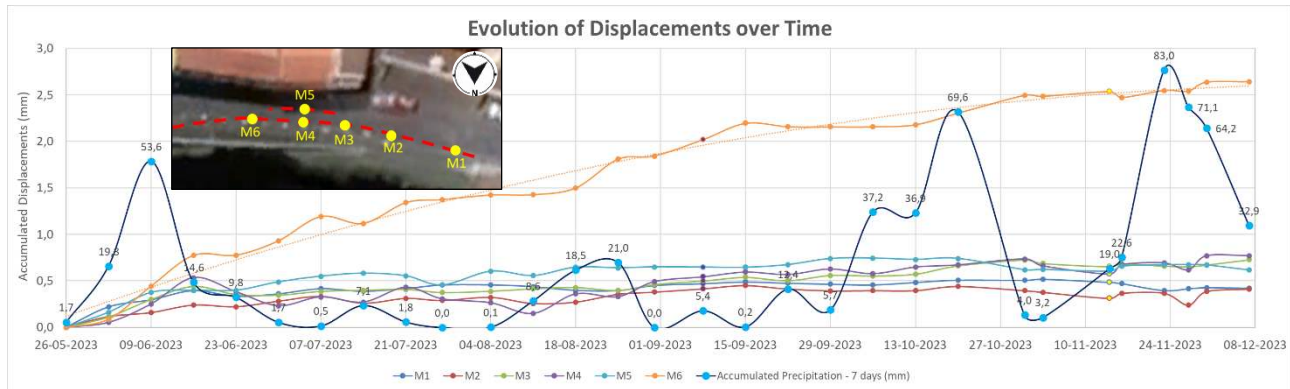
In May, after the crisis calmed down, six pairs of markers were placed along the two remaining crack alignments (2nd and 3rd) to evaluate its evolution weekly (Figure 4).

Figure 4. Evolution of the marks installed in the monitored cracks and precipitation.

During the current phase of the process, monitoring tension cracks near the crest of the cliff suggests that the mass rock does not react responsively to precipitation episodes, although, in the beginning, it seemed otherwise. Currently, this part of the cliff seems to have entered an inactive dormant state.
