# Geotechnical interventions to mitigate the geomorphological risk of the access road to Ribeira Quente parish - Azores archipelago

L. Moniz\*, P. Amaral, A.M. Malheiro, F. Marques, A. Santos  
*Laboratório Regional de Engenharia Civil, Ponta Delgada, Portugal*

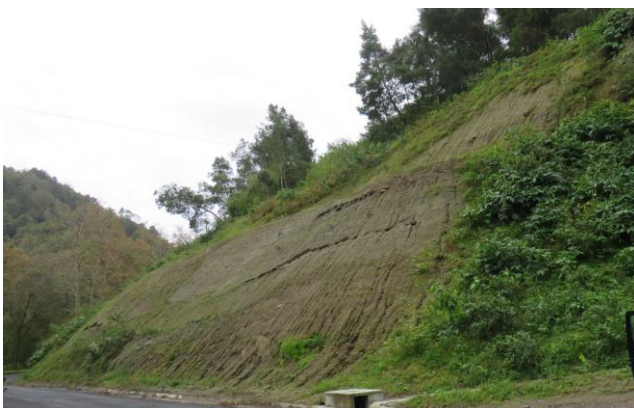
Site no. 4 corresponds to a slope about 20 metres high and is made up of intercalations of trachytic pyroclastic deposits of different grain sizes. The intervention carried out at this site involves altering the geometry of the slope, softening its slope, and creating a bench at approximately half height (Figure 3).

Figure 3. Site no. 4 - Slope re-profiling.

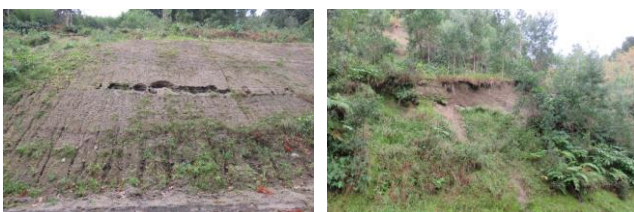
The slopes adjacent to the E.R. 2-2<sup>a</sup> usually have water levels. Evidence of this can be seen in the numerous springs and waterfalls that can be seen along the road. Despite this, no deep drainage system, such as sub-horizontal drains, has been installed at site no. 4. Thus, on the face of the slope, it is possible to observe signs of internal erosion caused by the outflow and accumulation of water, as well as gullies due to surface run-off (Figure 4 on the left). Apparently, no geological and geotechnical study or global stability analyses have been carried out on the slopes to be re-profiled to ascertain which tilt gives them stability.

Indeed, there have already been several surface geomorphological instabilities on the face of the re-profiled slopes. At site no. 6 (Figure 4 on the right), there was a superficial geomorphological instability on the face of the re-profiled slope.

Figure 4. Site n°. 4 - Erosion on the slope face (on the left). Geomorphological instability at site no. 6 (on the right).

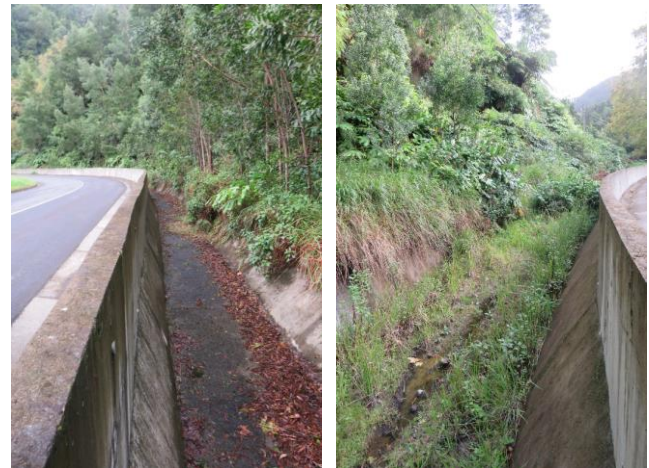
At site no. 5, a retaining wall was built with a ditch at its back, aiming to collect a large part of the material mobilised from upstream, preventing it from reaching the regional road platform (Figure 5). Over time, this measure has proved to be effective, as there have been several reports of these structures intercepting material that was heading towards vehicles travelling on the E.R. 2-2<sup>a</sup>. However, these are measures that need to be maintained, in this specific case by removing the material that is trapped inside the ditch, so that it remains operational, a situation that does not always occur, as is the case at site no. 7 (Figure 5 on the right).

Figure 5. Site no. 5 – Retaining wall with ditch (on the left). Site no. 7 – No maintenance (on the right).

Throughout the document, it was possible to see the importance of a prior study of the site to be intervened, with geological and geotechnical studies, as well as global stability analyses. In addition, all the works carried out require periodic maintenance, with cleaning and removal of debris, in order to guarantee their effectiveness. It should be noted that the main problems were observed in the places where the stabilisation solution involved slope re-profiling, with the occurrence of surface ruptures. Furthermore, places where retaining walls were built with a ditch at the end found a lack of cleaning of the ditches where the unstable deposits were trapped in that structure.

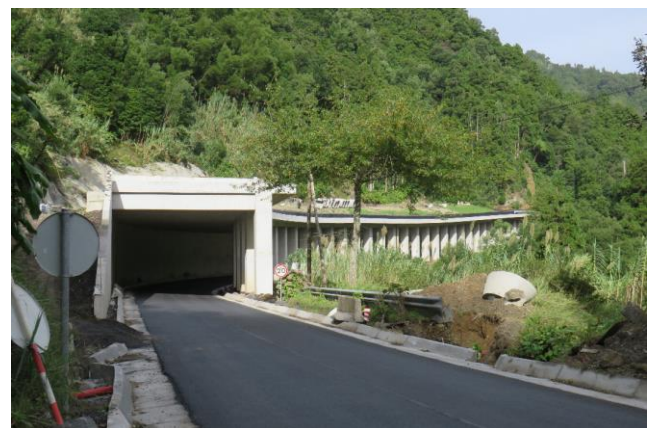
The slope adjacent to site no. 12 is 400 metres high. Taking into account the difficulty of implementing stabilisation measures there, a semi-tunnel was built, approximately 200 m long (Figure 6).

Figure 6. Site no. 12 – Semi-tunnel.

The length initially planned for the semi-tunnel was greater than that actually built. The initial extension was justified by the geological and morphological characteristics of the adjacent slopes. A heavy rainfall event in June 2023, which led to several landslides, debris flows, and debris avalanches, demonstrated

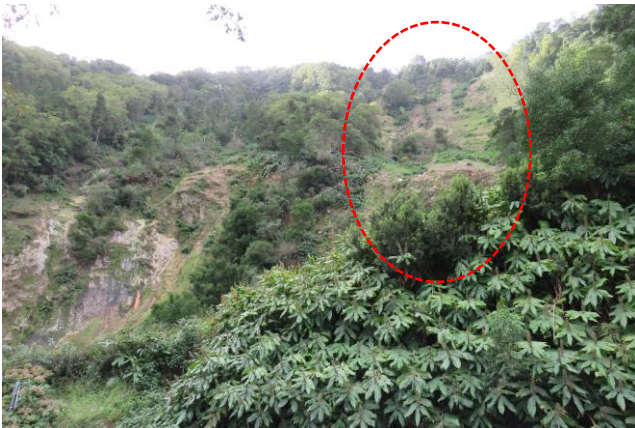
this. In fact, in this event, the most serious situation occurred on the slope adjacent to the section of the semi-tunnel that was chosen not to be intervened on (Figure 7). The unstable material was deposited at the entrance of the semi-tunnel, causing its interruption and, once again, leaving the population of the Ribeira Quente parish isolated for a few hours.

Figure 7. Geomorphological instability, of debris avalanche type, on the slope adjacent to the semi-tunnel.

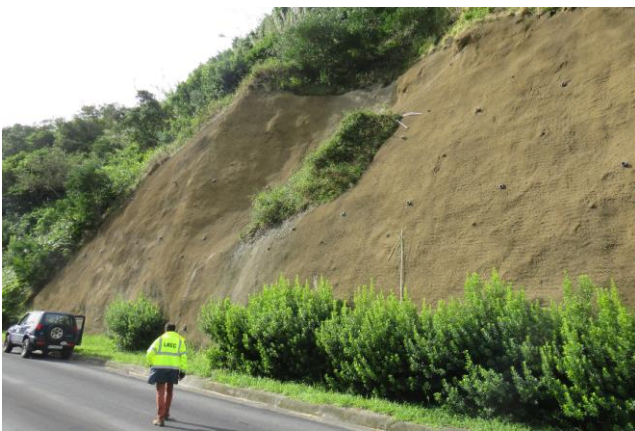
Finally, the last site presented (site no. 14) corresponds to the application of nailing, metal mesh and shotcrete (Figure 8).

Figure 8. Site no. 14 - Application of nailing, metal mesh and shotcrete.
