# Slope instability risk assessment along the Almada municipality coastline, Portugal

F. Paulino\*, E. Fernandes, A. Dinis  
*Geovia, S.A., Lisbon, Portugal*

A. Aires, A. Godinho  
*Câmara Municipal de Almada, Almada, Portugal*

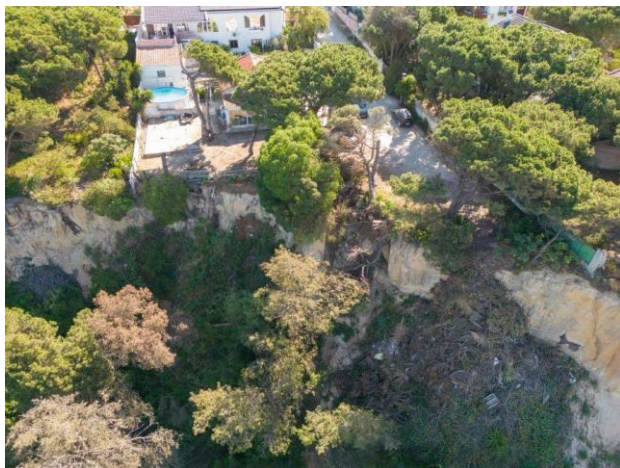
Figure 2. Panoramic view of the fossil cliff in Bairro do Fóni with houses adjacent to the cliff's crest (June, 2023).

In Bairro do Fóni, there is a very sharp cliff retreat with evidence of significant ravines. There are buildings located on the top of the cliff, with emphasis to an overhanging reinforced concrete structure at risk of structural failure.

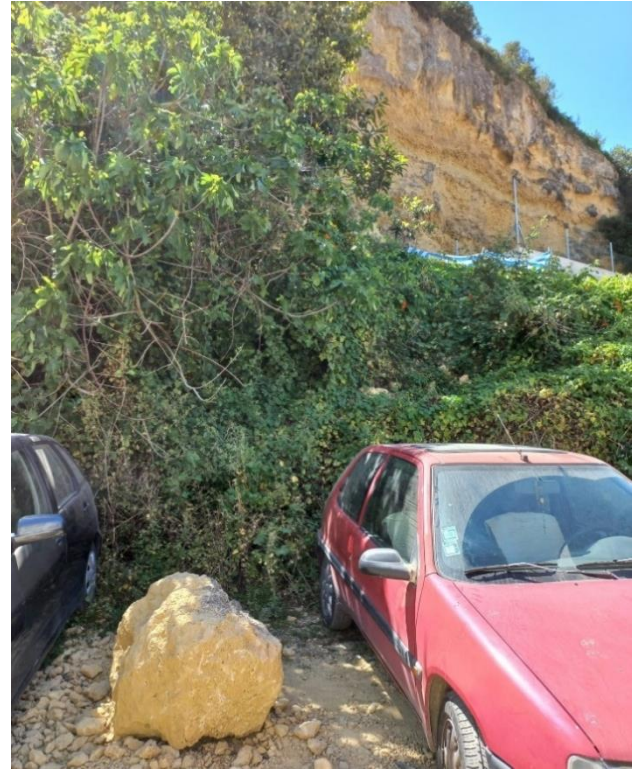
Figure 3. Limestone block from Banática Cliff near parked cars (June, 2023).

Table 1 shows that certain locations have a higher risk index due to the greater height of the cliffs, the history of incidents and the possibility of large blocks being mobilised from these locations (as shown in Figure 3).

In Banática, the houses are located near the slope (between 2.0m and 10.0m) and there is no protection against slope movements. This is a scenario of maximum damage potential and no response capacity.

The dismantling of some larger, potentially unstable blocks, must be considered using appropriate dismantling methodologies, as well as, the fixing of metal nets to control blocks that may detach from the cliff face.

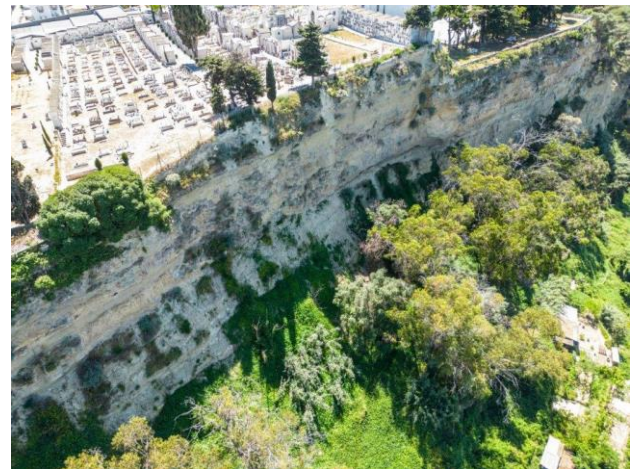
Figure 4. Panoramic view of the fossil cliff in Olho de Boi with Almada Cemetery behind (June, 2023).

For example, the landslides and rock fall events observed at the Olho-de-Boi cliff occurred at the base of the slope, leading to an overhang at the top. This indicates that the layers with the least resistance are located at the bottom of the cliff, while the ones with the most resistance are at the top. It is observed that the most weathered and the less weathered layers are divided by tension cracks parallel to the cliff and subvertical fractures visible at the top of the cliff.

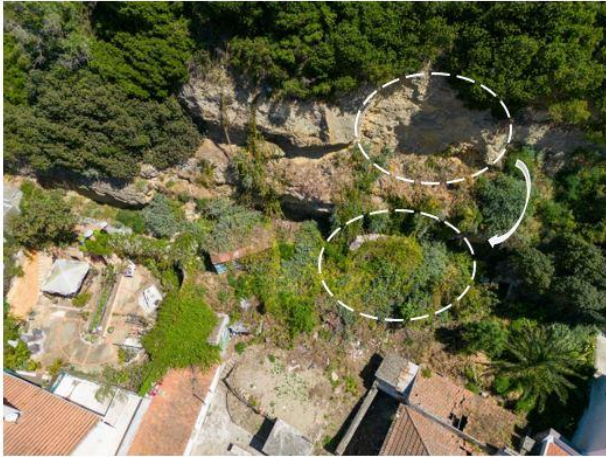
Figure 5. Panoramic view of the cliff in Porto Brandão with houses adjacent to its base (June, 2023).

In Porto Brandão, there are several residential and commercial buildings occupying the foot of the cliff with no safety distance. This represents a very high vulnerability, as there is minimum response capacity and maximum potential damage.
