Slope failures risk acceptance in the construction of roads on the clayey mine spoil dump, Czech Republic

J. Jurko*

ABSTRACT: In this paper, we present a study of a large slope failure, which endangered the construction of a bridge, occurred in 24 m deep cutting with a main scarp upper edge extending over 70 m in length. The stability analysis is discussed, with a critical analysis of safety factors, according to the Eurocode. The important place takes the analysis of slope stability during construction, but also the analysis of long-term conditions, back-analysis, in anthropogenic site, conditions that are not completely covered by geotechnical codes. Lessons learned showed, that a design basis in such an anthropogenic environment should ensure an advanced geotechnical characterizations and parametric engineering assessments. Even in such a case, it will be necessary to acknowledge the risk of slope instability by all stakeholders, mainly due to uncertainties associated with a construction of clayey mine spoil heaps and a subsequent mechanical properties heterogeneity of stockpiled soils. The role of geotechnics is inevitable in such "natural" conditions of mine spoil dumps to p

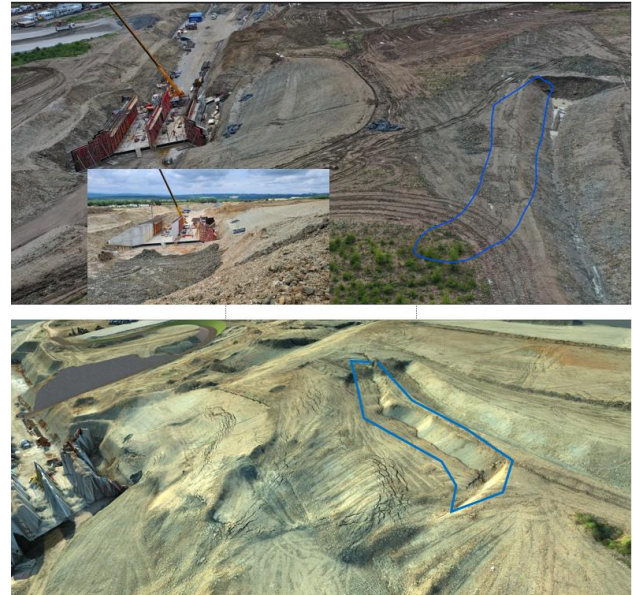
During the construction of a bridge structure, a slope failure (landslide) occurred in the cutting with a total depth of approximately 24 m, and length of the main scarp upper edge approximately 70 m (Figure 1). The sliding surface was clearly characterized by a smoothed plane-slip surface with soil displacement of up to 5 m downward at a slope of approximately 45° (Figure 2). The landslide body covered an area of approximately 5000 m² with a potential soil volume in the landslide of 50000 m³. Observations of the main sliding surface showed an interface of brown and distinctly coloured grey clays, which differentiated

Figure 1. Landslide within 24m deep cutting (upper picture shows a situation before the failure).

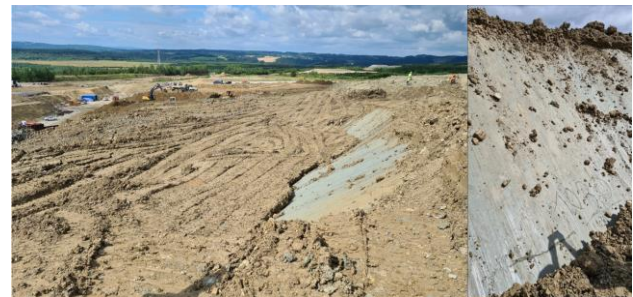
Figure 2. Main scarp upper edge of the landslide.

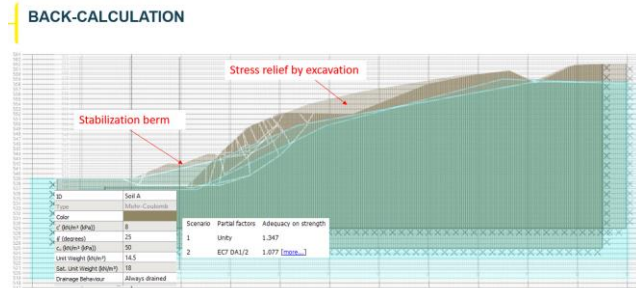
The numerical stability analyses results showed that the required theoretical safety factor was achieved in the phase of conducting stabilization measures, after the crack had occurred (Figure 3). Still, the question had arisen as to why the landslide occurred?

Figure 3. Back-analysis of the failure occurred after the construction of stabilization berm and excavation of upper part material.

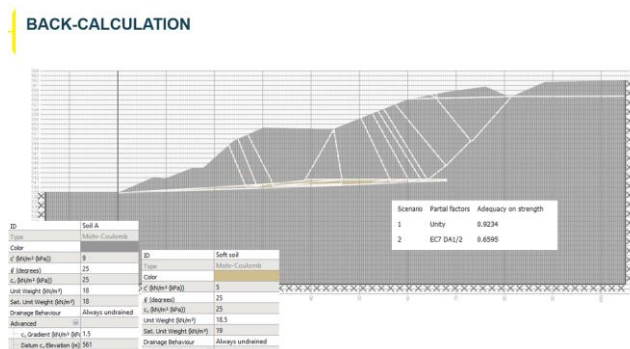
The geotechnical back-analysis included parametric studies with different elements of instability. It turned out that a geometric instability element had to be present in the system (model), which was a prerequisite for the occurrence of the slope failure (Figure 4). By including such an instability element in the form of a completely thin layer of soft clay in the body of the landslide, the calculated degree of safety was insufficient, which also confirmed the theoretical possibility of a slope failure. Such calculated representation corresponded well with the site observations.

Figure 4. Back-analysis of the failure including an element of instability – 0.5m thick seam of soft soil in the cutting.

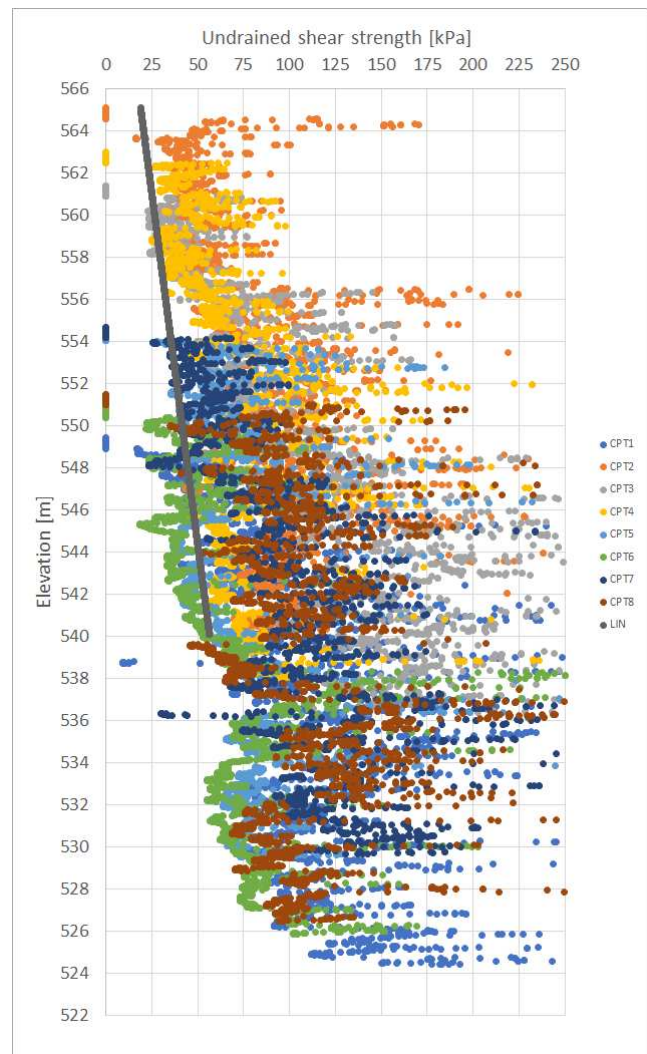
As part of the investigation of the occurred slope failure, an additional geotechnical investigation by means of static penetration tests was carried out. The results provided detailed information regarding the subsoil profile, showing multiple low-peak locations, at different depths, with very low to low shear strength in the body of the landslide as well as in the wider area

outside of the landslide body (Figure 5). These locations were local, very thin clay layers of very soft to soft consistency often only a few cm to a few dm thick. Thus, there was a practical confirmation of the hypothesis arising from the back-calculation, and that is a need for the presence of an element of instability in the system in order to model the theoretical failure. With the help of the interpretation of the static penetration results, the potential basal sliding surface was determined, which was necessary for the planning of remediation measures. The static penetration test results also indicated a random occurrence of very soft to soft clay deposits in locations outside the landslide itself. This confirmed the presence of the geotechnical risk arising from the nature of the spoil heap construction, the unpredictable interaction with water and the consequent change in the mechanical properties of the stockpiled clays.

Figure 5. Static penetration test results showing potential basal sliding surface.
