# The A83 Loch Shira landslide, Scotland

M.G. Winter\*

**ABSTRACT:** The A83 Loch Shira landslide has been active since the early-1990s, and this paper will present a brief history of this mass movement. Significant movements are evident in the bund immediately adjacent to the road, narrowing the verge from around 2m in 1995 to effectively zero in places. Movement is also apparent in the cut slope above the bund and evidenced clearly by the significant distortion of a catch pit, the date of installation of which, while post-1995, is unknown. The movement of the landslide is driven by groundwater, specifically water from rockhead at the interface with the superficial deposits. This drives movement downslope to the stiffer complex formed by a retaining wall, the road and the rockfill bund adjacent to the road. In 1995 it was postulated that this stiffer complex could store energy and potentially lead to a catastrophic failure. The movement of the bund and the cut slope above seems likely to be a manifestation of a limited pressure (or energy) release and the current state of the landslide is of concern. The potential adverse influences of climate change on the landslide include inc

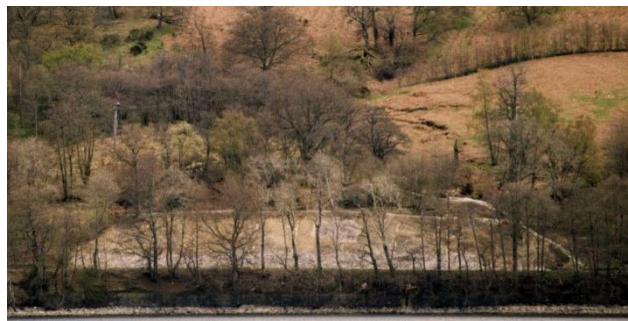
In April 1995, the first author and a colleague undertook an assessment of the slope (Figure 2). The primary conclusion of that work was that the failure was most likely controlled by water pressure at rockhead. Both old and new scarps were identified, recent slips in the regraded cut slope were observed and the entire area of the landslide was wet with some areas being identified as particularly boggy. Streams, both active and ephemeral were encountered, some of which fed into tension cracks and/or scarps. Other slips were identified in the area outside the landslide as might be expected.

Figure 2. The Loch Shira landslide in 1995.

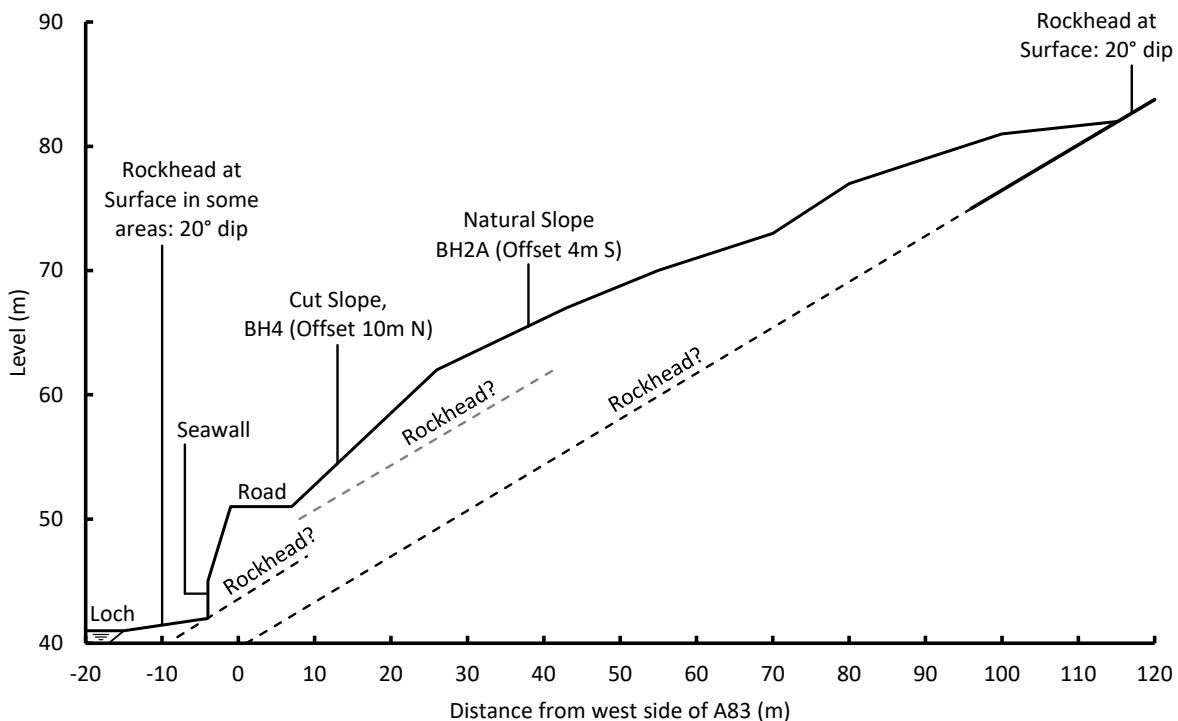
The depth to the Phyllite rockhead (Anon., 1897; Hill et al., 1905) at road level was, to some degree, uncertain (see Figure 3) and fundamental to the likely behaviour of the landslide. While only minor movements had been observed since the December 1994 rainfall, it was considered that further such rainfall could initiate further significant movement. The prevalence of an extensive network of drainage ditches taking water from a former forestry plantation to the head of the landslide and the removal of the trees were considered to be contributory factors. A full ground investigation was recommended and designed and supervised in summer 1995 by the first author.

Figure 3. East-west section through the Loch Shira slope: the landslide is approximately 100m at road level.

Rockhead was originally conjectured in three locations but the ground investigation conformed the deeper location with daylighting at the loch shore.

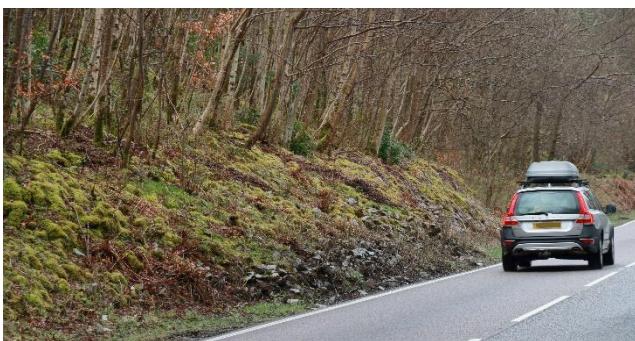
In 2022 (14 April, 18 and 26 October) the site was inspected by the authors as part of Transport Scotland's Vulnerable Locations Operations Group activities, which *inter alia* include identifying assets that need adaptation to provide adequate resilience to the effects of climate change. It was immediately apparent that there had been significant outward movement of the rockfill bund (Figure 4); as late as 1999 the distance from the toe to the edge of the

running surface was 2m whereas by 2022 the bund was, in places, touching the edge of the running surface.

Figure 4. The original distance of the toe of the bund from the edge line of the carriageway was approximately 2m, by April 2022 the distance had reduced to zero in places.

Recent observations suggest that significant downslope movement is occurring within the landslide mass and that this is manifesting at road level in downslope movement and distortion of the rockfill bund. The major concern is that if the movements are occurring at rockhead then energy is being stored behind the mass formed by the seawall, the road and the slope between, leading to the potential for a brittle failure of those components.

A review of potential remedial solutions is currently underway, but it is difficult to envisage a solution that does not involve large scale drainage features.

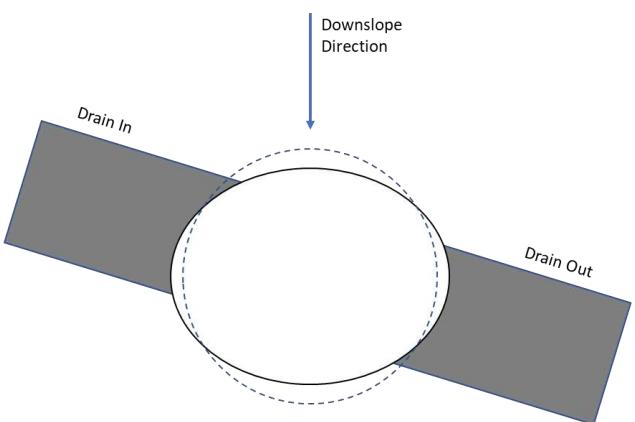
Inspection of the 2016 drainage scheme revealed measured strains of up to 15% in the downslope direction and up to 10% orthogonally (Figure 5).

Figure 5. Catch pit plan view showing the original circular shape (600mm diameter, dashed blue line) the current shape of the ellipse (minor axis 510mm, major axis 660mm as a solid black line), the inflow and outflow pipes, and the downslope direction.
