# Stabilization of excavation slopes between km 0+000 and km 2+000 of the EN337, in the municipality of Vouzela

F. Paulino\*, E. Fernandes, A. Dinis  
*Geovia, S.A., Lisbon, Portugal*

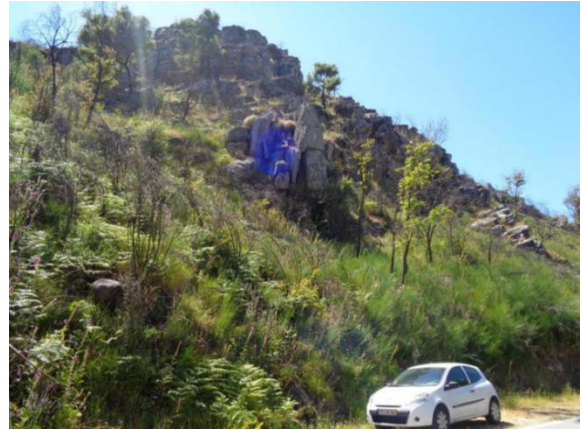
Between km 0+950 and 0+980, the rock massif is visible only at a height of around 10m, in a sub vertical structure (Figure 1). The massif appears much fractured, with loose blocks of medium large size with potential for instability.

Figure 1. View of the slope showing the heavily fractured rock mass at a high elevation with potential for instability.

The application of triple-twist metal mesh (Figure 4) was defined for areas of the granite massif that present simultaneously a low degree of alteration and a high degree of fracture, which could consequently imply the detachment of blocks of different dimensions and subsequent fall to the road.

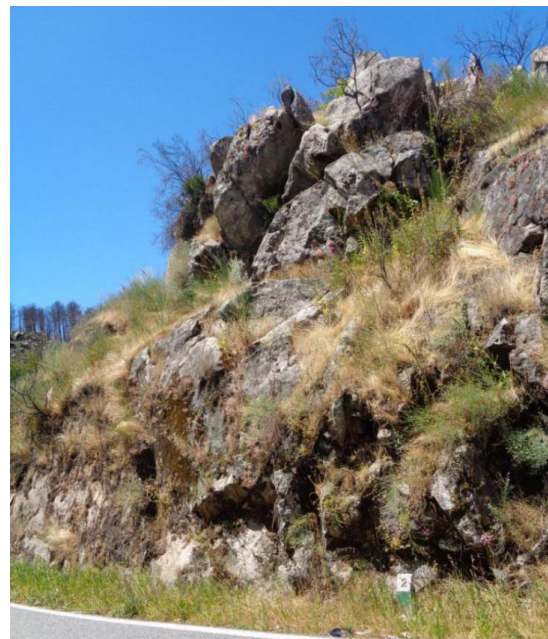
Between approximately km 1+020 and km 1+090, a scenario similar to the previous one was observed, with the difference that the outcrop of the granite outcrop is visible from area adjacent to the road, i.e., it emerges at a higher elevation, low, extending in height (Figure 2).

Figure 2. Slope featuring loose blocks with kinematic potential.

The solution for applying HEA panels (Figure 5) was defined only for areas where the isolated removal of blocks is unfeasible, due to steeper slopes and more significant slope heights. This solution aims to maintain rock blocks of considerable size in their position.

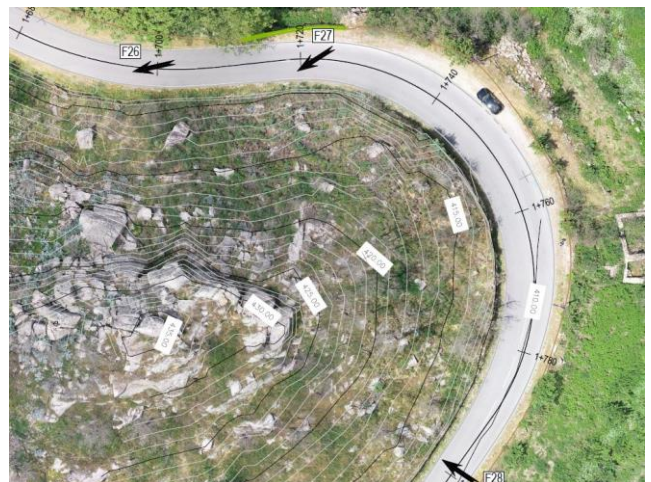
To support the work developed, a topographic survey was carried out using a drone. This allowed a perception not only of the position and size of the blocks, as well as, the elevation at which the rock blocks are located in relation to the EN337 (Figure 3).

Figure 3. General aerial view of the site under study.

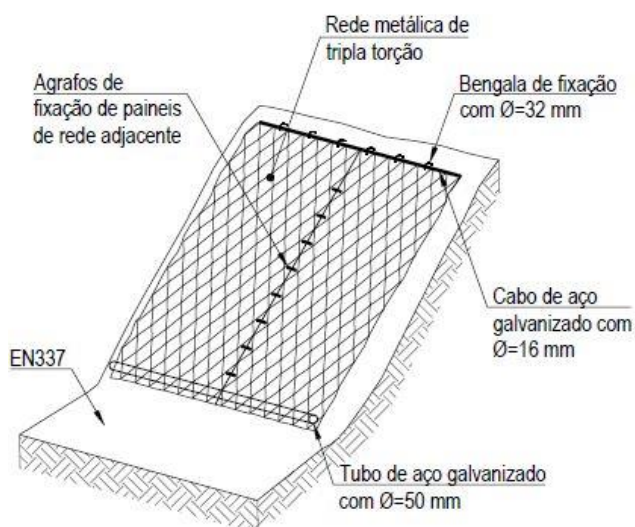
Figure 4. Triple twist wire mesh fastening diagram.

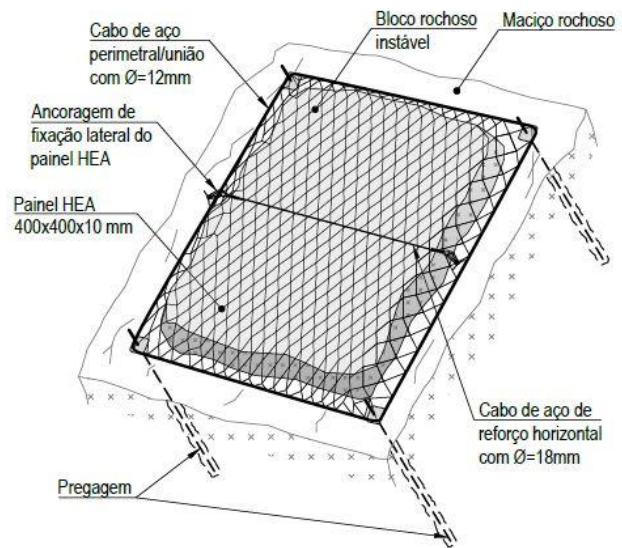
Figure 5. HEA panel fixing diagram.

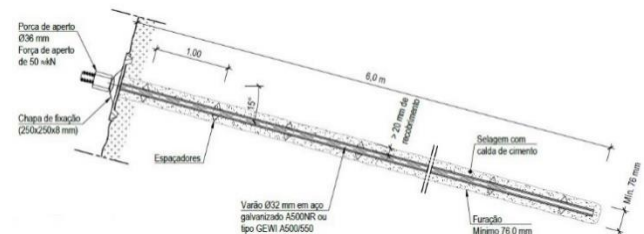
Figure 6. Rockbolt detail.

With the purpose of consolidating rock masses in areas where unfavourable joint planes are present, it was recommended to install localised rockbolts in exposed granitic masses with a low weathering grade (Figure 6). With its application, it was intended to prevent further development of the existing failure's surfaces and therefore increase stability.

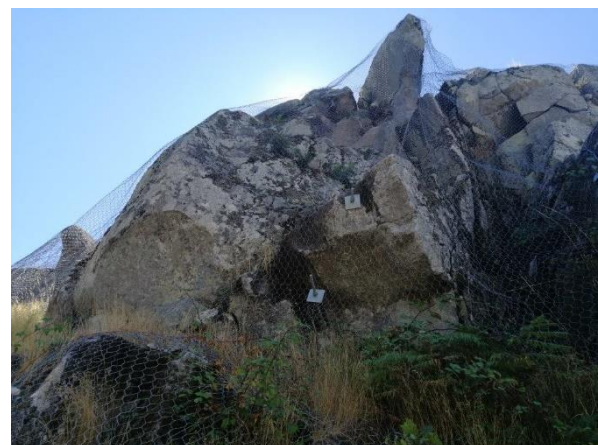
Figure 7. Application of triple twist net and nailing in excavation slope.

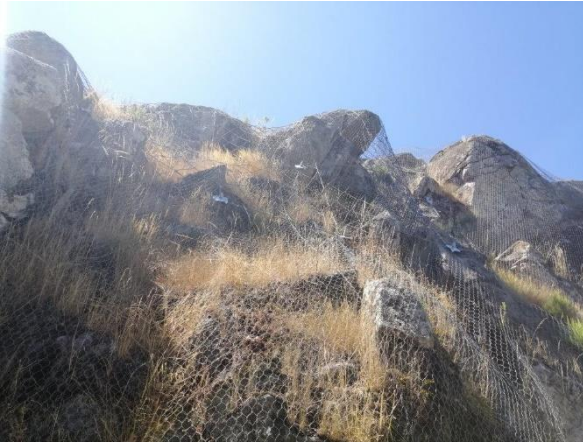
Figure 8. Application of HEA panels and nailing in excavation slopes.

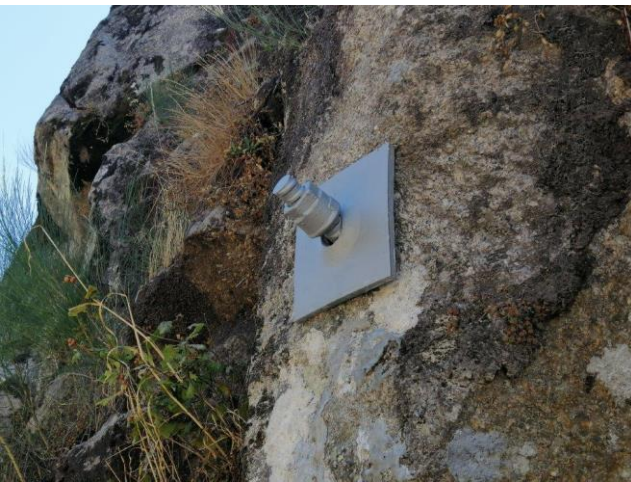
Figure 9. Application of punctual nailing in excavation slopes.
