Numerical analysis of an unstable slope

ABSTRACT: A slope adjacent to a northbound regional motorway, outside the city of Barcelona, has shown signs of instability, which have affected the functionality of the road. An extensive instrumentation system has allowed to observe the movement of the slope and locate the slip surface in various sections. The paper presents the study of the instability phenomenon and its origin by means of 2D numerical analyses. Monitoring data has been used to validate the numerical model and to reproduce the observed slope behaviour. In the present work, the features of the numerical study are described and the results are then compared with the in-situ observations.

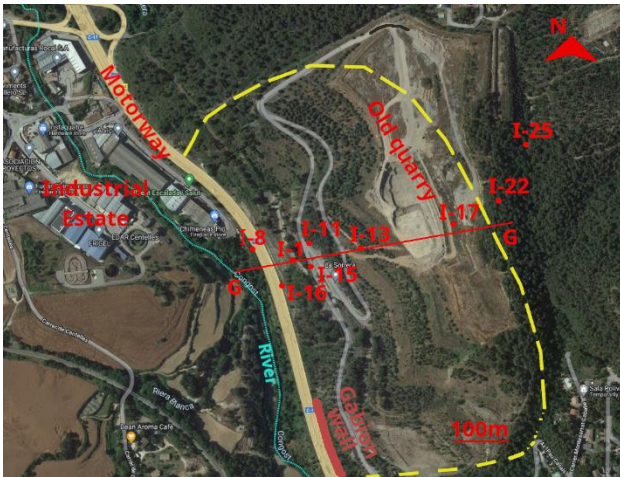
The slope object of this study borders a motorway whose construction dates back to the late 1980's. On the upper part of the slope an old quarry is present, the exploitation of which lasted a little over 40 years, from around 1960 to 2004 (Fig. 1). The materials extracted from the quarry were dolomites and limestones used mostly in the construction industry.

attributed to the possible presence of expansive materials below the pavement of the road. The implemented corrective measures, which included the construction of a gabion wall (Fig. 1), were nevertheless inadequate to definitely recover the road safety and functionality. Later on, in 2017, when significant repair works were being executed, the Contractor was able to relate the road deformation signs exclusively to the movement of its adjacent slope. An extensive monitoring plan was hence deployed to keep track of the slope instability phenomenon and properly define its limits.

Figure 1. Layout of the motorway and the old quarry on the upper part of the slope (right-hand side). The picture also shows the industrial estate on the opposite side of the road with respect to the unstable slope (discontinuous line) and the location of Section G object of this study (Google maps image).

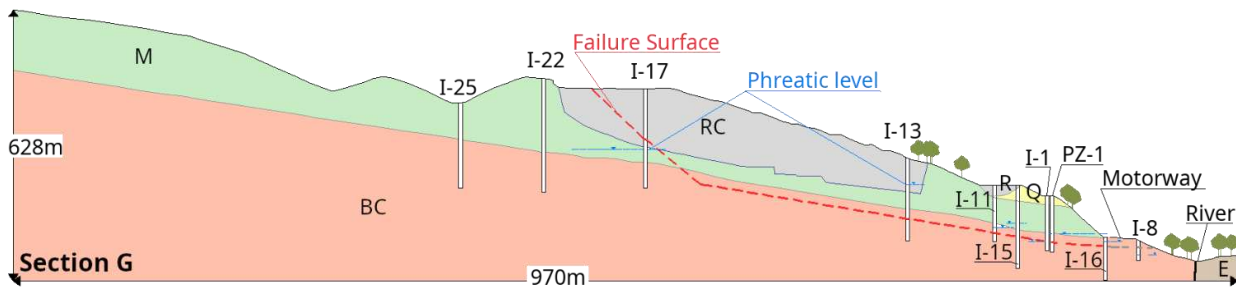
According to the latest available data, the failure surface of the slope is located at a depth of about 40 m, mainly placed within the shales layer (unit BC in Fig. 2), the upper part of which appears strongly weathered. During the exploitation of the old quarry, the excavation of the upper quaternary materials left the underlying shales layer exposed to atmospheric agents in many parts of the slope, probably favouring its weathering. When the restoration process began and the quarry was converted into a CDW disposal deposit, the hydraulic conditions of the slope changed mainly due to the fact that the base of the deposit was waterproofed.

The main purpose of this extensive monitoring plan was to identify the origin of the slope instability. The observed movements indicated that the slope was indeed moving and that the depth of the slip surface was about 40 m (Fig. 2).

Figure 2. Geological profile along Section G of the slope. The failure surface observed through the inclinometer readings is indicated in red.

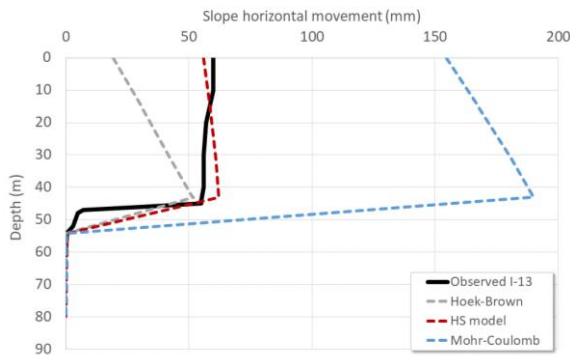
At first, all numerical analyses were run with the numerical model shown in Figure 3, using the three previously mentioned constitutive models with equal, or equivalent, strength and stiffness parameters. The observed slope movement at inclinometer I-13 (Figs 1-2) and the numerical results associated to different constitutive laws are shown in Figure 4.

HS constitutive model. As Figure 4 indicates, the HS model proved to be the one that best reproduces the slope horizontal movement with depth, confirming thus that it is indeed important to consider the strong non-linearity of ground materials. Also, in this case study, the unloading-reloading stiffness modulus (E_{UR}) plays a key role in characterising the ground behaviour; more relevant than the oedometric (E_{oed}) or secant modulus in drained triaxial tests (E_{50}).

Figure 4. Observed horizontal movement with depth, at inclinometer I-13 and numerical results obtained with different constitutive models.

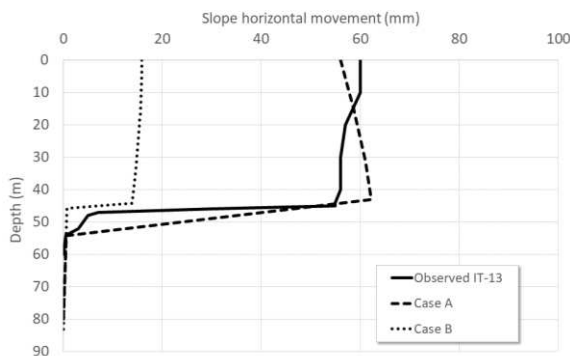
Figure 5. Observed horizontal movement, at inclinometer I-13 and numerical results, considering different slip surface thicknesses and the same HS constitutive model.

According to the different inclinometer readings, the thickness of the slip surface is not uniform throughout the slope, in general being thicker (up to about 10 m) further away from the motorway, as it is approximately represented by the varying thickness of the W-BC layer in Figure 3. In a second phase of this study, two different numerical models (both calculated with the HS model) were considered, each with a different thickness of the W-BC layer, in order to analyse how this feature affects the numerical results. Figure 5 shows the comparison between the observed slope horizontal movement, at inclinometer I-13, and the numerical results in two different scenarios: case (A), in which the thickness of the W-BC layer varies along the slope (Fig. 3) and case (B), in which the same layer has a uniform 2 m thickness. The results show

that the thickness of this layer greatly affects the results and, in general, the movement of the slope.
