# Collapse of the historical archive of the city of Cologne due to underground construction – Damage analysis and conclusions for quality assurance and risk management in geotechnical engineering

Christian Moormann

*University of Stuttgart, Institute for Geotechnical Engineering, Stuttgart, Germany MGC  
Moormann Geotechnik Consult, Stuttgart & Cologne, Germany*

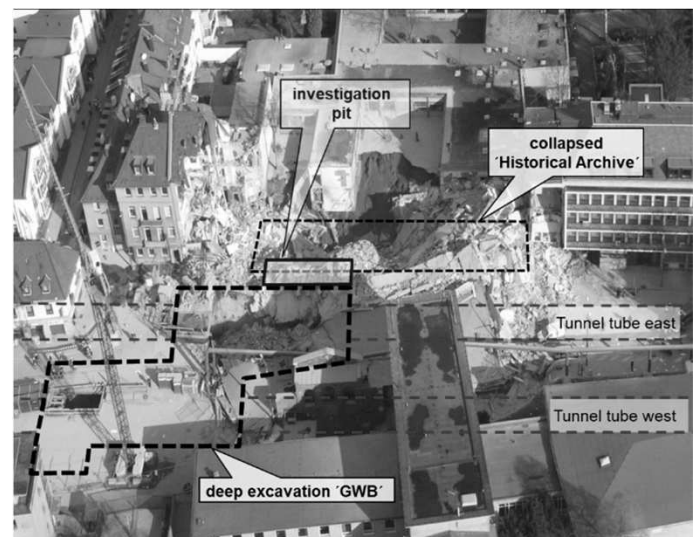
Figure 1. Aerial view of the collapsed Historical Archive and neighbouring residential buildings on Cologne's Waidmarkt immediately after the accident on March 3<sup>rd</sup>, 2009.

On March 3<sup>rd</sup>, 2009, at 13:58 pm, an accident occurred in the deep excavation 'GWB' during which about 5,000 m<sup>3</sup> of sand and gravel flowed into the excavation pit, causing the collapse of the adjacent 'Historical Archive' of the City of Cologne, a massive 7-storey reinforced concrete skeleton building, immediately adjacent to the excavation pit to the east, as well as of parts of the adjacent multi-storey residential buildings on both sides (Figs. 1, 3a). The spread foundation of the Historical Archive, consisting of single and strip foundations founded in the quaternary sands and gravels, sank into the ground (Fig. 2b); foundations were later recovered from a depth of up to 20 m below ground level. This sudden "loss of foundation" caused the building to tilt towards the street, then to completely collapse, thereby partly falling into the excavation pit, breaking through its covering (Figs. 1, 5). The soil inflow at the lowest level of the excavation pit resulted in the formation of a cone of debris up to 7 m high consisting of quaternary sands and gravels, the foothills of which reached into the four tunnel tubes (Fig. 3a) and whose greatest height was directly in front of the eastern diaphragm wall (Figs. 2b and 3b). Although the workers fleeing from the final excavation level of the 'GWB' pit who had noticed a rapidly increasing water and then soil ingress during final excavation and construction of the pump sump in front of the eastern diaphragm wall, warned the visitors to the Historical Archive and the residents of the neighbouring residential buildings of the impending accident at the proverbial last minute, two young residents tragically died in the subsequent collapse of the residential buildings. At that moment, around 30 linear kilometres of archives from 1,200 years of Cologne's city and regional history, the "city's memory" that has grown over the centuries, seemed to have been destroyed within seconds and lost forever.

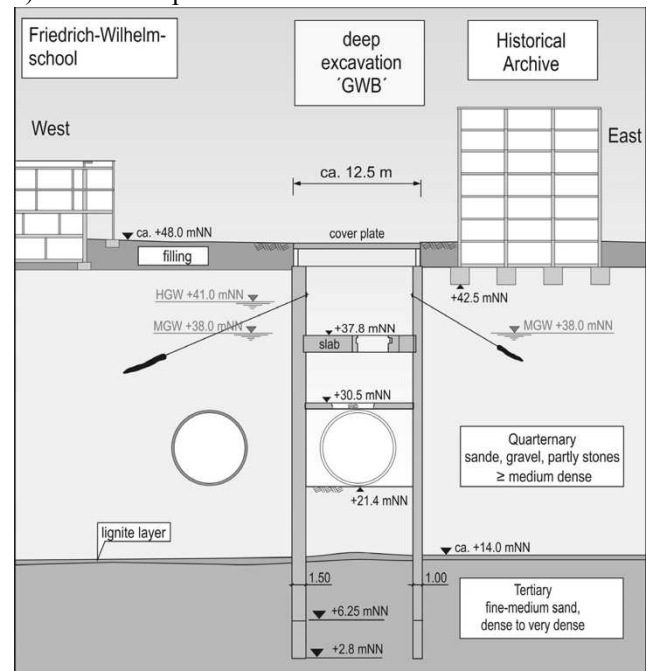
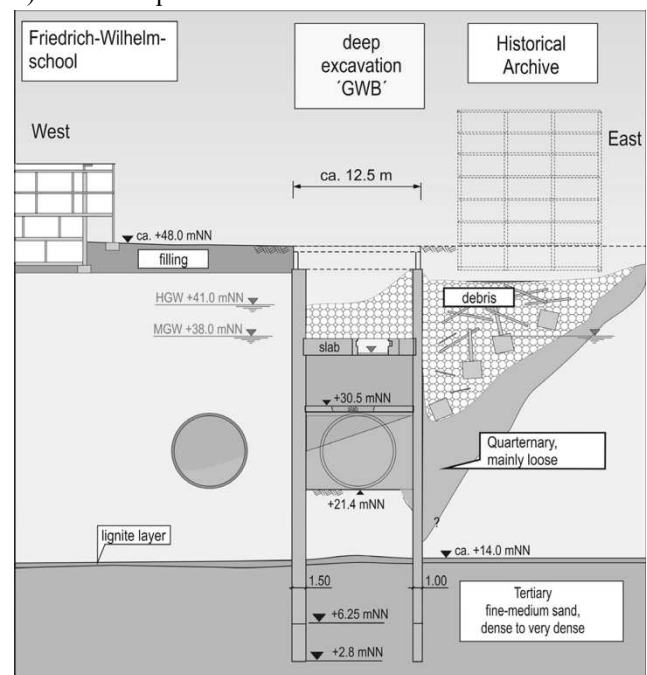
Figure 2. East-west section through the deep excavation ‘GWB’ with neighbouring buildings and subsoil situation (position of section corresponds to section 1-1 in Fig. 3).

The subsoil conditions at the 'Waidmarkt' site are illustrated for an east-west section in Figure 2. Below street level and up to 6 m thick fillings Pleistocene terrace deposits (Quaternary) down to a depth of around 14 m a.s.l. which consist of terrace gravels and sands of the Rhine of varying grain size and composition, into which cohesive, slightly silty secondary sediments and isolated cohesive layers of decimetre thickness can be incorporated in some areas.

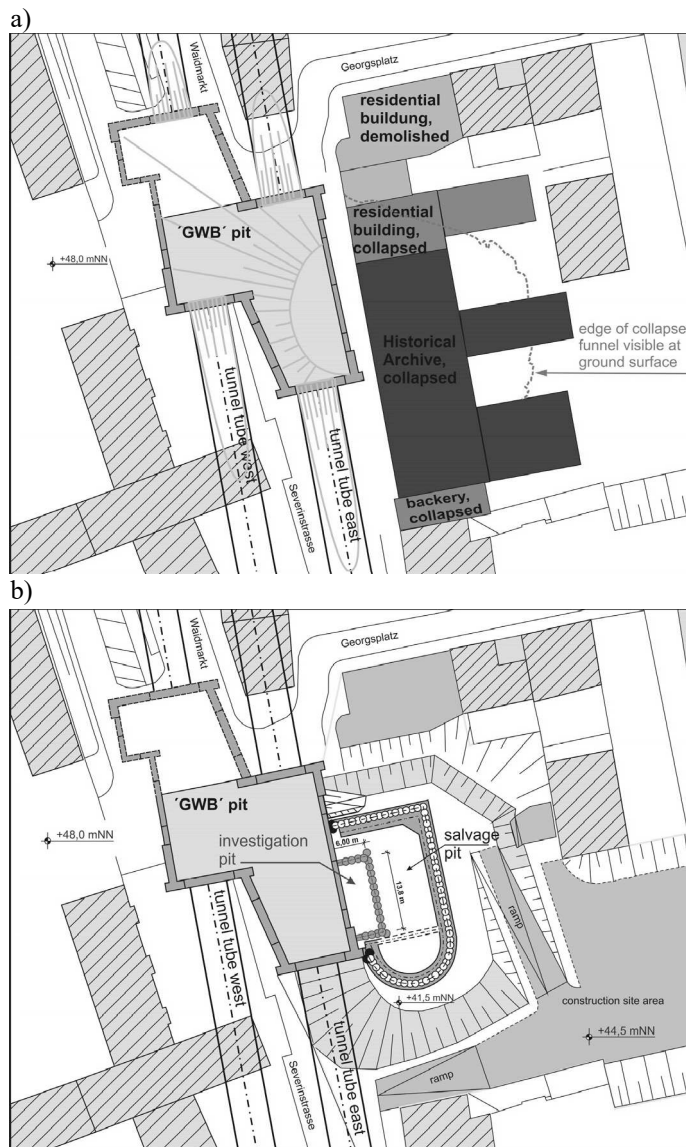
Figure 3. Site plan of the deep excavation 'GWB' at 'Waidmarkt' square in Cologne, a) at the time of the collapse with existing buildings and upper edge of the failure funnel, b) with salvage pit and investigation pit after the accident during salvage and preservation of evidence.

In the east of the 'GWB' pit, in the area of the collapse funnel recognisable here by its tearing edge (see Fig. 3a), the debris from the historical archive was removed to just above the mean groundwater level, i.e. around 9 m below street level. In this way, by September 2009, 85 % of the archive material had already been recovered, albeit mostly severely damaged. The recovered relics were initially stored temporarily in almost 20 asylum archives throughout Germany. Damp archive materials were partially freeze-dried to prevent mould growth.

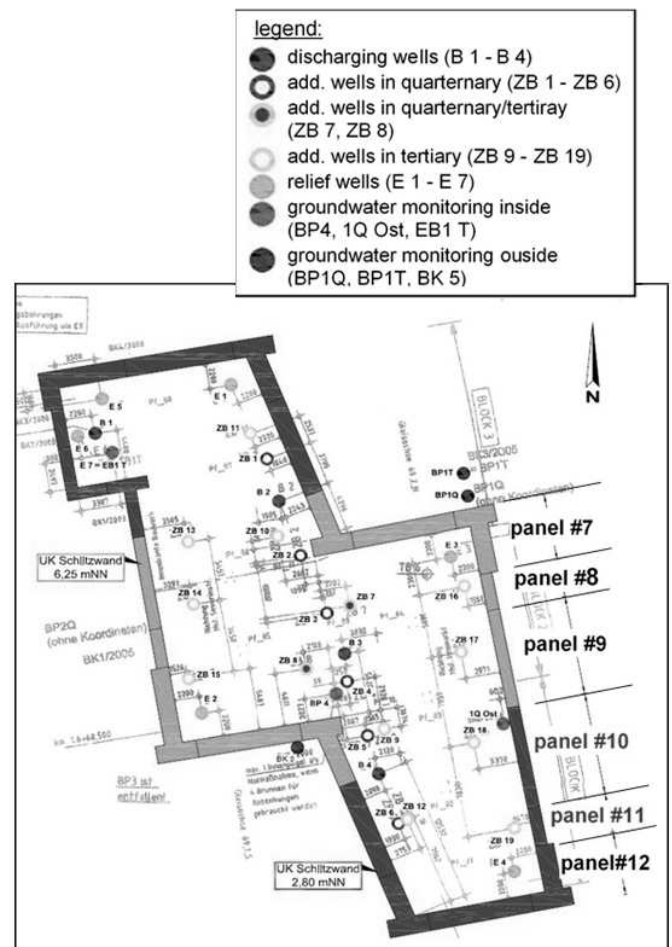
Figure 4. Ground plan of the excavation pit 'GWB' with diaphragm wall panels and groundwater discharging and relief wells; status before collapse in March 2009.

Parallel to the further excavation, dewatering was carried out in the excavation pit, initially with four discharging wells (B1 to B4) and four relief wells (E1 to E4) connecting the tertiary with the quaternary aquifers (Fig. 4). As it was not possible to achieve with these wells a groundwater drawdown corresponding to the excavation progress and, in particular, the necessary relief of the hydraulic head in the tertiary aquifer three further discharging wells and a total of 19 additional wells were successively installed (Fig. 4). The recorded water extraction rates show that despite the roughly constant water level differences between the outside and inside water levels over a longer period of time, a significant increase in the extraction rate from around 115 l/s (corresponding to 414 m<sup>3</sup>/h) to around 180 l/s (648 m<sup>3</sup>/h) and a maximum of >200 l/s (720 m<sup>3</sup>/h) was recorded at the beginning of December 2008 in connection with the commission-

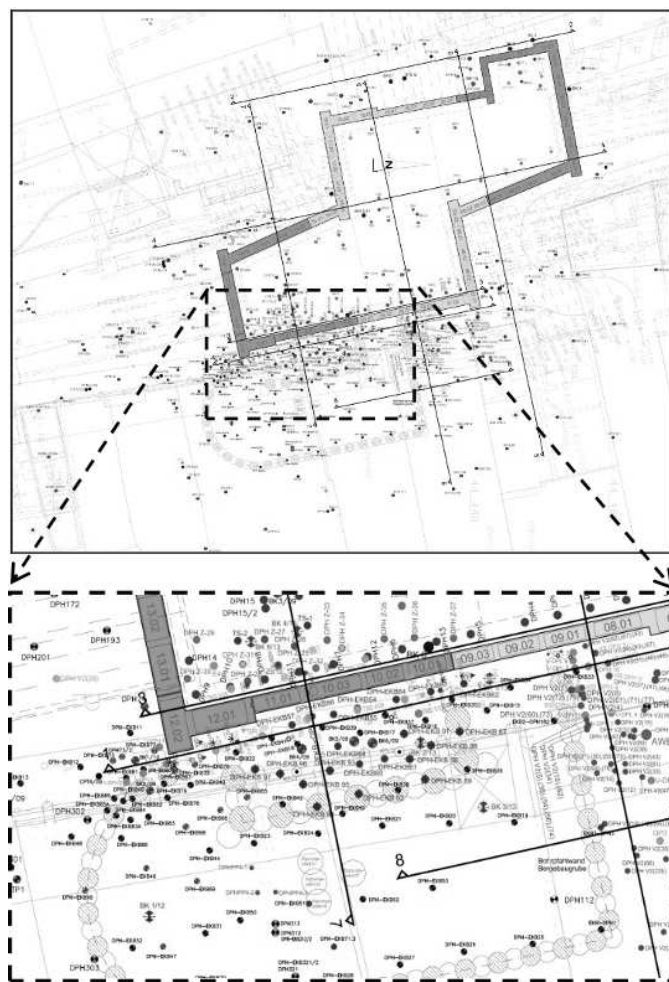
vicinity of the eastern diaphragm wall. In addition, extensive laboratory tests were carried out also. These investigations made it possible to identify the centre of the damage to a tightly confined area in the vicinity of panel #11 in the eastern part of the diaphragm wall of the 'GBW' pit. The core drillings being modified to monitoring wells were used by the court-appointed expert to investigate the integrity of the eastern diaphragm wall of the 'GWB' excavation pit by applying indirect methods. In particular, seismic cross-hole tomography was successfully used to check the presence, quality and integrity of the diaphragm wall panels. The planned geometric embedment of the diaphragm wall panels could be verified, but at the same time, in the area of the joint between the adjacent panels #10 and #11 at a depth of approx. 16 m to 23 m a.s.l., i.e. between the final excavation level down to the quaternary base, significantly reduced local wave velocities were clearly recognisable identifying anomalies (Fig. 9).

Figure 8. Ground plan: Soil investigation focusing on the south-eastern corner of the 'GWB' pit.

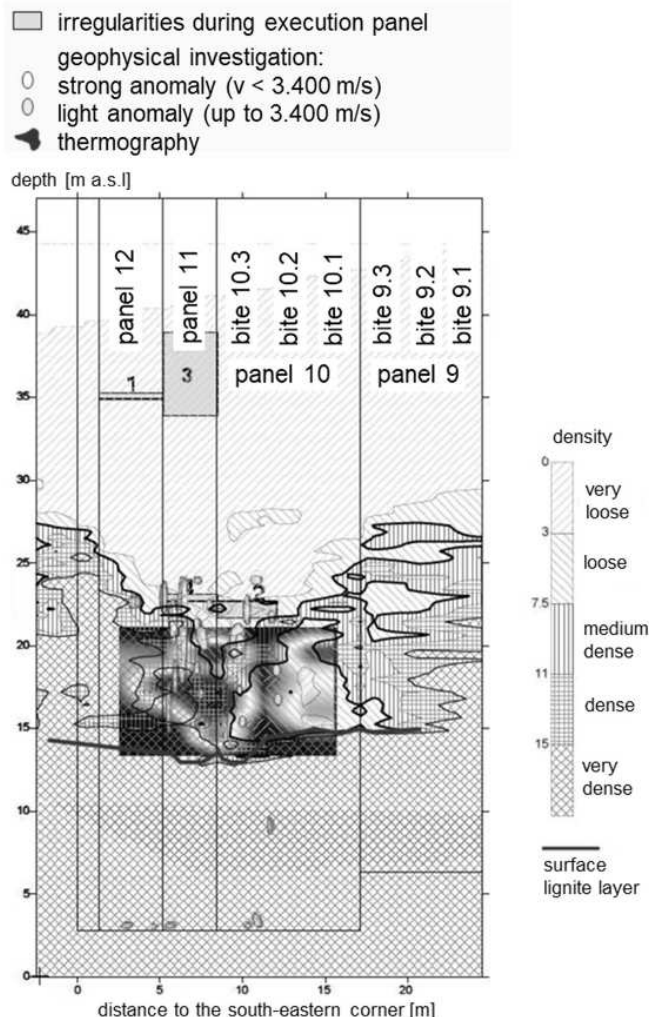
anomalies in the groundwater flow and thus clear indications of hydraulic pathways in the area of the joint between the diaphragm wall panels #10 and #11 in a depth range of approx. 13 m to 20 m a.s.l. (Fig. 9). However, there were no indications for a vertical flow around the base of the diaphragm wall.

In accordance with the anomalies identified during the construction of diaphragm wall panel #11 (see section 2.3), the results of the investigation gave rise to the suspicion that the accident was probably due to one - or possibly several - defects in the joint area of the eastern diaphragm wall, in particular in the joint area between panels #10 and #11 at a level between the final excavation level and the lignite layer (Fig. 9), while a hydraulic ground failure was largely ruled out as the cause of the failure and an erosion ground failure due to a thin vent appeared unlikely even as a (co-) cause of the damage event (Sieler et al. 2012).

Figure 9. View of the eastern diaphragm wall of the 'GWB' pit (looking west) with compilation of the results of all indirect exploration measures (source: expert report by Prof. Kempfert (2011-2020), modified).

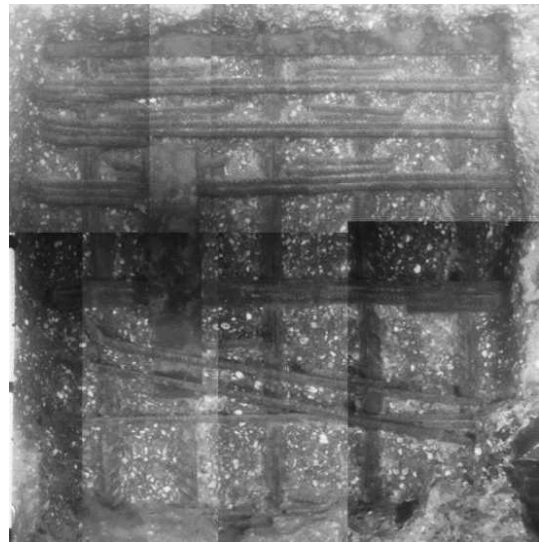
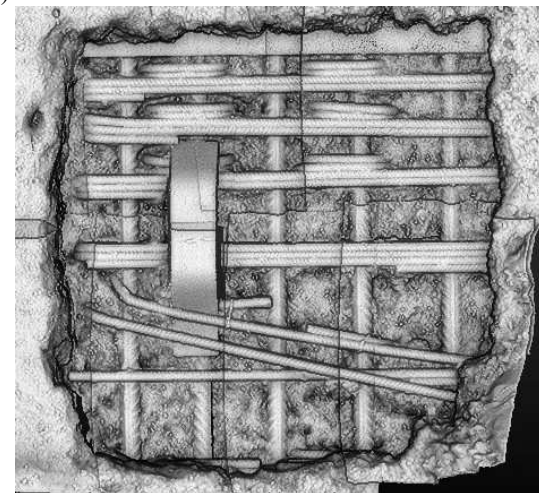
Figure 12. Exemplary image of a reinforcement window in the diaphragm wall panel #10.1, a) photographic, b) with underwater laser scan.

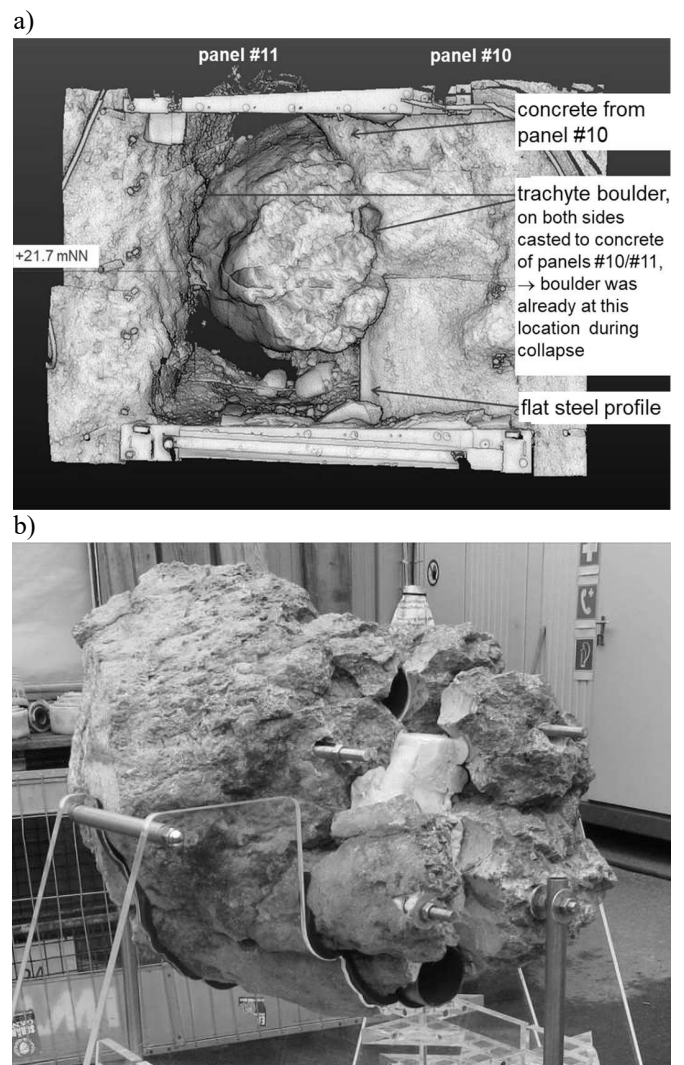
The trachyte boulder with a diameter of around 600 mm and a length of around 1.20 m was first extensively documented in situ. It was then divided into two half-shells with the help of guided overcut hori-

zontal drillings, which were carried out with an underwater drilling template approximately in the centre of the block, and recovered from the joint using anchors. In dry conditions, the boulder was reassembled and examined (Fig. 13b). Traces of the teeth of diaphragm wall grabs were found on both the northern and southern sides of the boulder; traces from the reinforcement cage of panel #11 were also found on the southern side. These traces prove that the natural boulder was already in the position encountered during the exploration of the evidence when panel #11 was executed (Fig. 15). In conjunction with the triangularly growing concrete from panel #10 found above it, it can be concluded that the natural boulder was encountered in the course of the execution of panel #10 and was displaced into the ground section of the later panel #11 during the attempt to salvage it, without the salvage being successful (Fig. 15). During the construction of panel #11 the boulder was then not removed from under the overlying concrete; after the change to the 2.4 m wide grab shells, the teeth of the diaphragm wall grab merely "scraped" along the natural boulder (Fig. 15).

Figure 13. Natural boulder (trachyte) from the joint between panels #10 and #11, a) underwater laser scan in situ, b) recovered and assembled block (basis: Kempfert (2011-2022), modified).

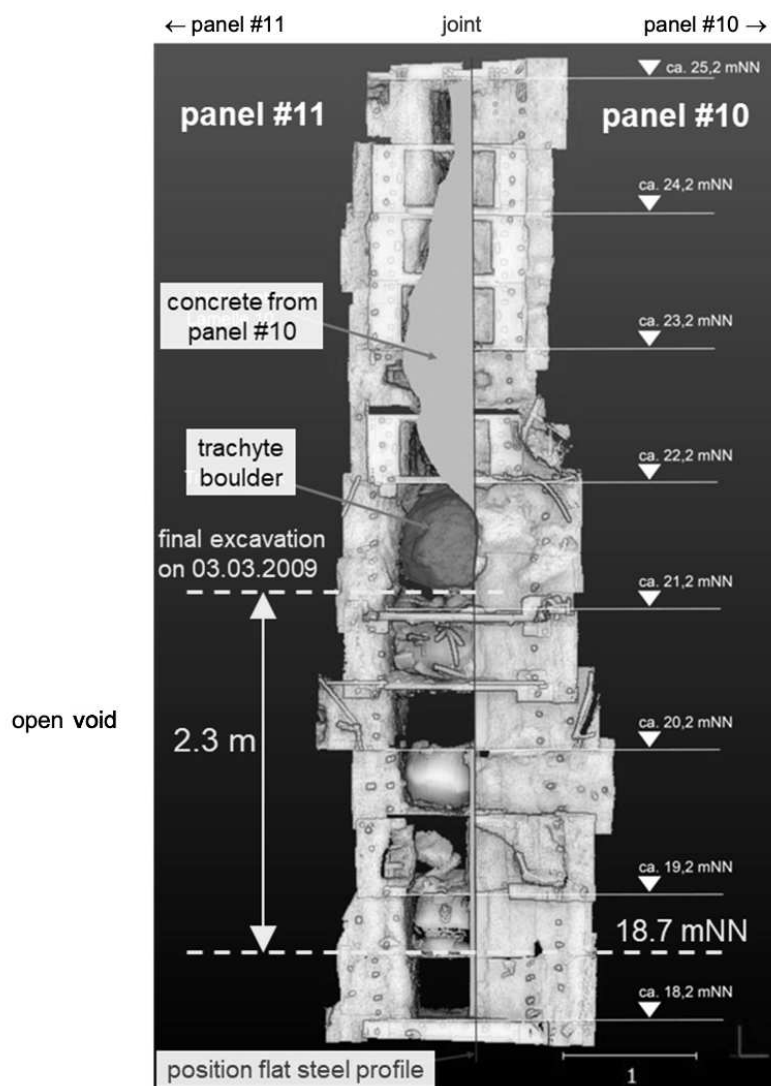
Under the trachyte boulder, a continuously open void up to 600 mm wide and filled with quaternary material was encountered in the further excavation

over the depth, which, although only explored up to the surface of the lignite, is expected to be in fact open to the lower edge of the diaphragm wall.

Figure 14. Compiled visualisation of the explored situation in the joint area of the diaphragm wall panels #10/#11 (evaluation of the underwater laser scans based on Kempfert (2011-2022)).

Based on the distribution of anthropogenic findings, colour changes of the in-situ soil material and other indicators such as the erosion/ presence of the filter cake in the joint surfaces, it was possible to identify and to prove that the base of the "moving" masses (collapse funnel) in the void lies at a level of around 18.7 m a.s.l. In consequence it can be concluded that the area of the void through which around 5,000 m<sup>3</sup> of quaternary material flowed in the course of the accident is only around 2.3 m high and about 600 mm wide and therefore has an area of only approx. 1.5 m<sup>2</sup> in total (see Fig. 14).

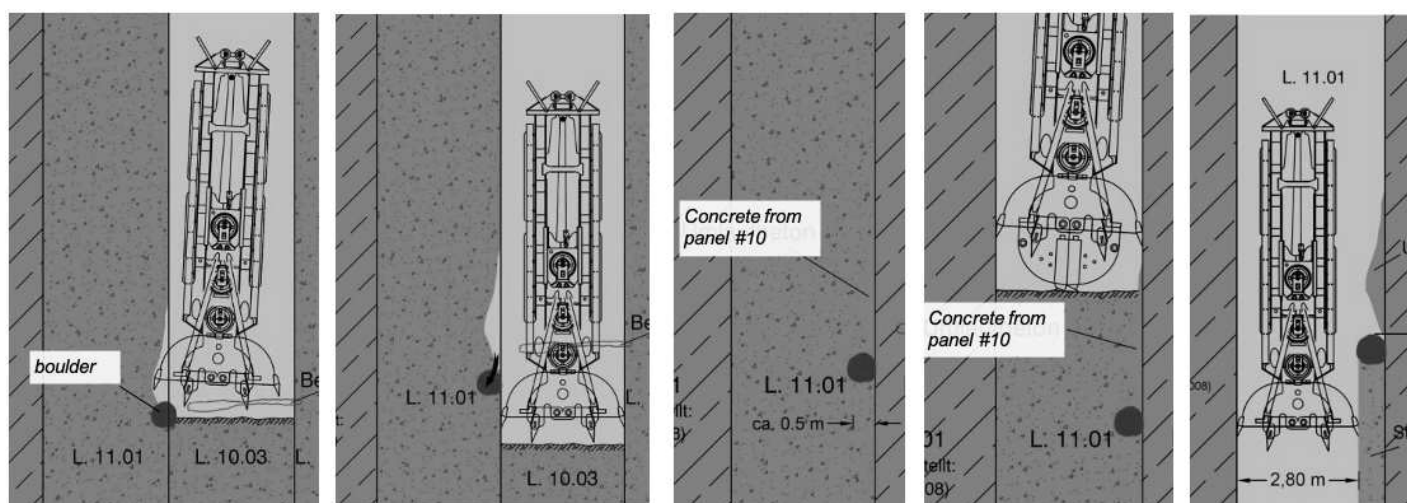
Figure 15. Construction sequence of the panels #10 and #11 of the eastern diaphragm wall with the natural boulder (trachyte, marked in red) encountered during execution of both panels.

can be attributed solely, i.e. mono-causally, to a defect that remained in the joint area between two panels during the construction of the diaphragm wall. In the area of the joint between the panels #10 and #11 an approximately 600 mm wide void was found below approx. 21.7 m a.s.l., i.e. at about the level of the final excavation of the 'GWB' pit downwards. This defect results from the fact that the existing soil material in this area had not been excavated and replaced by concrete during the construction of diaphragm panel #11. A triangular wedge of concrete, which protruded into the cross area of panel #11 (Figs. 14 and 15), had not been removed in the course of the excavation of panel #11 and was therefore the initial of this defect. The triangle-shaped concrete originates from previous execution of adjacent panel #10: during excavation of this panel the trachyte boulder was hit in the southern outer edge of the panel's cross section and trials to catch and remove the boulder create a void in the area of the adjacent panel #11 which was poured by concrete which flowed behind the flat steel profile that was used as joint resp. stop end element (Fig. 15).

The cause of the damage can therefore be traced back to an execution issue respectively to the fact that suitable countermeasures were not taken in response to the difficulties encountered during the execution of panel #11 of the diaphragm wall in 2005. The obstacles encountered during excavation of this panel and the failure to remove these obstacles, finally the change of the grab shells from 3.40 m to 2.80 m wide for excavation of the 3.4 m wide, single bite panel #11 were an unambiguous evidence that the panel #11 was not executed in a regular way and that from the depth where the grab shells were changed most probably a 600 mm wide void filled with quaternary sand and gravels was left.

Technically, it would have been possible to reliably seal the remaining defect in panel #11, for example with one or two columns executed using the jet grouting method.
