Comparing geometric TSF breach volumes with case histories

C. Cilliers & J.R. Collins

BEAL Consulting Engineering, Pretoria, South Africa

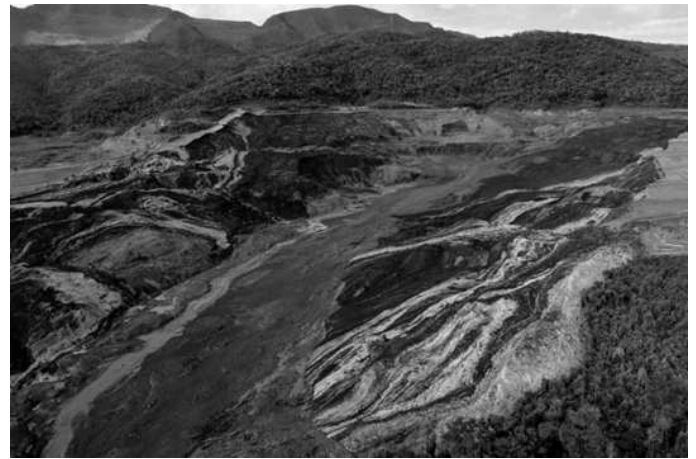
The Brumadinho dam failure shown in Figure 1, occurred on January 25, 2019, in Brumadinho, Minas Gerais, Brazil. This upstream iron ore tailings dam released approximately 9.7 Mm³ of tailings. The embankment on which the breach occurred was approximately 720 m long. The breach geometry included a base width of approximately 100 m and a height of 80 m, forming quickly and causing complete failure within seconds. The tailings travelled over 9 km downstream, severely impacting the Paraopeba River. Investigations revealed that static liquefaction, caused by insufficient compaction of tailings and high pore water pressures, caused by poor drainage caused the failure (Robertson & Wilson 2019). Inadequate design and management, including insufficient monitoring systems, further worsened the situation (Robertson & Wilson 2019).

Figure 1. Brumadinho dam failure (Pearson & Lewis 2021)

The findings indicate that the estimated volume for the Brumadinho Dam breach closely matched the recorded breach volume. Since no supernatant pond was present, the outflow primarily consisted of tailings (both solid and interstitial water). The results showed an 18% difference between the calculated geometric volume and the recorded volume.

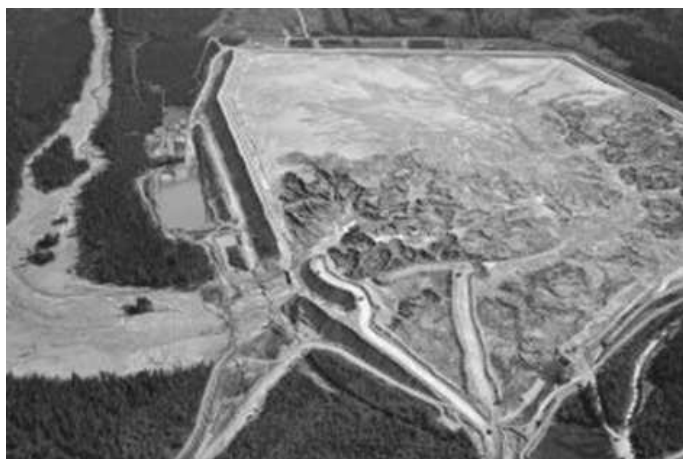
The Mount Polley dam failure occurred on August 4, 2014, in British Columbia, Canada, presented in Figure 2. This centreline copper and gold tailings dam released approximately 25 Mm³ of water and tailings. The embankment length at the site of the breach was approximately 1800 m. The breach geometry included a base width of approximately 42 m and an initial height of 36 m. The failure developed over several hours, depositing tailings over an 8 km stretch into Polley Lake and Quesnel Lake. Investigations identified weak glacial till foundation material and undetected subsurface failure as the primary causes. The Independent Expert Engineering Investigation and Review Panel concluded that design flaws and foundation instability were key contributors (Mount Polley Expert Panel Report 2015).

Figure 2. Mount Polly dam failure (Parsons 2016).

The Mount Polley Dam results showed a significant difference between the calculated and recorded volumes. This difference can largely be attributed to the presence of a large supernatant pond (10 600 000 m³ of the total 25 000 000 m³). The geometric method

does not account for the supernatant pond's contribution to the breach outflow. It was estimated that approximately 20% of the pond's area was covered by the breach cone, leaving 8 480 000 m³ of supernatant water beyond the cone area.

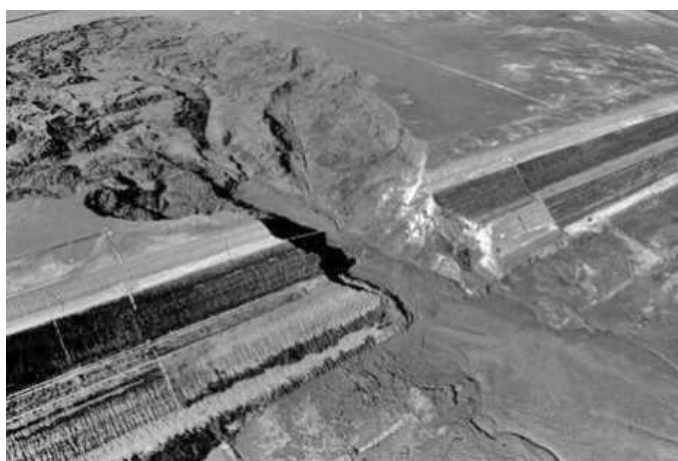
The Merriespruit tailings dam failure occurred on February 22, 1994, in Merriespruit, Virginia, Free State, South Africa. This upstream tailings dam as seen in

Figure 3, used in gold mining, released approximately 650 000 m³ of tailings. The embankment length at the breach site measured around 1000 m. The breach geometry included a base width of 55 m and a height of 27 m. The failure occurred abruptly, with tailings traveling over 2 km and inundating the nearby suburb of Merriespruit, resulting in 17 fatalities and extensive property damage. Investigations revealed that the dam's failure was primarily due to overtopping caused by heavy rainfall, compounded by poor design, inadequate freeboard, and insufficient drainage systems. The lack of emergency preparedness further worsened the disaster's impacts as indicated by ICOLD (ICOLD 2001).

Figure 3. Merriespruit dam failure (Schoeman 2018)

In contrast, the Merriespruit Dam breach, which resulted from overtopping, did include a supernatant pond. Here, the calculated geometric volume was approximately 50.9% higher than the recorded release volume. The reason for this could be attributed to the failure mode of Merriespruit which was overtopping followed by embankment collapse, which did not occur in the foundation. This would mean that only the pool and erodible tailings had been released as opposed to other failures such as Mount Polley which was a foundation failure and therefore encapsulated additional materials beyond only the tailings in the failure mechanism.

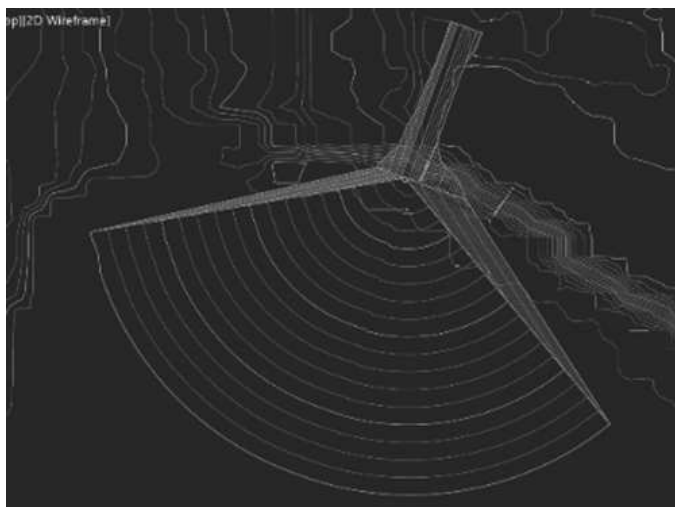
Figure 7. *Mount Polley Dam Breach model*

This means that the results obtained using the geometric modelling indicated only an 11% difference.
