Case study: Investigation vs construction for a sinkhole remediation project

T. Kubayi, R. Naidoo, F. Van der Berg & T. Green
Jones & Wagener, Johannesburg, South Africa

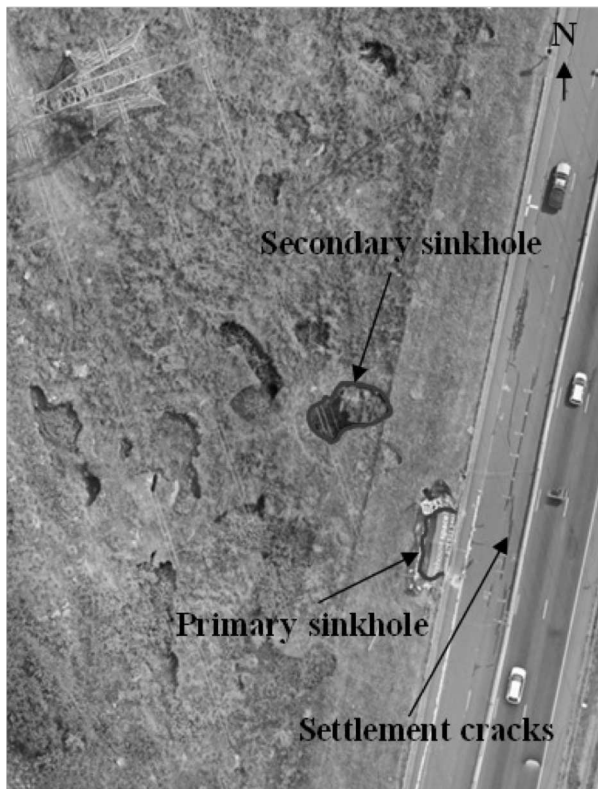
Figure 1. Site layout and location of the sinkholes

Following a period of high intensity rainfall, a 13 m wide x 8 m deep sinkhole formed within the road reserve adjacent to the northbound carriageway of a 4-lane highway. Settlement type cracks were observed running parallel to the highway along the paved Lane 1 and Lane 2 (i.e. the two slow lanes) adjacent to the sinkhole. This resulted in Lane 1 and Lane 2 of the Northbound carriageway being closed as an interim precautionary measure. A secondary sinkhole (11 m wide x 5 m deep) situated at the toe of the road embankment was identified as part of the investigation, which could also directly affect the road embankment, and hence the roadway, should further instability occur. An additional eight sinkholes were identified directly west of the study area. However, these sinkholes were located outside the road reserve and study area. Aside from the challenge of being

bounded by a major highway on the east and numerous sinkholes to the west, the site is also constrained by high voltage overhead powerlines. The positions of the sinkholes relative to the road is shown in Figure 1.

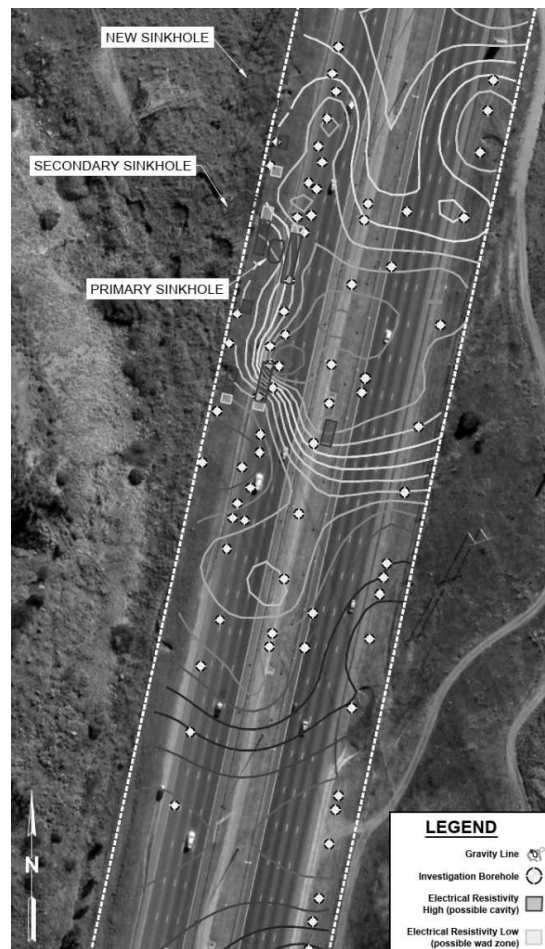
Figure 2. Gravity survey and ERT zones of interest.

Findings from the gravity survey is illustrated in Figure 2. A strong gravity gradient which can be indicative of karst dolomitic conditions occurs very close to the position of the primary sinkhole and trends in a southerly direction. An area with low gravity is evident in the southern part of the site which may suggest a regional gravity trend from low to high in a south to north direction. A zone of high gravity is located to the east of the sinkholes, which indicates the possibility of shallower dolomite bedrock, or a change in lithology. A low gravity feature is located towards the north of the site.

Interpretation of the ERT data suggested the location of possible cavities (shown in red blocks) and thick wad layers (shown in blue blocks) on the map. These features were identified in close proximity to the sinkholes as well as further south / southeast.

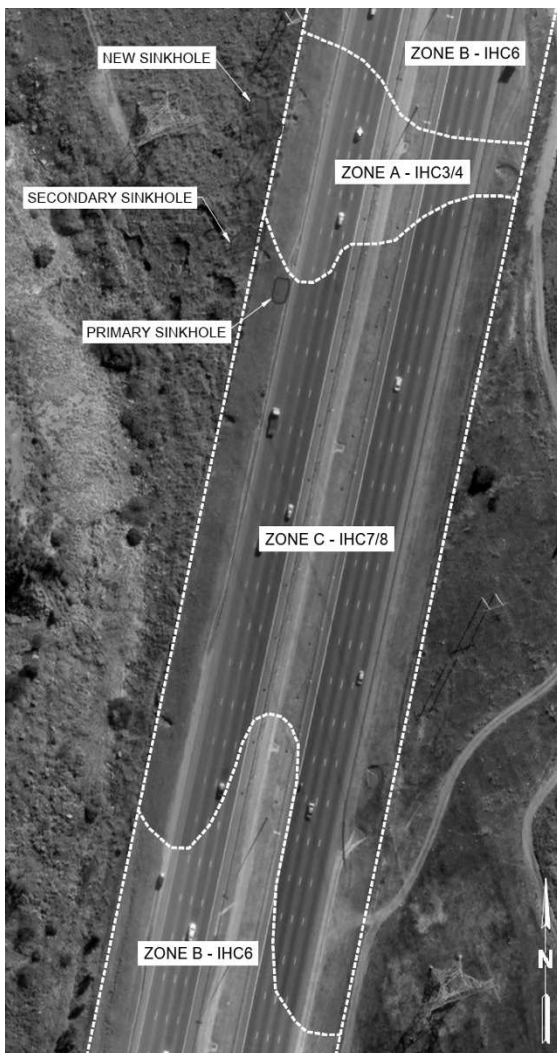
Figure 3. Dolomite Inherent Hazard Classification for the site.

Very low penetration rates (less than 0.05 min.s/m), cavities and sample loss were evident throughout the site. Following completion of the drilling campaign, the site was subdivided into three major zones, as illustrated in Figure 3 and described below:

- **Zone A: IHC 3 and 4 (Overall risk to the road = Low)**
Boreholes drilled within this zone were designated to be underlain predominantly by Inherent Hazard Class 3 and 4 conditions. Within this zone, there is a medium susceptibility for the development of small (i.e. < 2 m diameter) and medium (i.e. 2 m to 5 m diameter) sized sinkholes and a low to medium susceptibility for the development of large sinkholes (i.e. 5 m to 15 m). There is also a medium susceptibility for the development of dolomite related subsidence.
- **Zone B – IHC 6 (Overall risk to the road = Moderate)**
Within this zone, the boreholes were predominantly classified as having a high susceptibility for the development of small and medium sinkholes (i.e. 2 m to 5 m diameter) and subsidence development and low susceptibility for the development of large and very large (i.e. 5 m to > 15 m diameter) sinkholes.

- Zone C – IHC 7 and IHC 8 (Overall risk to the road = high to very high)

Based on the boreholes drilled, this zone is characterised as having a high susceptibility for the development of small, medium and large sinkholes (i.e. 2 m to 15 m diameter) and subsidence development. IHC 7 conditions are considered to have a low susceptibility for the development of very large sinkholes. However, IHC 8 indicates that there is a high susceptibility for the development of very large sinkholes (i.e. > 15 m diameter).

A sequence of boreholes drilled to the north of the sinkholes, including targeting areas of interest identified from the ERT survey, consistently encountered shallow bedrock which contributed to a IHC 3/4 classification. Isolated pockets of IHC 3 and IHC 4 conditions were noted within Zone C, which was interpreted as isolated boreholes encountering pinnacles present across these portions of the site.

Zone C was designated as high to very high risk, particularly given the high chance of very large sinkholes forming. This area was therefore identified as the area requiring remediation.

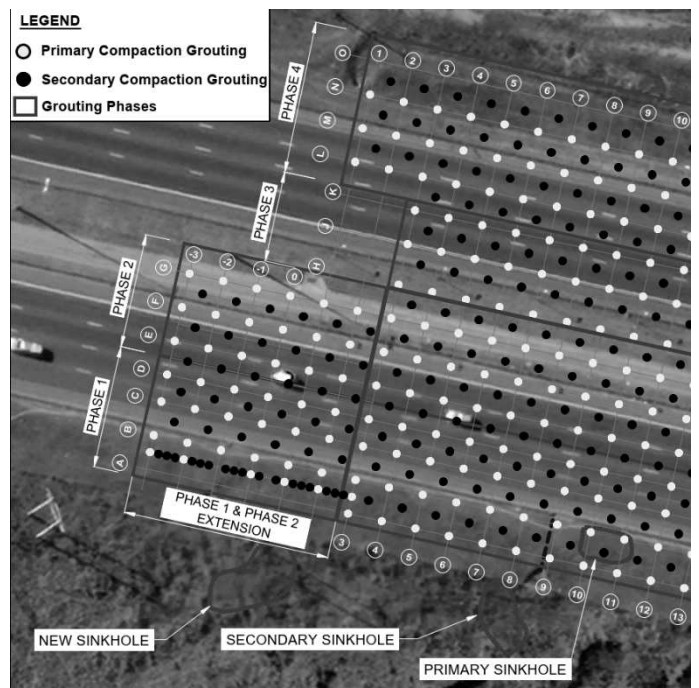
Figure 4. Remediation area extension due to sinkhole I formation.

Following a period of heavy rainfall during construction phase, a new sinkhole formed adjacent to the northbound road reserve. This was in close proximity to an area previously characterised as Zone A (IHC 3/4) located to the north of the sinkholes and was, therefore, not included within the original remediation area extent. The development of the sinkhole highlights the gaps that can manifest when relying on point data to assess a site, regardless of how comprehensive this investigation may seem.

The development of this sinkhole required an extension of the remediation area by an additional 30 m to the north for phases 1 and 2 to ensure the safety and stability of the highway should the new sinkhole expand further, as shown in Figure 44. The inherent variability of dolomite, combined with external factors like heavy rainfall, means that subsurface conditions can evolve in ways that are difficult to anticipate. This occurrence highlights the importance of remaining adaptable within the design and construction phases, to the variability and unpredictability of dolomite conditions, even in areas initially deemed lower risk.

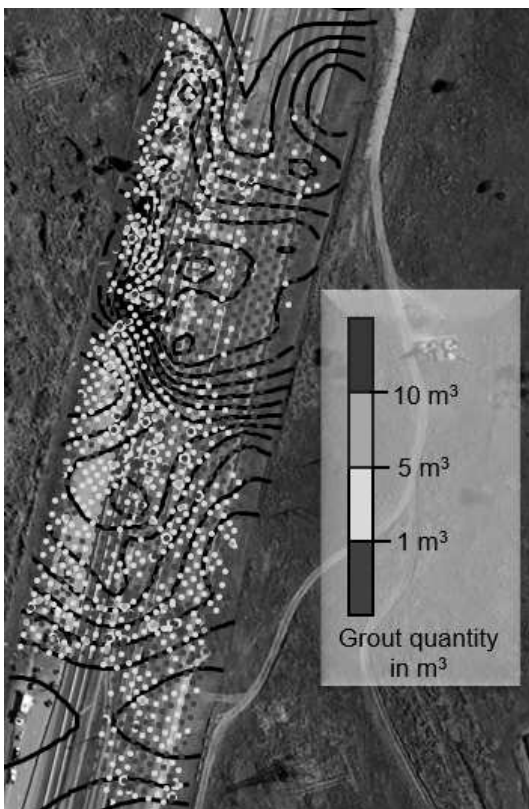
Figure 5. Grout takes in m³ for each borehole.

The final remediation phase resulted in a total of 1747 boreholes drilled – 347 boreholes more than anticipated. Figure 5 shows all boreholes drilled during the construction phase overlaid on the bouguer gravity survey. Steep gravity gradients and low gravity trends are generally considered to be areas of concern during a dolomite investigation. These features are representative of steeply sloping bedrock and highly weathered subsurface conditions, and thus considered high risk areas (Wagener 1985). The black clusters of boreholes on the figure reflect areas where tertiary and/or post-tertiary boreholes were required. Concentration of boreholes is an indication of exceptionally poor subsurface conditions. This may be due to the presence of void or cavities within a profile, or zones of highly weathered, low density features which are highly prone to erosion thus significantly increase the risk of sinkhole formation.

Figure 5 and 6 show a good correlation between areas of concern identified by the bouguer survey and clusters of boreholes drilled during construction. Dense concentration of boreholes reflect locations where secondary and tertiary boreholes were added, in response to high grout takes or challenging subsurface conditions encountered on site. These borehole clusters were concentrated on regions of high gravity gradient and low gravity trends, aligning well with the survey’s findings. However, some outliers were observed where the survey did not detect localised areas of exceptionally poor subsurface condition (as depicted by the concentration of boreholes).

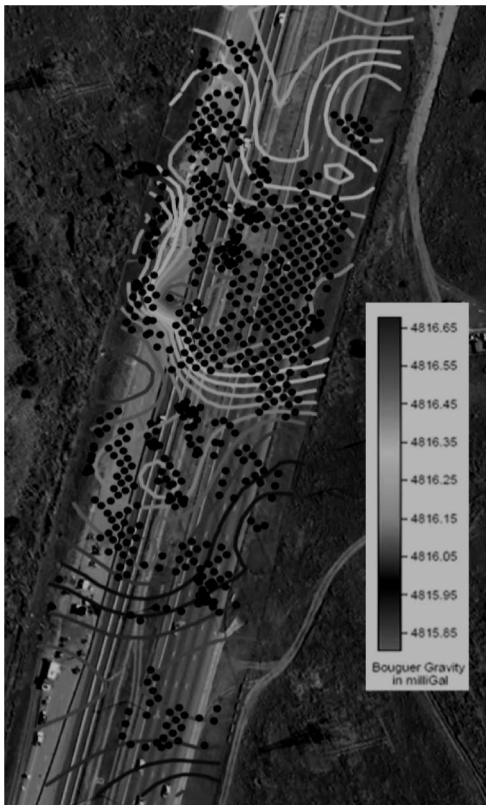
Figure 7. Comparison of boreholes reaching bedrock (< 25 m) and gravity survey results.

Figure 7 illustrates the distribution of boreholes that terminated on bedrock within the upper 25 m of the profile, overlain on the gravity survey map. The higher gravity regions, coloured in red, are indicative of shallow bedrock while the lower gravity portions, coloured in blue, are indicative of deeper lying bedrock. The figure reveals a notable concentration of boreholes terminated in bedrock within areas of high gravity, which aligns well with expectations. This consistency between the gravity survey and actual on-site conditions provides validation of the gravity survey’s reliability as a tool for identifying depths to bedrock.

However, there are boreholes within the low gravity area that also reached bedrock. This suggests the occurrence of localised variations within the regions characterised by deeper lying bedrock, which were overlooked by the survey. While this discrepancy is considered to be insignificant in terms of the efficacy of the design, it does highlight the complexity of predicting subsurface dolomitic conditions, even with advanced geophysical techniques. However, the overall reliability of the survey is well-supported by the broader consistency of the findings.
