# Large-scale structural-geotechnical rehabilitation of the Ferreira's Gold Mine, Crown Interchange, Johannesburg

**ABSTRACT:** This paper discusses the bespoke structure and geotechnical rehabilitation measures implemented on the Ferreira's Gold Mine, which transformed derelict mining land into valuable real estate in the heart of Johannesburg. The mine - the earliest of the initial large-scale workings in Johannesburg, dating back to the gold rush of the late 1880s - was abandoned in the 1960s, and loosely backfilled with ash from the nearby power station. In the absence of formal rehabilitation, the land was effectively sterilised, precluding any development. Given the value of the land, an ambitious rehabilitation project commenced in 2022 to construct an inclined reinforced concrete bridge deck ~ 200m long, spanning the 15m wide stope and founded 18m below ground. Extensive geotechnical challenges were overcome utilising design-on-the-fly solutions, without the benefit of any exploratory work or time for formal analysis. These included injection grouting of open rock joints while working below a brittle quartzite hanging wall - leaning ~10° into the excavation - installation

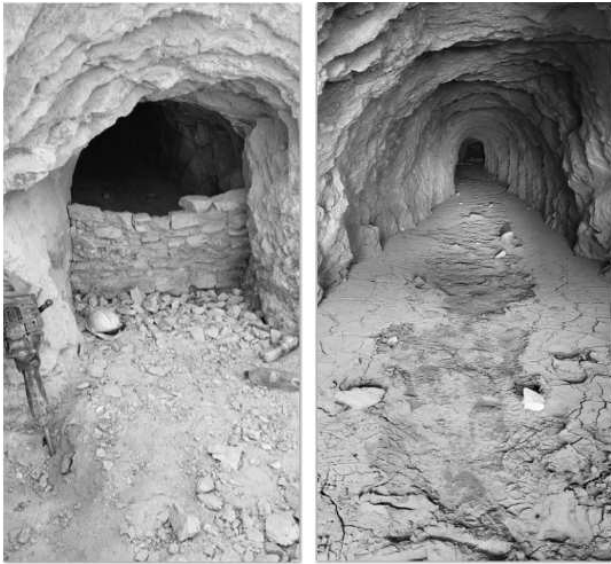
This underground mining appears to have been facilitated by several vertical shafts, and at least one adit tunnel discovered during our rehabilitation works detailed below (Fig. 1).

Figure 1. Exposure of an adit (access) tunnel approaching the mine stope from the north beneath Anderson Street

Near ear the west end of the pit, the footwall excavation unearthed an adit tunnel, cut and perpendicular to the stope beneath Anderson Street (see Fig. 1), necessitating a concrete collar prior to backfilling.

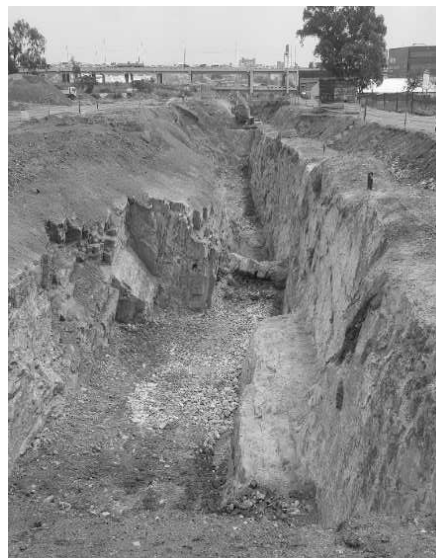
the extent of the mining operations was undefined and costs unquantified, only becoming apparent as the site was progressively cleaned out and opened up (Fig. 6).

Figure 6. Exposure of the mined reef after backfill removal

This led to the works being substantially larger than originally anticipated by the developer, morphing from just the Main conglomerate reef (MR) to include three parallel reefs - namely the Main Reef (MR), Main Reef Leader (MRL) and South Reefs (SR), conceptually similar that shown on Figure 4 – which had effectively collapsed into one another, forming the massive void.

The only real benefit of further deepening was the reduction in the collapse zone between the adjacent reefs, due to an increase in the retained, non-ore-bearing country rock. Closer to surface, this retained rock mass had simply collapsed into the excavation, creating a massive void – particularly at the east end - depicted in Figure 6.

This was particularly the case in the midspan region (depicted in Fig. 6), which comprised a particularly highly fractured rock mass, likely to have been aggravated, or induced, by a diabase dyke cutting across the bedding planes which appeared to have fractured the proximate quartzite rock mass either side of the intrusion.

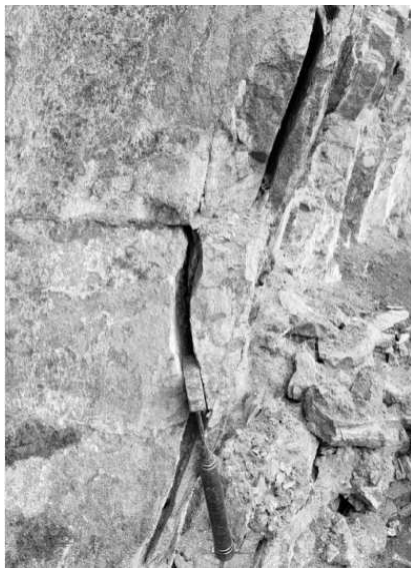
Only really through the process of the backfill removal did the sheer magnitude of the mining operations begin to take shape, eventually exposing a nominally 18 m deep stope – at cut-off level - some 200 m long and up to 15 m wide. This slot was formed between a competent quartzite footwall, dipping ~80°

S into the trench, and an extremely brittle, metastable quartzite hanging wall, leaning at a reciprocal 100° into the mined stope as demonstrated on Figure 7.

Figure 7. Joint widening in the hanging wall during excavation

On subsequent removal of this supporting backfill, however, the hanging wall was left unsupported, leaning precariously into the excavation, with the near-vertical rock joints opening progressively in the absence of this passive pressure as the backfill was removed (Fig.7).

This was the very case exposed at Ferreirasdorp, where the mined conglomerate reef followed the natural dip of the metamorphosed rock strata, laterally distressing the adjacent quartzite which opened the primary rock joints parallel with the original sedimentary bedding planes (Fig. 7).

On inspection of the early stages of the works, it became clear that lateral movement of the hanging wall was taking place, manifesting as open joints widening vertically towards the surface exposure. In many instances, these joints were measured, by the geotechnical specialist, to be as much as 50 mm.

This posed a severe design challenge for the bridge functionality, where no more than 50 mm of lateral movement could be tolerated, since any greater lateral movement risked rotational instability of the deck, in the event of the underlying fill collapsing.

To mitigate this lateral movement risk, the geotechnical engineer opted to drill into the rock mass behind the spreader beam, to seal any open joints with a cementitious grout of progressively increased viscosity to limit lateral dispersion beyond the zone of value.

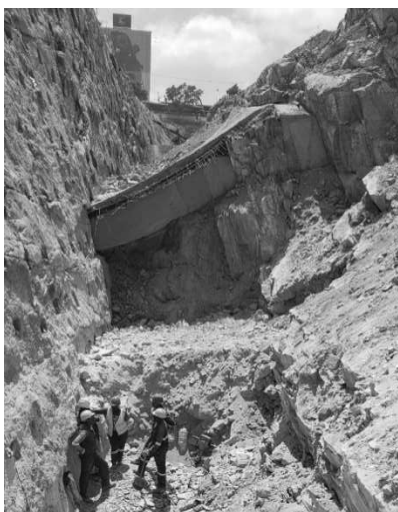
Unlike during the original mining era, where large timber stulls were socketed into the footwall to maintain lateral stability (Fig. 8), these valuable timbers had clearly been removed during the original backfilling operations, fully transferring lateral stability to the backfill material.

Figure 8. Inclined beam-deck arrangement before backfilling

As such, all beams would need to be both self-supporting and the deck able to carry its on self-weight in addition to around 18 m of deadload from the compacted soil to be placed on the deck in the closure operation (Fig. 8).

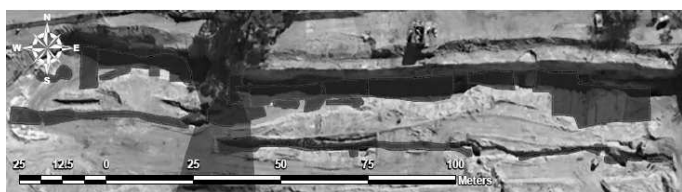
Given the erratic nature of the hanging wall, which was periodically deliberately pre-collapsed where excessively unstable, virtually every beam necessitated a bespoke design, determined by the span and the allowable bearing pressures of the hanging and footwalls, which were judged on inspection by the geotechnical specialist, leading to the irregular arrangement of bridge decks illustrated on Figure 9.

Figure 9. Plan view of completed deck spanning the Main Reef slope

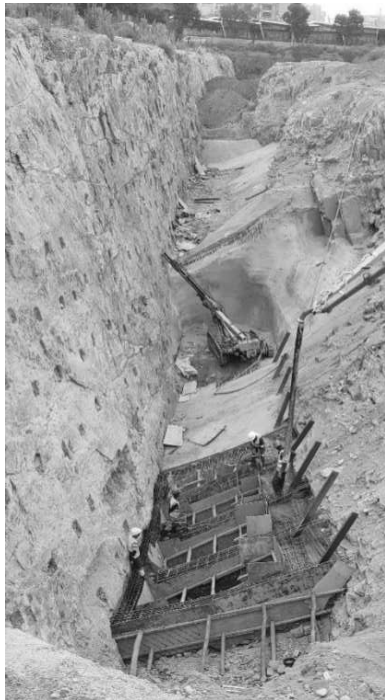
Upon entering the midspan zone, the hanging wall was found to be extremely fractured and judged to be leaning too far into the excavation for the grouting operation – which could physically dislodge the rock mass - to be safely undertaken.

Figure 10. Temporary lateral support to facilitate safe construction of the mid-span bridge deck

To mitigate this risk, a temporary soil nailed arch wall was installed as a protective shield to ensure the

safety of the grouting operation, following which this was integrated within the longitudinal lateral support operations (Fig. 10).
