Causes and remediation of slope failures on the N2 national route

G. Wojtowitz, S.C. Canto & C. Edmond
Zutari, Pretoria, South Africa

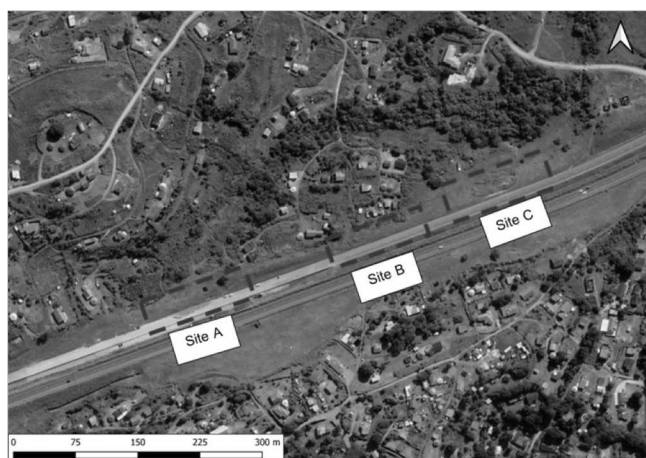
The three slope failure sites along the northbound carriageway are shown in Figure 1. Site A was the original creeping slope embankment with Site B and C the additional failure sites. Prolonged rainfall would have saturated the constructed fill and underlying insitu soil horizons. The slope at Site A before failure is shown in Figure 2 with the resultant failure on the road surface extending into the fast (far-right) lane of the northbound carriageway shown in Figure 3. Figure 4 shows the road surface at Site A before failure. Repair works had been undertaken due to cracking from the creeping slope over a few years as shown in Figure 4.

Figure 1. Locations of three slope failures

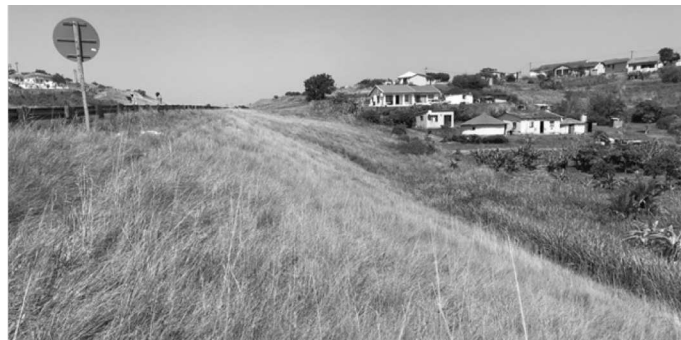
Figure 2. Embankment slope before failure at Site A

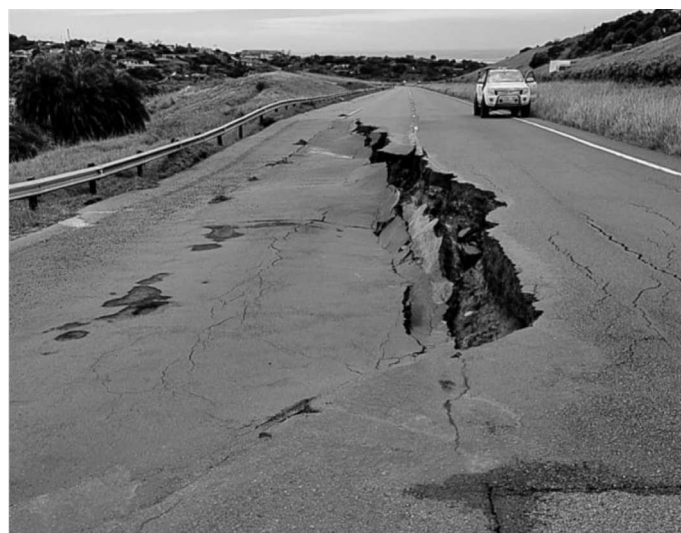
This slip was understood to have a history in excess of 15 years of periodic movements, particularly after heavy rains (Drennan & Maud 2019). After the period of prolonged heavy rain, cracks opened up and an instruction was issued to close the carriageway. The failure occurred overnight and extended over a 100m length where the road surface dropped by over 1m. The failed material was observed down the slope showing a deep-seated failure.

Figure 3. Slope failure at Site A

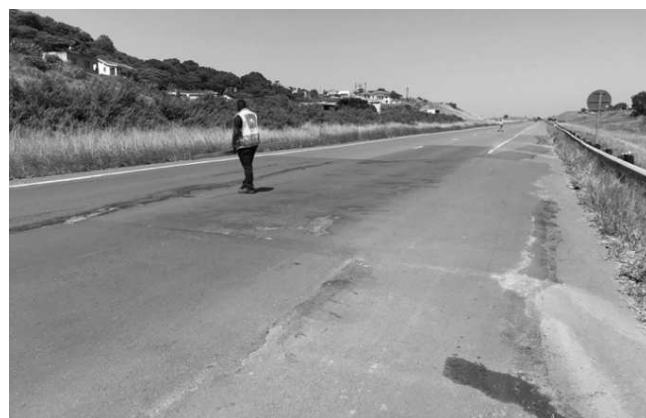
Figure 4. Site A before failure showing previous repair works due to movements

As shown in Figure 4, Site A had a history of periodic movements after heavy rains. An assessment into the movements in 2019 reported that “the embankment is likely experiencing on-going creep type movement each time there is pore pressure build-up or phreatic surface elevation on the underlying sliding surface, resulting in further displacements occurring.” Due to previous episodes of movement, the shear strength along the sliding surface had surpassed its peak strength and was only relying on residual strength. Catastrophic failure was stated as being a probable occurrence in the event of a severe storm. The regional geology shows that the historic slip at Ilfracombe / Bonnyrigg Interchange and the Site A slip occur on the same underlying regional geology.

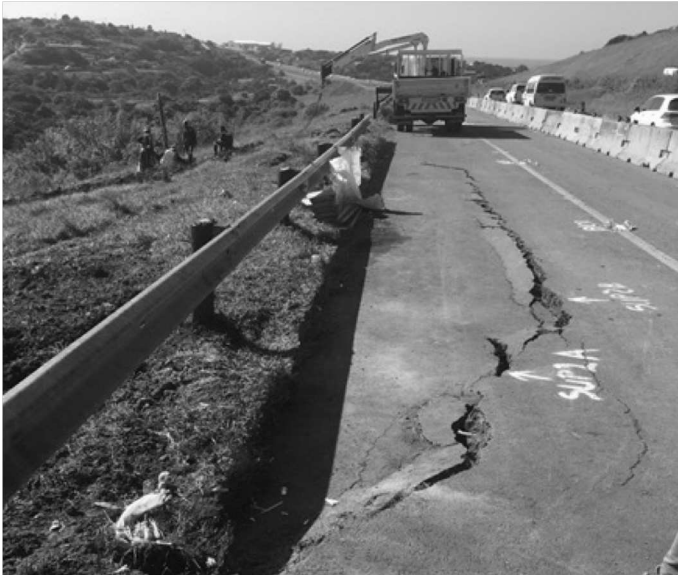
The observed failure at Site B is shown in Figure 5. The slope was flatter than at Site A and the cracking occurred in the road shoulder over two 20 m stretches, with settlements measured to be over 50 mm.

Figure 5. Site B observed failure

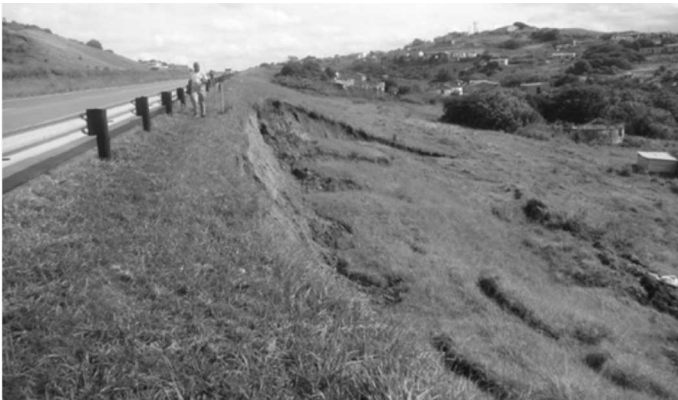
The third failure (Site C) (over a 60 m section) manifested as a circular failure surface in the soil horizons of the embankment fill with a near vertical failure scarp in close proximity to the road with bulging of the toe of the slope. Longitudinal cracks were also noted in the northern carriageway adjacent to the failure zone. Unlike the failures at Sites A and B which can be described as deep-seated failures, the failure at Site C had a high and very steep failure scarp and can be described as sloughing failure as shown in Figure 6.

Figure 6. Slope failure at Site C

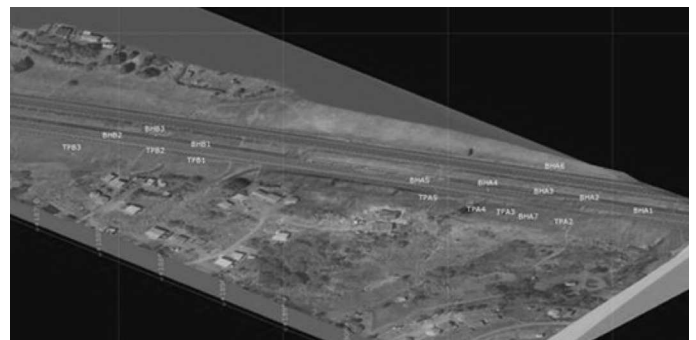
A 3D digital geological model was created using Bentley Leapfrog (Version 2021.2) software, the topographical and drone surveys and borehole and test pit data. A geophysical survey was applied to correct rock levels generated in the model. The 3D geological model (shown in Fig. 7) assisted in visually and spatially understanding the complexity of the

Figure 7. 3D model generated in Leapfrog showing surface and geological layers (drone survey image overlain over geological model)

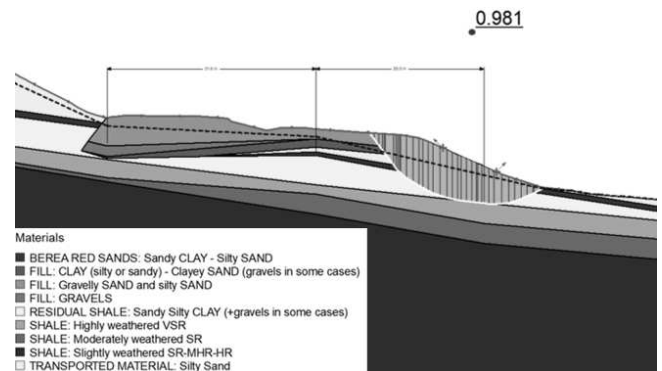
The resultant failure mechanism for the back analysis for Site A is shown in Figure 8 and Figure 9 for the Slope W and Plaxis 2D assessments. The slip at Site A had been moving over a number of years. This creep type movement resulted in the strength of the residual shale clay layer within the slip zone reducing over time reaching a remoulded residual undrained shear strength value. The heavy rains that occurred, resulted in a rise in the water table and saturated ground conditions. This further reduced the shear strength of the residual shale clay material and failure of this layer in an undrained manner, resulting in the deep-seated failure that was observed. This was shown by the back analysis.

Figure 8. Slope W Failure mechanism for Site A

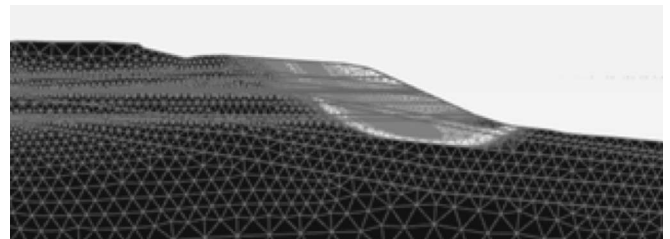
Figure 9. Plaxis 2D Failure mechanism for Site A

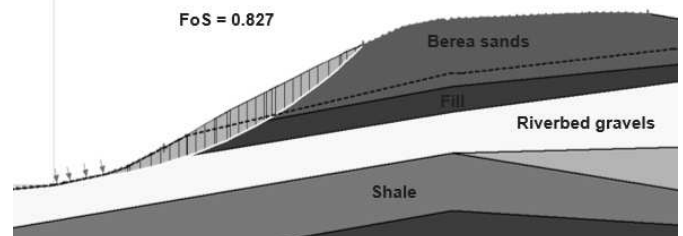
Figure 10 shows the resultant failure mechanism for Site C. Site C has different ground conditions to those observed at Site A. This typically shows ground

profiles for higher topographical elevations where there is no or limited presence of the residual shale clay layer. There was a clear boundary observed between the Berea Sands and the shale bedrock comprising of a boulder/gravel layer separating the overlying sands with the bedrock. The presence of this layer and no residual shale clay influenced the observed resultant failure mechanism.

The slope failure appeared to be constrained to the fill and soil horizons and its extent was limited by the presence of the gravel/boulder layer overlying the shale bedrock. This observation is important and indicates how the underlying ground conditions and geology influences the failure mechanisms and their extent especially in these geological conditions in KwaZulu Natal. This understanding guides remediation solutions applied and could also be used to assess the potential impact of slope failures in this type of geology.

Figure 10. Slope W back analysis failure mechanism for Site C
