# Embankment stabilisation on Van Reenen's Pass, Kwa-Zulu Natal

**ABSTRACT:** The National Route 3 highway is the main artery between the hubs of Johannesburg and Durban. This route passes through the Van Reenen's Pass on the border of Free State and Kwa-Zulu Natal, an area which has historically been noted for slope instability, and with little alternatives for diverting traffic. One such area of historic slope instability below the roadway showed clear signs of settlement and cracking in the 2021-22 period. This paper discusses the investigation, design, and construction of a piled solution intended to protect the roadway from progressive slip caused by the downslope instability. Special attention is paid to the underground morphology, subsurface water regime, and strength of fill, colluvium and weathered rock layers which lie at the root of the instability.

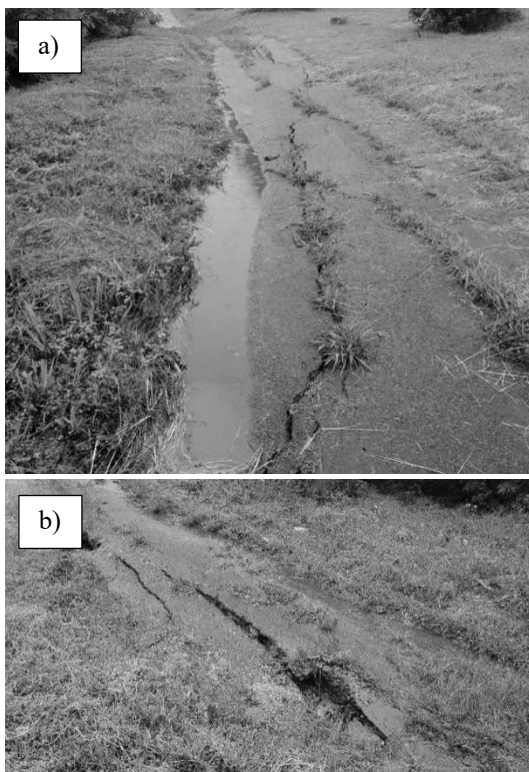
Cracking in the old road in 2021 (Fig. 2) necessitated reviewing the history of both the current N3 roadway and the old road itself. There records of slope stability problems on this site dating back to the early 1990's as the Department of Transport commissioned in-depth investigations on the causes of cracking and settlements in both the current N3 roadway and old roadway. As a result of the deteriorating situation, N3TC undertook stabilisation of the N3 roadway once they had been awarded the Concession Contract. Stabilisation and rehabilitation of the N3 roadway was achieved with an anchored pile wall system, completed 2003.

Figure 2. Old road in 2021 after heavy rain a) longitudinal cracking and settlement, b) open cracks and voids.

The anchored pile wall has been successful in preventing settlements in the N3 roadway, but in 2021 the renewed cracking was noted on the old road after particularly intense rains. The distance between the old and current roadways meant that this did not immediately affect the current roadway, but this cracking was nevertheless treated, sealed and inspected regularly. Cracks on the old road subsequently reopened after heavy rains in 2022, whereupon it was decided that further investigation and structural intervention was required.

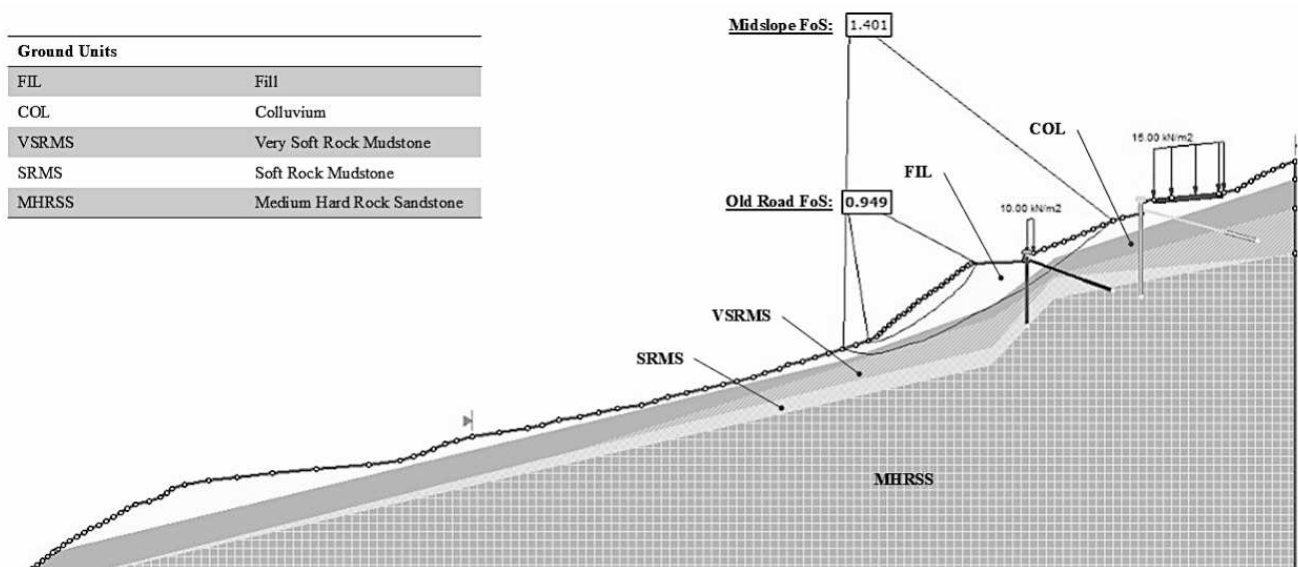
Figure 4. Gully section stabilisation analysis

The critical section was then modified to allow analysis of a stabilised solution. A pile wall was created with ground anchors drilled into the soft rock mudstone and medium hard rock sandstone layers. A 2 m excavation was then created in front of the pile wall to relieve load on the underlying slip surface. Pile shear and anchor tensile capacities were iteratively tested to find a solution that satisfies the permanent stability criteria through the midslope. For the critical section it was found sufficient to use 700 kN shear capacity piles (0.9 m diameter) and 600 kN tensile capacity anchors (5-strand anchors) at a spacing of 1.25 m c/c. Figure 4 provides the analysis of critical section with a FoS of 1.4 through the midslope.

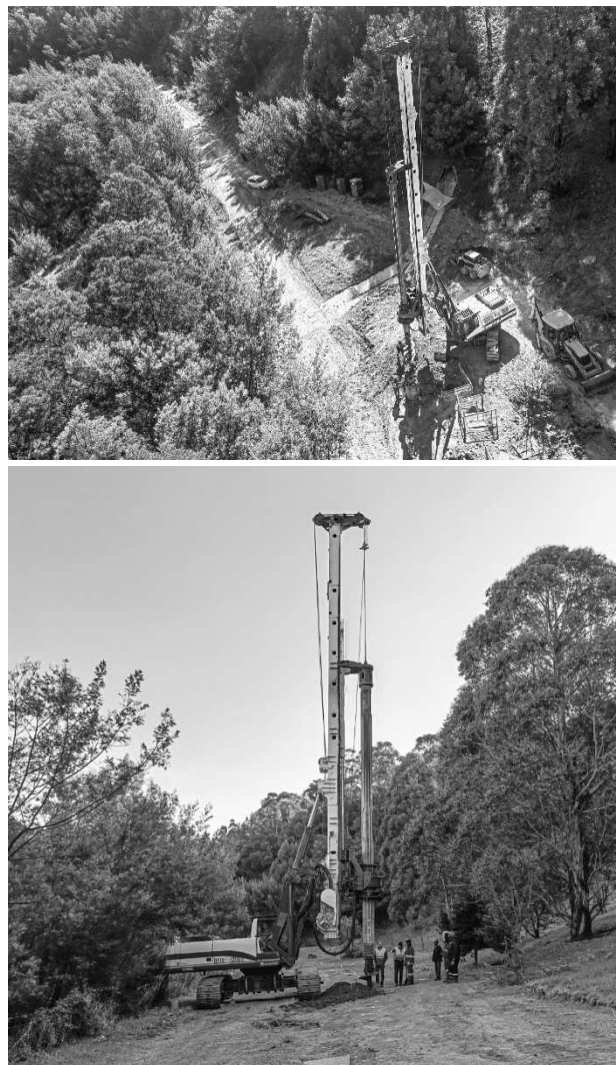
Pile installation commenced at the southern end of the pile wall with Pile 60 and proceeded well towards the centre of the pile wall length (Fig. 5). Talus boulder horizons were occasionally found as 1-2.5 m thick on the southern centre side of the wall, however drilling became significantly more challenging at the centre with thicker boulder horizons in more pile holes.

Holes at Piles 16-26 would prove to be the centre of the boulder deposits, with boulder horizons of 6-10 m deep in this zone. Furthermore, these horizons would prove to be voided in areas, which further complicated drilling. Holes at Piles 21-23 would prove the most challenging drilling conditions, as voids were substantial enough to form a joined cavity. Concrete was poured into Pile hole 23 while Pile hole 21 was open. Concrete was observed to rapidly sink in Pile hole 23, while Pile hole 21 partially filled. Pile hole 21 was loosely backfilled immediately after the observed concrete loss in Pile hole 23. Thereafter, Pile hole 23 was successfully cast with approximately 136% additional concrete due to the voided nature of the talus.

Figure 5. Piling work.

With an understanding of the extent of the thicker talus zone, the remaining Piles 18-22 were drilled successfully by reducing the drilling rate, ensuring adequate auger traction along the flight, and maintaining proper alignment. These factors facilitated more stable drilling operations and assisted the auger in penetrating the voided talus zone.

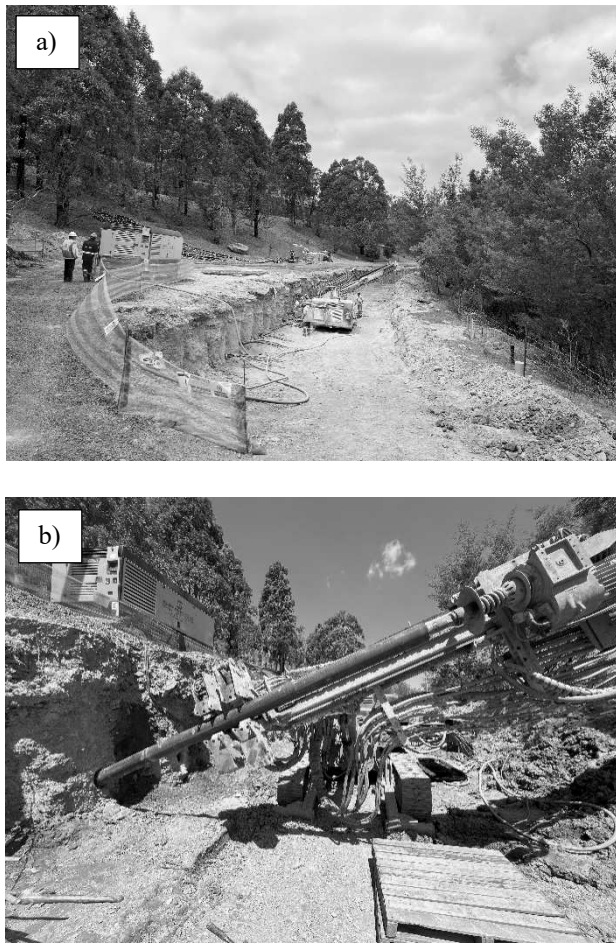
Talus was once again encountered in several holes. Anchor holes 17-28 proved very difficult to drill due to the influence of voids and water. The following was observed in this area:

1. Hole collapse due to water.
2. Loss of air and grout in voids.

Figure 6. a) Anchor drilling and installation, b) drilling of cased anchors.

With ever increasing probability and quantity of rainfall on site, it was decided to install Anchors 17-28 with full length metal casing up to rock level

(Fig. 6b). While this did have a time and cost impact, the full-length casing was an effective intervention and allowed all of the anchors to be installed and made operational before the close of the year.
