Frost fracturing of riprap armour stones in Sporðalda Dam, Iceland.

The Sporðdu Dam was constructed in 2011-2013. It is a part of the Búðarháls Hydroelectric Project (95 MW) in Southern Iceland. It is a conventional earth and rockfill dam with a central moraine core. Following the first subzero temperatures in the autumn of 2012 extensive fracturing of recently placed riprap armour stones and coarse grain fill material was noted. Riprap placed during the summer was largely unaffected. Site and laboratory investigation were conducted showing that it is hard to test armour stones for this type of fracturing.

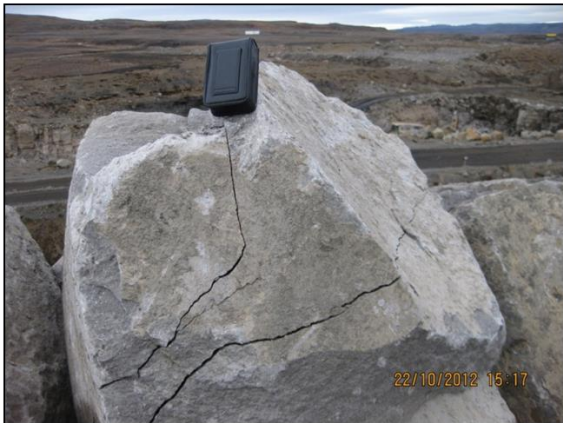
Once the filter and shell material problems had been sorted out during the summer of 2012, the dam construction proceeded as foreseen until fall 2012. Considerations of possible floods required that the dam had to be filled up to an elevation of 333 m a.s.l. in 2012. On October 22nd 2012 following a weekend break, during which the temperature in the area reached -5 °C for the first time that autumn, it was noted that considerable portion the riprap stones placed during the previous two weeks was fractured. Figure 6 shows an example of this. During that particular weekend the stones in the riprap may have experienced one or two frost/thaw cycles.

Figure 6. Fractured riprap stone.

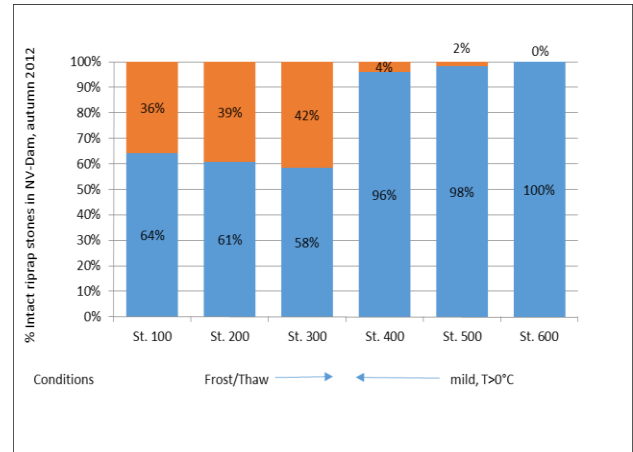
Examination of the rip rap already placed in the Dam in late October 2012 showed that the riprap that had been placed in the preceding one or two weeks was extensively fractured. This was the case for station 100-350 along the dam axes in the NW dam. Riprap placed during the summer and early autumn at station 400–700 was largely intact. The percentage of fractured stones was determined at six locations. Figure 7 shows the result of this investigation. At each

location 60-80 stones were examined. The riprap material in all cases came from the basaltic lava flow formation and appeared to be similar in every respect. The only difference was that the ambient temperature had fallen below 0°C shortly after the rip rap at station 100-350 was placed.

Figure 7. Percentage of intact riprap stones in the NW Dam in autumn 2012

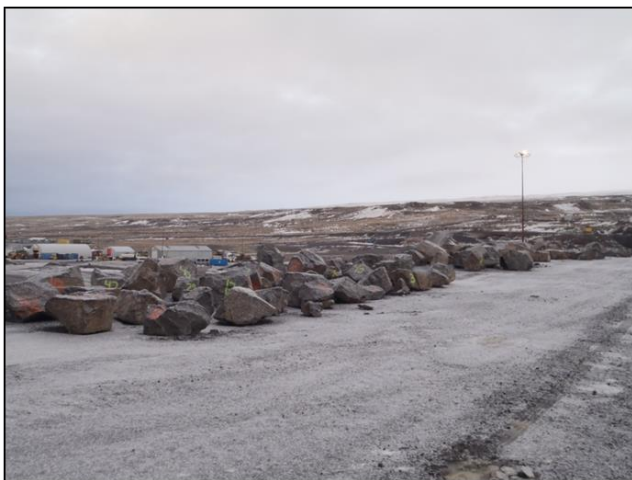
Table 1 shows the quarries, number of stones from each source, date of blasting, date of first exposure to frost, date of transport to test site and first examination of stones. The test site was selected on top of the dam fill so that snow would not cover the stones. Figures 8 to 11 show the test site and stones in the test.

Figure 8. Site test of riprap stones

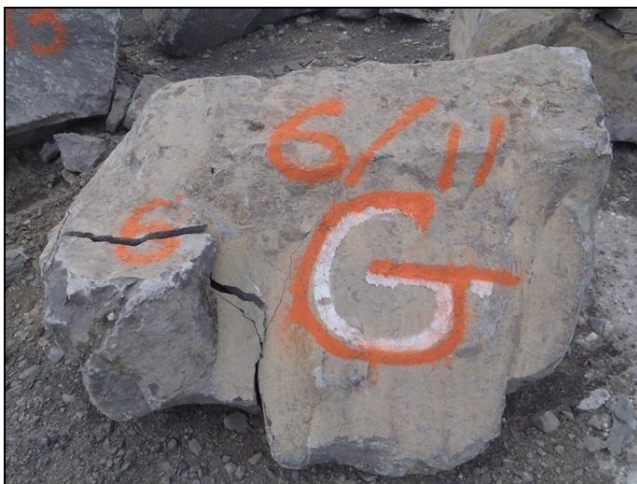
Figure 9. Fractured riprap stone in the site test

The fracture surfaces are in many cases completely fresh and don't appear to follow pre-existing weaknesses in the rock.

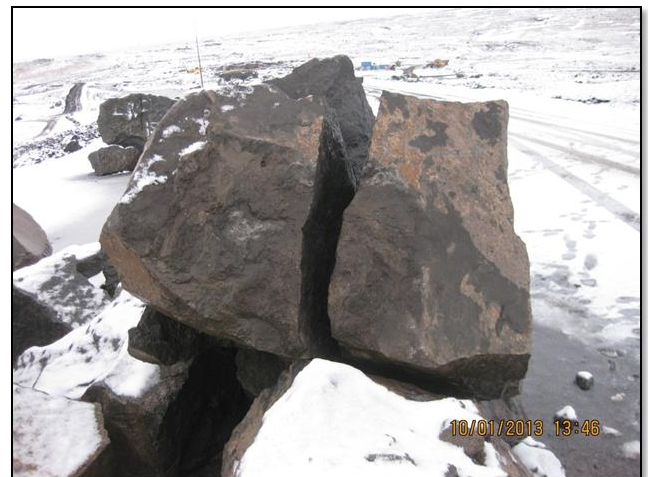
Figure 10. Another fractured riprap stone in the site test

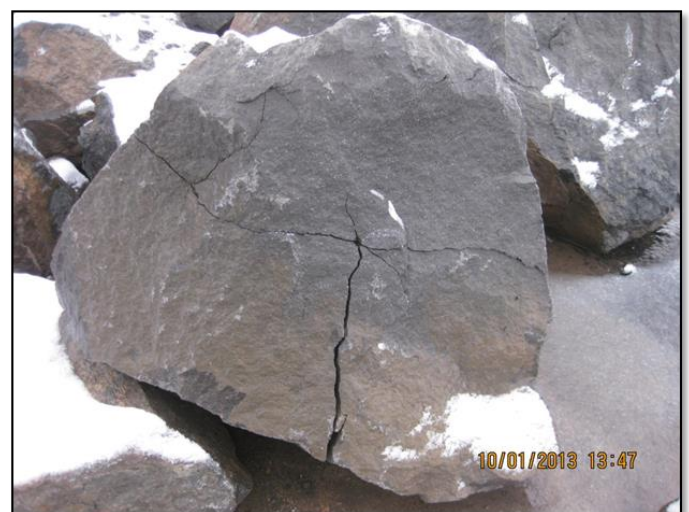
Figure 11. Fractured riprap stone in site test

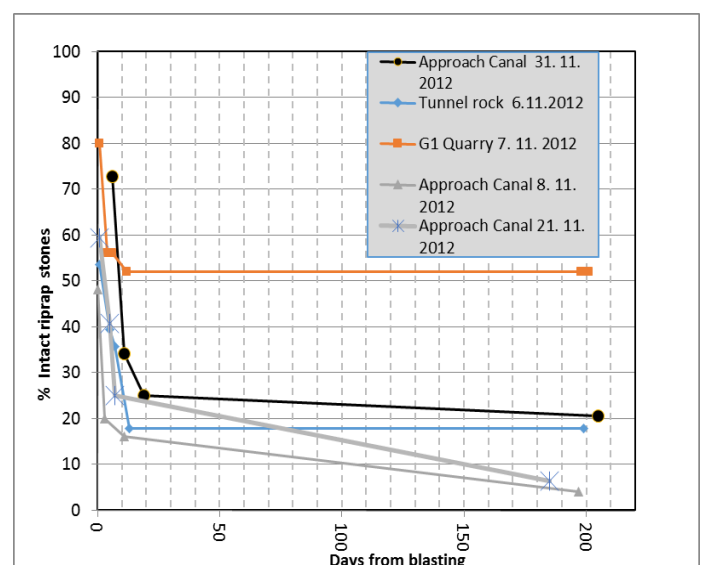
The riprap stones in the test were examined three or four times in the period from November to December 2012 and again in summer 2013. Figure 12 shows the results. It appeared that the stones started cracking following first exposure to mild frost (-5°C). Most of the fracturing took place within the first 10 days. The number of freeze/thaw cycles does not appear to have a significant effect on the progress of fracturing. The degree of fracturing seemed to be independent of stone size.

Figure 12. Results of site investigation of riprap stones.

Further surveying of the test stones could have revealed if the fracturing all takes all place within the first month or not. However, the test stones became covered with ice and snow and could not be examined further until next spring. The rock from quarry G-1 appears to have a higher resistance to cracking than rock from other sources in the area. The rock in quarry G1 may not have been saturated at the time of blasting while rock blasted from the Approach Canal and from the Headrace tunnel were probably saturated.

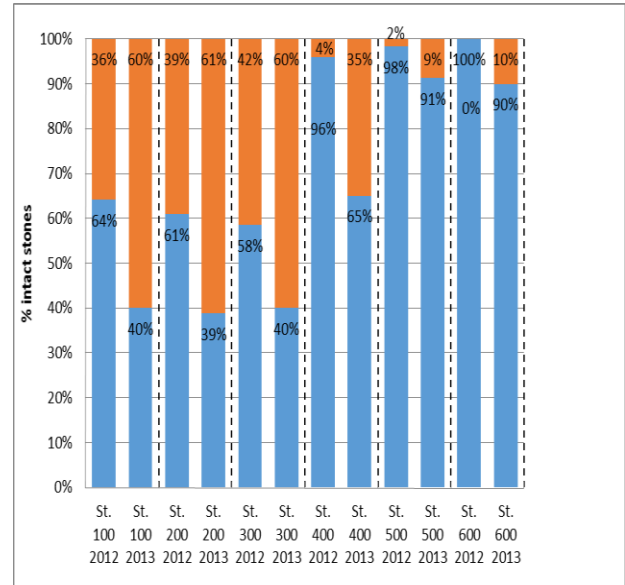
In June of 2013 when snow had disappeared from the riprap already placed in the Dam the counting of fractured riprap stones was repeated in the same locations as in November 2012, counting essentially the same stones as before. The results are shown in Figure 13.

Comparing the results from 2012 and 2013 reveals that the proportion of fractured rip rap stones that were placed during the summer of 2012 increased to 10 % at station 600 and 500.

For rip rap stones placed at stations 100-300 the fracturing increased considerably. Only 40 % were unfractured in June 2013. The 20 % increase of fractured rip rap stones at stations 100 -300 shows that the initial fracturing was not over by the end of October 2012. At stations 500 to 600 the number of intact stones was about 90 % which is similar to observations from other dams in Iceland. The results at station 400 do not fit into either of the above classes and is unexplained.

Figure 13. Proportion of fractured rip rap stones along the dam axes in 2012 and 2013.

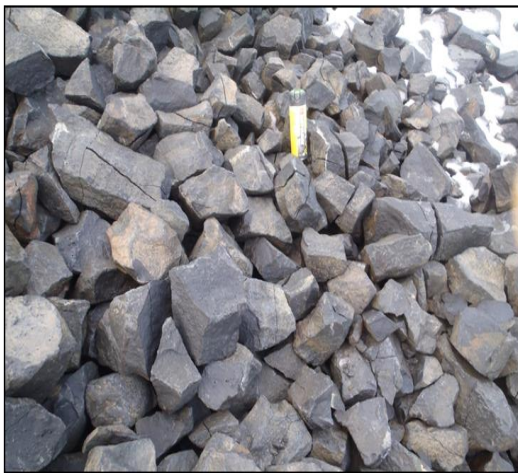
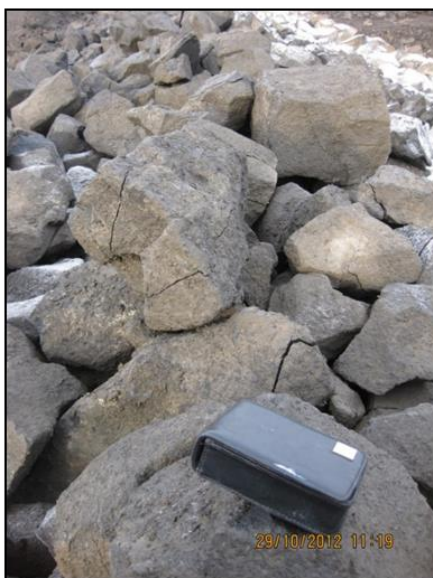
As explained earlier the slope protection materials (20-40 cm) and the coarser filter (0-20 cm) were obtained from the cube jointed Sporðalda basalt formation. On that dreadful autumn day in 2012 when the fractured riprap was discovered it was also found that the slope protection material was extensively fractured.

Figures 14 and 15 show this. This was serious not only for the upstream slope protection but also because slope protection material is underlying the riprap wave protection and filter criteria had to be fulfilled. Cube jointed basalt has not commonly been used for damfill materials in Iceland. Parts of many quarries in basaltic material contain some cube jointed basalt. Fracturing due to frost has not been noticed as far as the authors know. Cube jointed basalt with smaller cubes than found at the Spordalda dam has been used in bearing courses for roads with good results. Therefore, extensive frost fracturing of this material was unexpected.

Figure 14. Frost fractured slope protection materials in autumn 2012.

The use of cube jointed basalt as a slope protection material (20-40 cm) on the upstream slope was discontinued. Instead material processed from tunnel spoil was used. This material had been exposed to several freeze/thaw cycles.

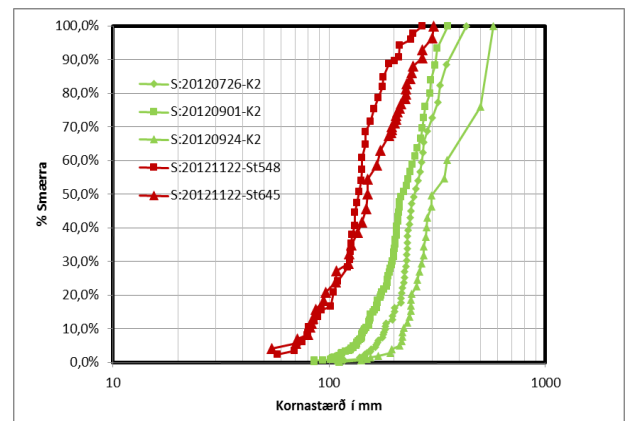
Figure 16 shows a comparison between fractured and unfractured slope protection material (20-40 cm) from cube jointed basalt. The d_{50} (average grainsize) of the unfractured samples taken during the summer is reduced from approximately 250 mm to 150 mm in a sample taken from the dam in late November. The fractured material still fits the originally specified gradation for slope protection.

Figure 16. Grain size of frost fractured and unfractured fill from cube jointed basalt. K2: Unfractured fill from K2 quarry, St548 and St645, frost fractured material from dam.

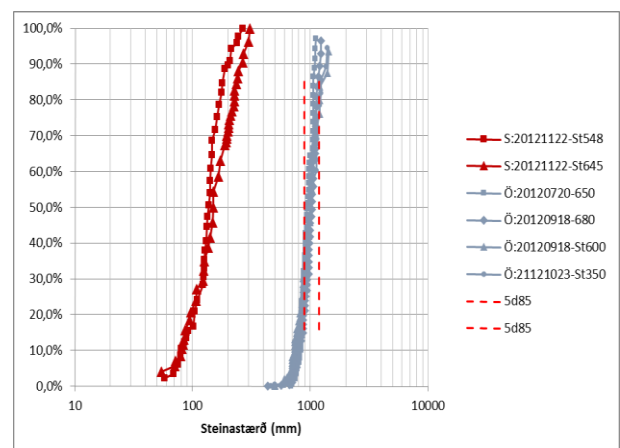
Figure 17 shows a comparison between the grain size of the fractured slope protection material and measurement of riprap stone sizes from 2012. As can be deduced from Figure 16 classical filter criteria for the riprap stones is just about fulfilled between the riprap and the slope protection

Figure 17. Comparison between the grain size of frost fractured slope protection material and measurement of riprap stone sizes in 2012.
