Guldborgsund Tunnel. Operation of tunnel and drained ramps

The tunnel at Guldborgsund is an immersed tunnel connecting the Danish islands Lolland and Falster. The tunnel is a twin tube road tunnel. The tunnel is approximately 500 m long including portal structures, and has approx. 400 m open ramp on each side of the tunnel. The tunnel is owned and administered by the Danish Road Directorate.

The article focus on the operation and maintenance works done for the last 10-15 years in order to secure the open ramps against hydraulic failure and piping, but do also include work with permissions from Danish authorities. Regeneration with hydrochloric acid and sodium dithionite has been executed, but also additional wells have been supplemented to the system.

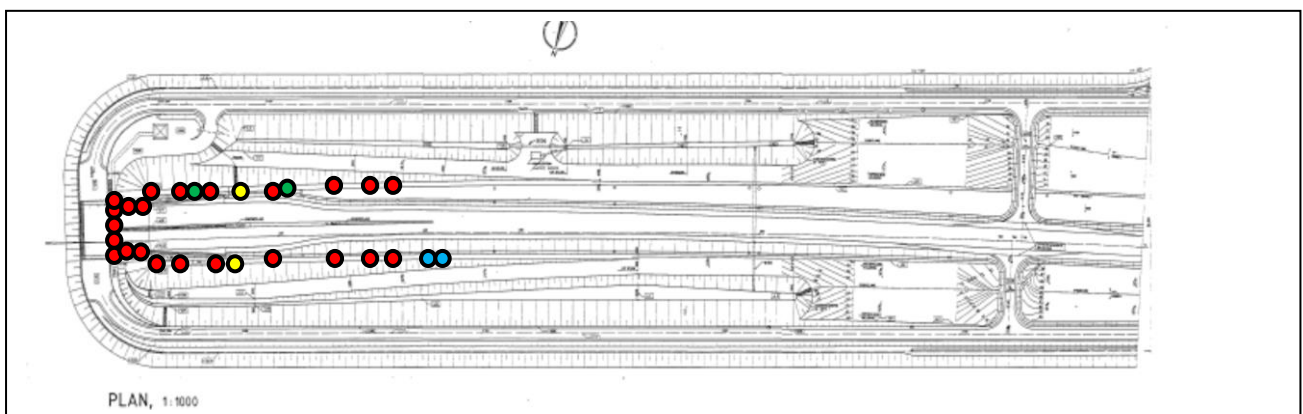
Figure 1.3 System of relief wells. Overview.

4 new relief wells (marked with yellow in Figure 1.3) were established in the middle of the ramps on both sides.

In 2009 piping was observed in a small local area in the north side of ramp on Lolland and 2 additional relief wells (marked with blue in Figure 1.3) were established.

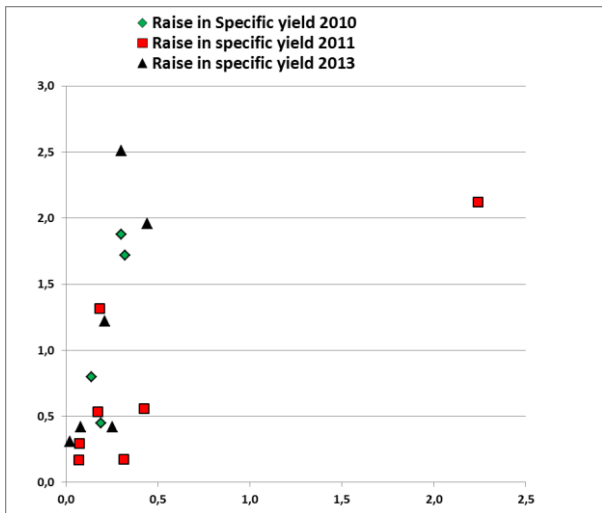
Very different improvements were identified, but in general improvement above 100-200 % was seen. Improvements in an selected amount of wells are shown in figure 1.4, where “specific capacity” after treatment are shown vs. “specific capacity” before treatment.

Figure 1.4 Results of acid treatment. Specific capacity after treatment vs. specific capacity before treatment. Units are m³/hour/m lowering.

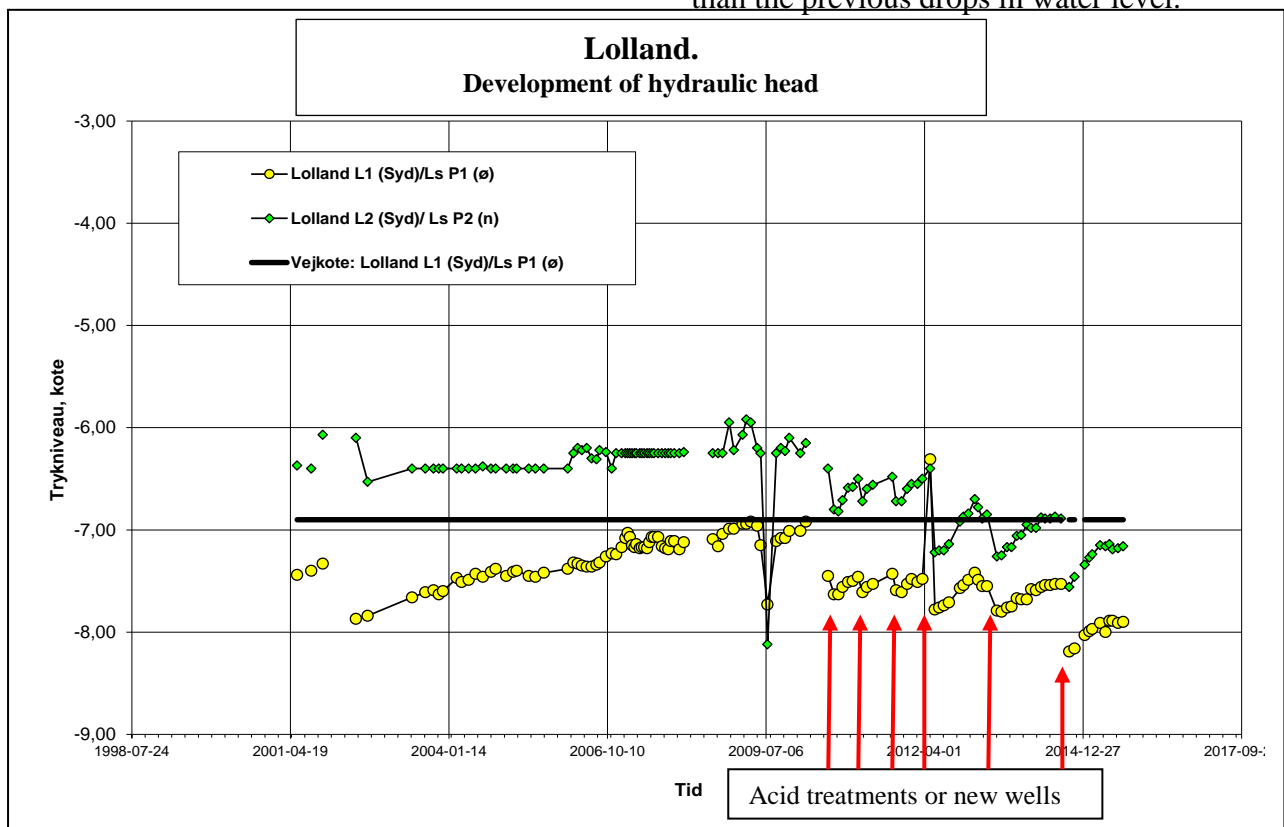
Figure 1.5. The typical variation is a raise of water level of 3-5 cm per month. Each year 8-10 wells are chosen for acid treatment and bringing the water level down corresponding to the degeneration. Last shown drop on figure 1.4 is related to acid treatment of all 5 wells in the portal reservoir close to L1 and L2 and the drop in water level here is higher than the previous drops in water level.

Figure 1.5 Lolland. Overview of water levels in 2 monitoring wells.

Access challenges to these wells gives reasons to take them all in one sequence instead of 1-2 each year. The yellow dots in Figure 1.5 represent water level in upper part of chalk and the green dots represent waterlevels in the chalk 5 m lower. It might not verify the presence of increasing permeability by depth, but it verifies the presents of several flow zones in the chalk. On Falster the clay till layer is present from top chalk to base of road foundation. Here it is accepted that the water level around the deepest part at the entrance to the portal structure is above surface and observation wells here are closed to avoid relief of water. The wells are sealed and are being monitored by manometer. The water level here is monitored and managed in order to have a reasonable uplift safety against uplift, but also to avoid upwards gradients above 0.6.

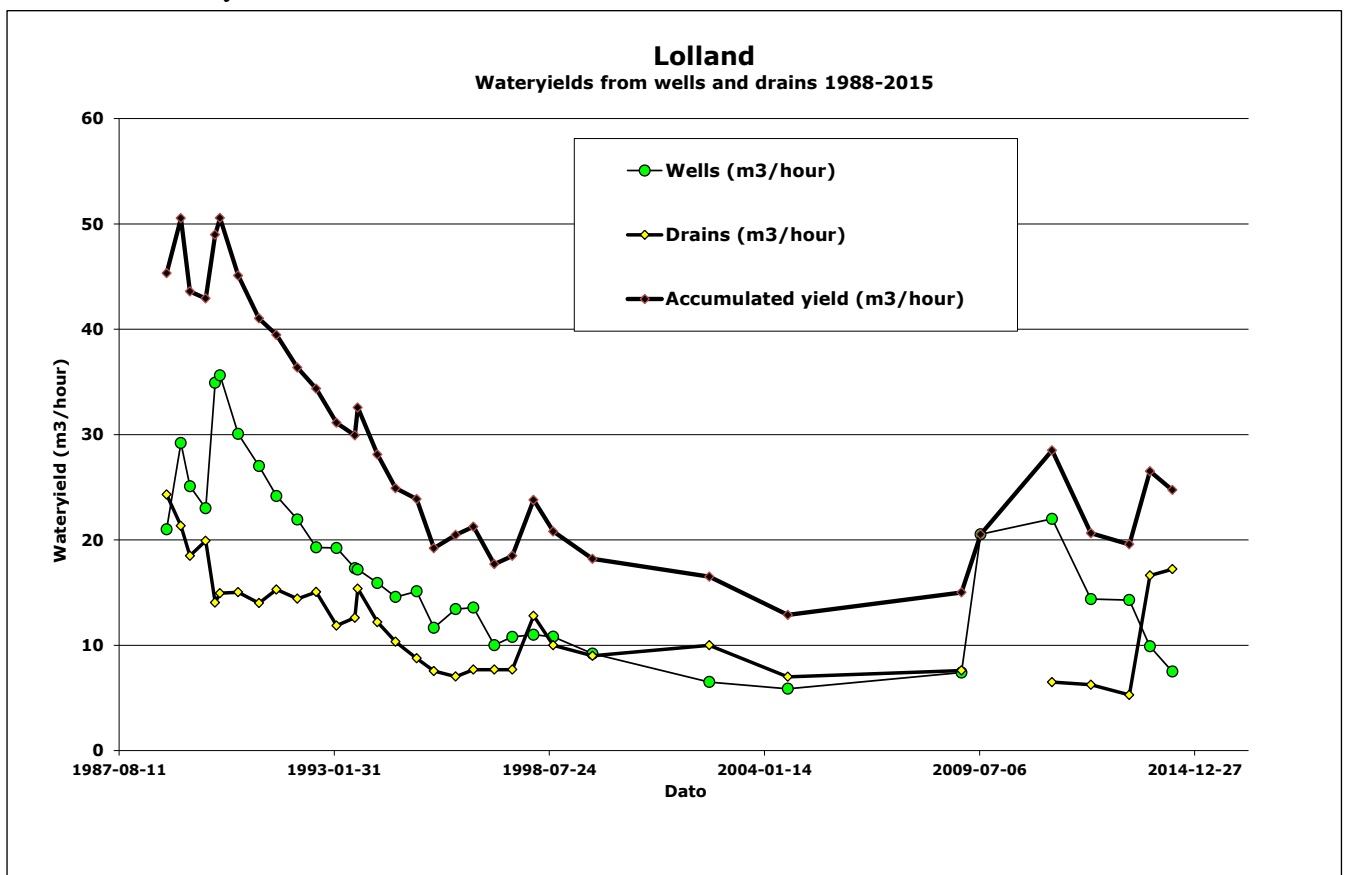
There are only few data available from the initial operation phase and summarized yields from Lolland ramp are shown in Figure 1.6. It is seen that initial relief of groundwater from the wells and drains was approximately 50 m³/hours and dropped in the period up to 2007 to a little below 15 m³ /hour. From 2007 a more regular maintenance of the relief wells started.

As seen on Figure 1.6, the initial relief of groundwater from the wells and drains were 50 m³/hours but are now stabilized on 25 m³/hours. The initial yield on Falster side is not available but today this yield is also around 20-25 m³/hour.

The increase in yields is in general related to the ongoing acid treatment of the wells, but in 2009 it was related to additional 2 wells established to handle the piping area.

Figure 1.6 Yield measurements 1988-2014

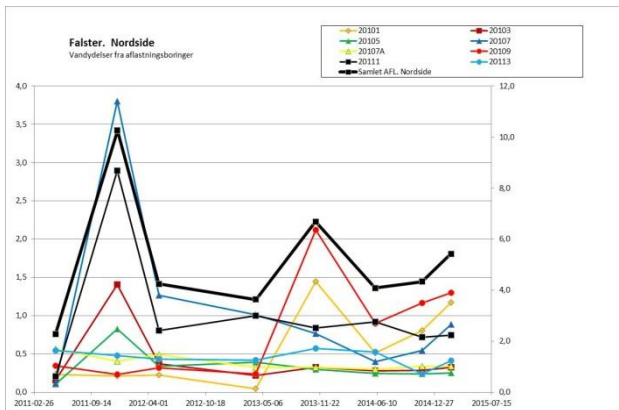
Section 4 comprises an explanation to understand, why we in 2016 can maintain acceptable water level for 25 m³/hours relief, which required 50 m³/hours in 1988. Yield monitoring in single wells are ongoing twice a year and used for selecting relevant wells for reconditioning. Measurements for the period 2009 to 2015 are shown in Figure 1.7 for the relief wells on Falster North ramp.

Figure 1.7 Yield measurements Falster North.

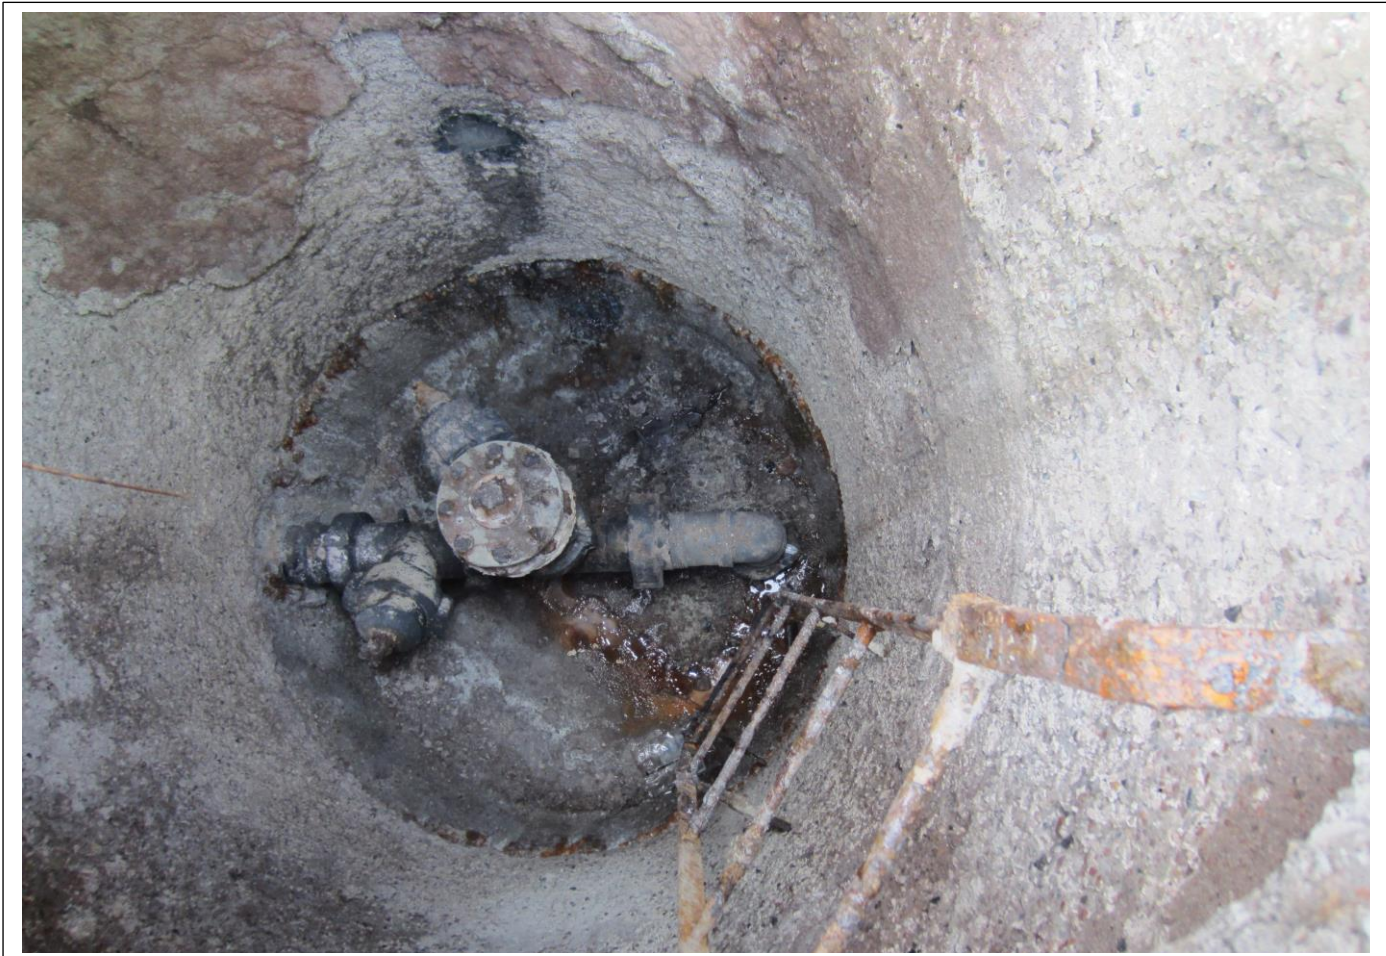
On Lolland the groundwater has a significant content of sulfur, which has led to a chemical attack on parts of the concrete structure (portal reservoir) and the relief wells (installations and concrete protective structures). To prevent concrete deterioration ventilation has been installed in the portal reservoir on Lolland and concrete structures for relief wells have been repaired/ exchanged. On the concrete protection of the relief wells the corrosion is very visible as can be seen on the photo in Figure 1.8.

Figure 1.8 Installation of relief well in concrete ring on ramp at Lolland. Photo T.N. Petri.

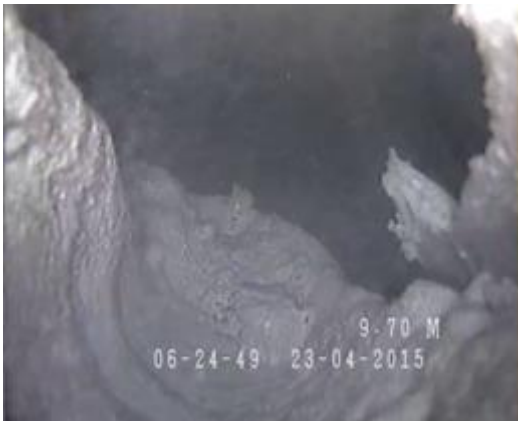
Damage in filter screen: In one well on Lolland filtersand and blue PVC screen parts with slots were airlifted/pumped up from the well during capacity testing of the well before acid treatment. A following video inspection of the well identified a damaged screen, where a significant “handball size” big hole could be seen in bottom. Se Figure 1.9

Figure 1.9 Still picture from well video.

The well has not been mechanically treated since commissioning and it is likely that the hole has been present since establishment. So far no remedial actions have been taken as the situation seems stable in the chalk.

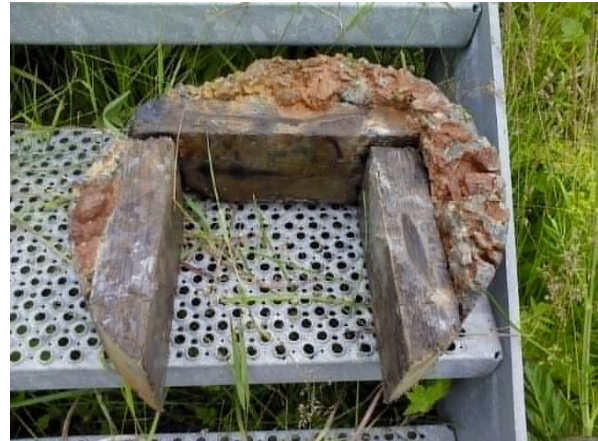
In one of the wells it was identified that the concrete bottom was not able to resist the pressure from the acid treatment and it was found that only a poor thin blinding layer was present in bottom of the concrete protective structure. In the bottom plate of the concrete structure a recess was made by wood allowing the well to be drilled from surface

and the recess could afterwards be sealed. Apparently this was not done. Se photo in Figure 1.10.

Figure 1.10 “Bottom” of well “protection”

Thorough final supervision of all works before commissioning is recommendable as significant deficiencies are registered 28 years after commissioning.

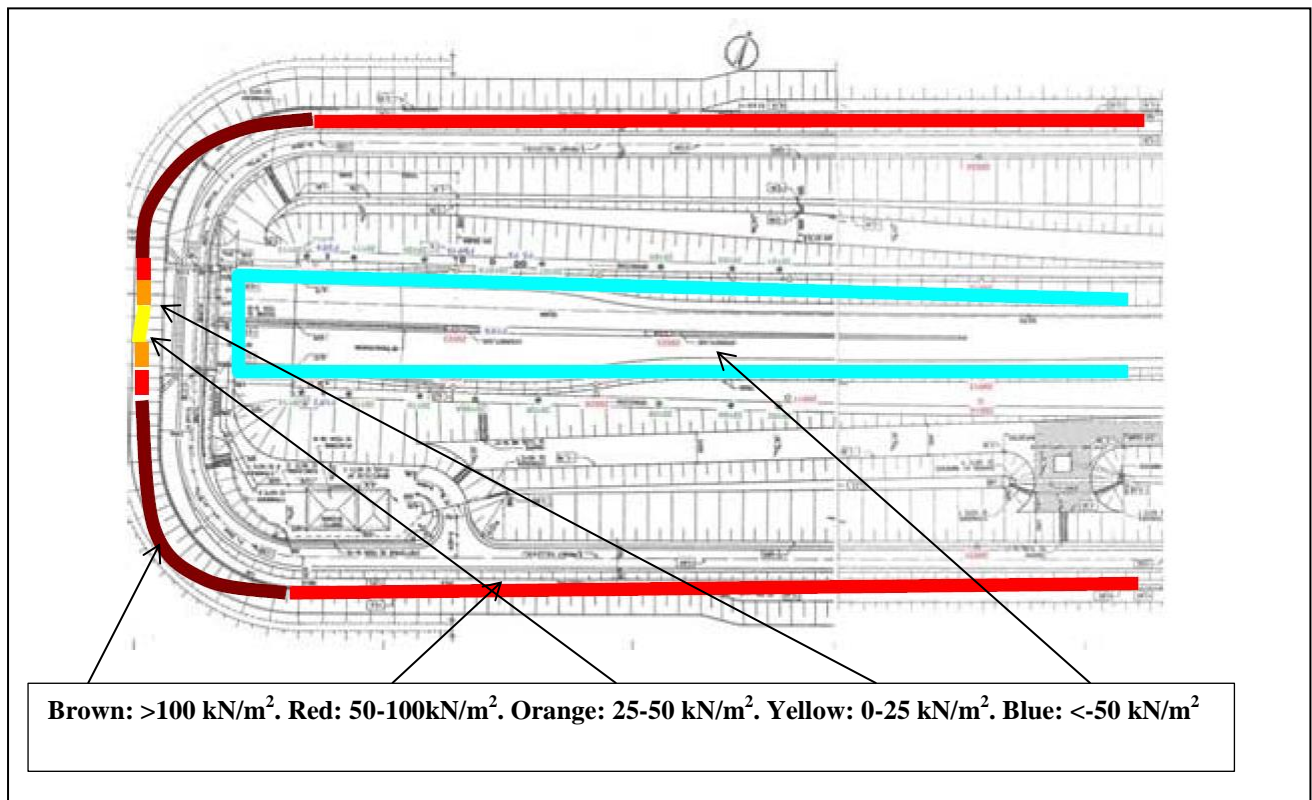
The system today can be operated with acceptable water pressure below the ramps for 50% of the initial yield from 1988. It is considered that settlements have caused a reduction in the fractures in the ongoing consolidation process of the chalk.

In Figure 1.11 an overview of the increase in effective stresses are established based on groundwater lowering, dike-establishment and gravity structures. Areas marked with brown indicates stress increases above 100 kN/m², red is 50-100 kN/m², orange is 25-50 kN/m² and yellow is below 25 kN/m². The figure is not 3-dimensional correct as effective stresses from dike load and gravity structures will decrease by depth due to spreading and increased stresses from the groundwater relief will maintain the full additional effective stress in the whole aquifer to an unknown depth.

Figure 1.11 Falster overview. Estimated changes in effective stresses.
