Analysis of the failure mode of slopes with open sharp toe notches

Luis E. Vallejo

Mingzhou Li

ABSTRACT: A notch (or toe crack with an open angle) in coastal and inland slopes is one of the primary factors responsible for their failure. For the case of coastal slopes, the open notch at the toe of slopes is caused by the erosion of the toe material by wave action. For the case of inland slopes, the open notch is produced by the combination of water-induced slaking of the material at the toe of the slopes and the expansion of the face of the slope resulting from the stress relaxation that takes place when a cut is made in soil or rock. This study describes the mechanics of formation of open notches in coastal and inland slopes which are located in England and the United States. An open notch in a slope acts as stress concentrator. If a slope with an open notch fails, the failure starts at the tip of the open notch where the stresses are the highest. Thus, a notch dictates the way the slopes fail. An explanation for the influence of sharp open notches on the stability of rock and soil slopes is presented. The sharp notches considered had varying degrees in the angle formed by the w

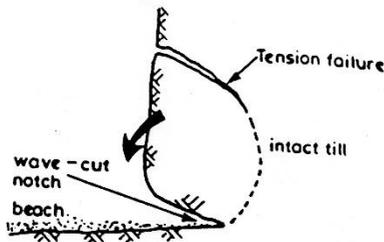
Figure 1. A wave induced notch in a till coastal slope located at Aldbrough on the coast of England (Hutchinson, 1986, 1988).

The slope shown in Figure 1 is located in the Holderness coast in the north east part of England. The height of the slope is about 3 meters, and its inclination is about 65 degrees. The slope is made of the Holderness till (Hutchinson, 1986, 1988). The slope in Fig. 2 is made of loess. Its height is about 10 meters and

The notches and the failure surfaces in the soil slope shown in Figure 1 was the result of wave action at their toes (Figure 4)(Vallejo and DeGroot, 1988). The action of the ocean water waves on this coastal slope consists primarily of

the erosion of previously intact soil occupying the slope foot and adjacent to the wave-cut platform. The erosion takes the form of wave impact and abrasion. The net result of the wave erosion is the formation of a notch at the foot of the coastal slope. The notches shown in Figure 1 act as stress concentrator and causes the tensile failure of the material surrounding the notch

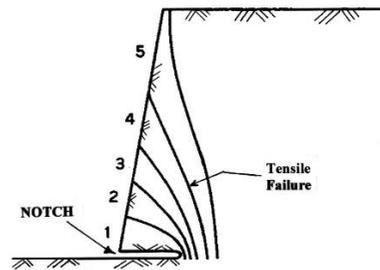
Figure 2. Progression of toe failures from an open notch in a soil slope located at Vicksburg, Mississippi (Lutton, 1969).

its face is inclined at 70 degrees with the horizontal (Lutton, 1969).

For the case of the loess slope shown in Figure 2, the notch was produced by the water induced slaking of the loess. After rain, water accumulates at the toe of the slope resulting on the slaking of the slopes' toe material (Vallejo, 2011). Like in the coastal slopes, the notch acts as stress concentrator that causes the tensile failure of the slope as shown in Figure 2.

For the case of the case of the slope shown in Figure 2, the notch was produced by the water induced slaking of the loess. After rain, water accumulates at the toe of the slope resulting on the slaking of the slopes' toe material (Vallejo, 2011). For the case of the soil slope shown in Figure 2, the first tensile failure surface was inclined at about $\alpha=160^\circ$ in a counter clockwise direction with respect to the horizontal [Fig. 6(b)]. The second failure surface was inclined at about 130° . The subsequent failure surfaces took place at smaller angles than the first two. The notch shown in Figure 2 acts as stress concentrator that causes the tensile failure of the slope. The soil slope in Figure 1 also failed when a tensile crack inclined at an angle $\alpha > 90^\circ$.

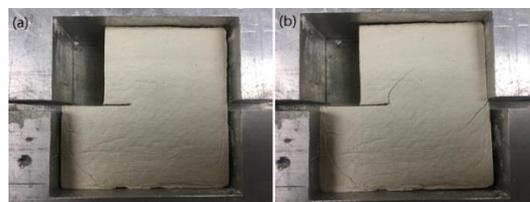
Figure 5. (a) The fissured clay sample before testing, and (b) after testing in the PSDSA.

shear stress, τ , on the solid horizontal section of the crack [Fig. 5(a)]. The lateral stress (σ) was gradually increased until the toe crack began to propagate, which occurred when the shear stress $\tau = 513$ kPa [Fig. 5(b)]. The toe crack propagated in the model in the form of a secondary crack that extend from the toe of the pre-existing crack and deviated from the original horizontal direction. Figure 5(b) shows the clay model after the test. The secondary tensile crack propagated at an average angle of 80° with the direction of the pre-existing horizontal crack.

For the case of the laboratory slope the angle of secondary crack α was equal to 80° . For a ratio between τ/σ equal to 6.3. For this ratio, the theoretical value of α given by Fig. 8 is about 80° .
