# Investigation on the damages induced by slope movements on historic buildings: the case of San Nicolò di Capodimonte church in Liguria

L. Cambiaggi

R. Berardi

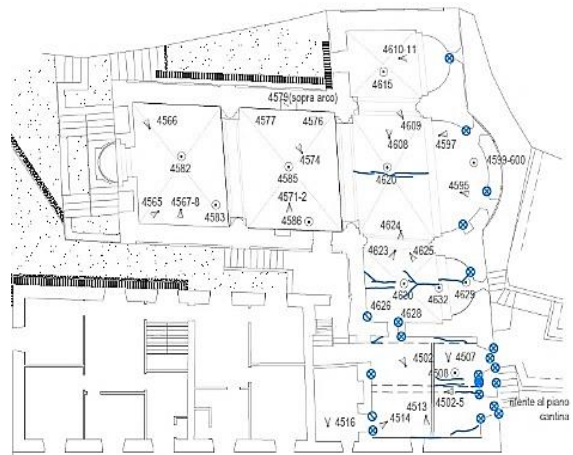
Once the displacement profiles have been obtained, the crack pattern of the S. Nicolò complex has been studied. From the profile at the founding level of Fishermen's House, highlighted by the analyses, a correspondence can be observed between the relative settlements in section E and the identified damage; in fact, serious cracks have been detected at the ground floor of the Fishermen's House (Figure 7).

The effect of the connection between the two buildings, which is highlighted in the analysis in the drag effect that one structure exerts on the other, points out the criticality of this portion of the complex. This is also confirmed by the concentration of damage observed in the transept, placed where the Fishermen's House is connected to the church (Figure 7-8).

Figure 7: Crack pattern along section E

For the church, considering a section at the foundation plane, maximum displacements  $u_x$  and  $u_y$  of the order of 1 cm are obtained, which, compared to the 12 m plan dimensions of the church transept, provide mean lateral deformation values  $\epsilon_L$  and angular distortion  $\beta$  equal to about  $8 \cdot 10^{-4}$  and  $1 \cdot 10^{-4}$ , respectively.

Analyzing the results of the Fishermen's House, horizontal displacements are higher, also

associated with a phenomenon of differential settlements; this leads to values of  $\varepsilon_L$  equal to about  $2.6 \cdot 10^{-3}$  and of  $\beta$  about  $1.6 \cdot 2 \cdot 10^{-4}$ .

The values of horizontal deformation and angular distortion were used to estimate the degree of damage according to the approaches suggested by Son and Cording (2005) and Schuster et al. (2009), particularly committed to deep excavations (Figure 9). According to the Son and Cording's approach the damage is slight (for the church) to medium (for the Fishermen's House). A similar result is obtained with the approach proposed by Schuster et al., being the Damage Potential Index DPI equal to 16 (slight damage) and 52 (moderate damage) respectively for the church and the Fishermen's House.

These results correspond to the actual survey of the cracks, which appear more serious in the basement of the Fishermen's House, compared to those of the church that, although relevant, have a generally lower opening.

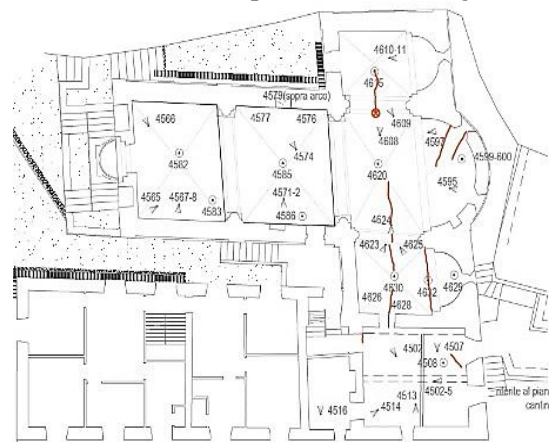
The presence of other damages with an almost perfectly perpendicular trend with respect to the aforementioned cracks, also presupposes the presence of a phenomenon of local subsidence probably due to infiltration of water below the apse of the church (Figure 8). This aspect is supported by water discharge from the floor, in periods of heavy rain, and by the presence of a stream outside the apse in which, during those periods, water is canalized. The whole obtained results have pointed out a possible correlation between the re-opening of cracks and particularly rainy periods, which necessarily influences the oscillations of groundwater level and the phenomena of local infiltration.

The comparison between damage monitoring and cumulative rain frequencies in recent years has shown an effective correlation between these phenomena.

Figure 8: Crack pattern perpendicular to the one shown in Figure 7
