Slope stability issues close to local road P130 near the town Sabile, in Latvia – case story

M. Grava

Latvian State Roads SJSC, Riga, Latvia

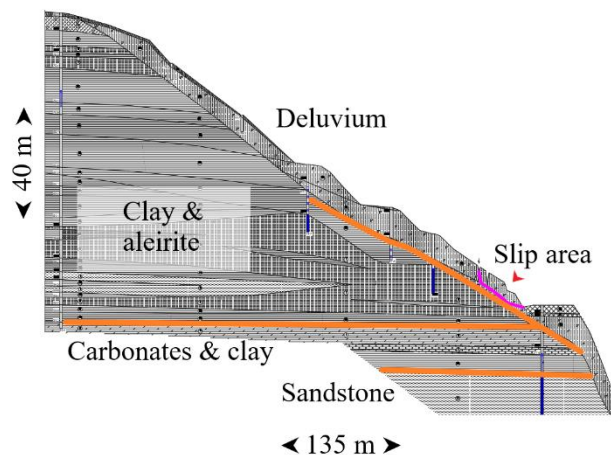
Figure 1. Geotechnical cross-section (BMGS, 2015 with comments)

Beneath road P130 down to elevation 32 m a.s.l. there is deluvial material at the main part of the slope slip site. That is approx. 80...90 meters length of road at the slope slip area. At the rest of the length of road that was enclosed in this investigation works, there is only one cross-section. That gives no data at the depth of the 32

m a.s.l.. Starting from depth approx. 40 m a.s.l. sandstone strata are shown, above that up to 46 m a.s.l. are carbonate (dolomites etc.) and clay layers. And from that depth up to road construction, that lies at the elevation 50 m a.s.l. there is deluvial material. In summary, at the longitudinal cross-section of the road length of 150 meters, the thickness of the deluvial material varies from 1 to 15 meters (approx.).

Above elevation 50 m a.s.l. deluvial sediment layer is partially saturated, water saturation of sand like sediments is highlighted in previous mentioned investigation reports. Deluvial material that lies lower elevation 50 m a.s.l. has not been displayed as saturated material.

In the upper part of the geotechnical cross-section clay strata is shown as unsaturated and in the lower parts saturated interlayers of the aleirite are shown. Approx. from 60 up to 55 m a.s.l. (upper part of the slope slip) aleirite is considered water saturated (BMGS, 2015). According to information enclosed in investigation reports (Latdoravtoprojekt, 1962; BMGS, 2015; Firma L4, 2016), aleirite delivered water and precipitation water caused oversaturation of the clayey material and stability loss of the slope.

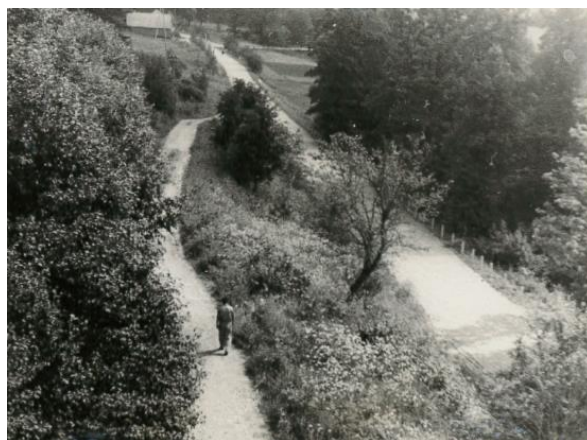
Figure 2. Slope slip area (Latdoravtoprojekt, 1962)

Before this particular case (slope slip) in the year 2014, there is geological investigation report from the year 1962 that investigates slope instability problem at the site (Figure 2) and areas close to that (in a range of couple hundred meters). In this (Latdoravtoprojekt, 1962) investigation report information is given about slope slip occurrences in the year 1954 during reconstruction work of the road. Information is given regarding existing slope instability

solutions - existing concrete wall with a drainage system (not working). There is also mentioned existing trench, that has been made above connection road. As stated in the report – trench was working as precipitation water collector, not a drainage system.

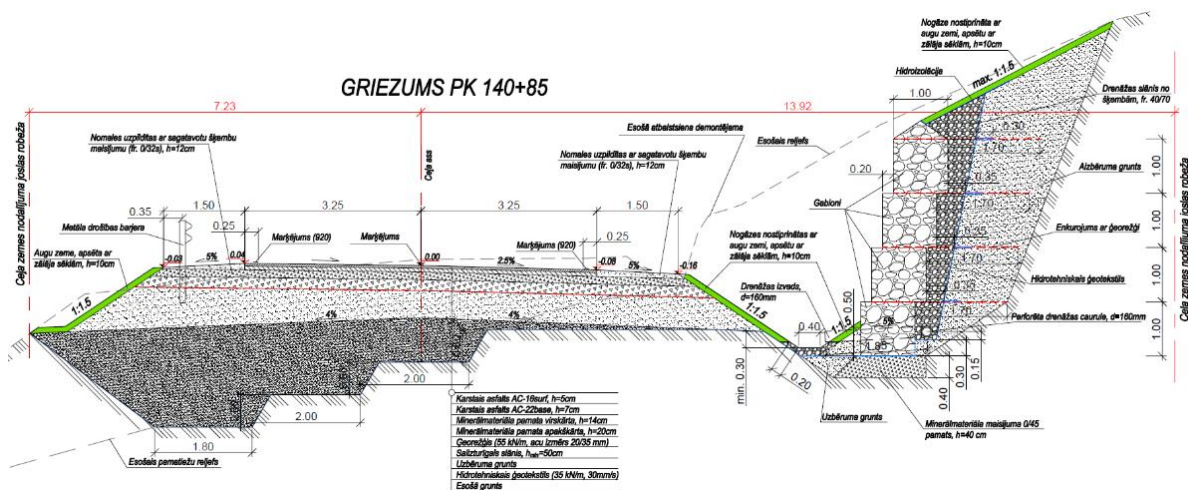
Figure 3. Cross section from design prepared in year 2013 (Polyroad, 2013)

In the year 2013 design project was prepared. Design project dealt with several geotechnical problems in this area, like road embankment and slope instability. According to information that can be found in the design project, the slope slip problem supposed to be solved with gabion type wall (Figure 3). That wall was planned in the length of 120 meters, 4 meters in height and design location was approx. 4,5 meters from road pavement. Only cut in the slope was made, until slope slip occurred.

Regarding gabion wall stability calculations, there is information in the project, from which can be assumed that geological situation was considered as uniform one layer, not as described in the geotechnical report – complicated.

During construction works the road construction was fully built and cut in the slope for gabion wall was made. Slope slip occurred in October of the year 2014. Soil mass moved towards the road, gabion wall was not built and the situation was left as it is.
