# CPT investigation of mining-induced fissures and implications in respect to built development, Staffordshire, UK

R. D. W. Lowman

*Wardell Armstrong, Stoke-on-Trent, United Kingdom*

**ABSTRACT:** Fissures are cracks or openings in rock formations resulting from ground movements associated with underground coal mining. Within the Cannock area of the Staffordshire Coalfield, there are numerous records of fissures within the sandstone formations of the Triassic Sherwood Sandstone Group overlying deep mined Coal Measures strata. The mining-induced fissures, which can extend for hundreds of metres and to considerable depths, present risks to existing property and future development in respect of surface subsidence and structural damage, many instances of which have occurred in the Cannock area. Within the Pye Green area of Cannock, the general location of mining-induced fissures has been identified by geophysical survey in respect to a proposed school development. The precise location of the fissures has not been identified by traditional ground investigation techniques, due primarily to the presence of several metres of granular soils immediately beneath ground surface. Cone Penetr

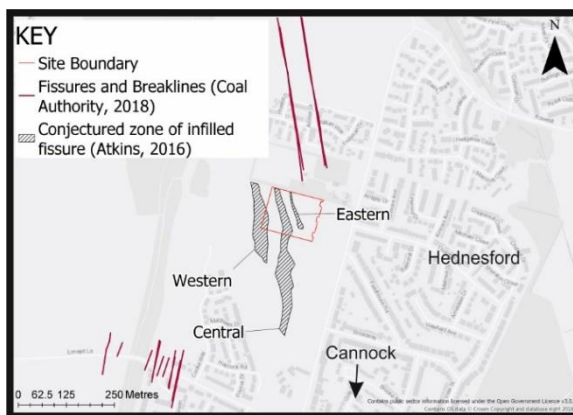
Figure 1. Site location plan showing fissures identified by previous investigations (Atkins, 2016) and The Coal Authority (Coal Authority, 2018)

Geophysical surveys have been undertaken at the site in 2011 and 2013 to investigate the location of the fissures employing magnetic gradiometry, resistivity and ground probing radar survey techniques. The results of the surveys recorded 3 main linear features (Figure 1), which have subsequently been defined as the Western, Central and Eastern Fissure respectively (Atkins, 2016). The maximum widths of the broadly defined fissures (conjectured zone of infilled fissures) are recorded to be c.34m, c.18m and c.14m in respect of the Western, Eastern and Southern Fissures (Atkins, 2016).

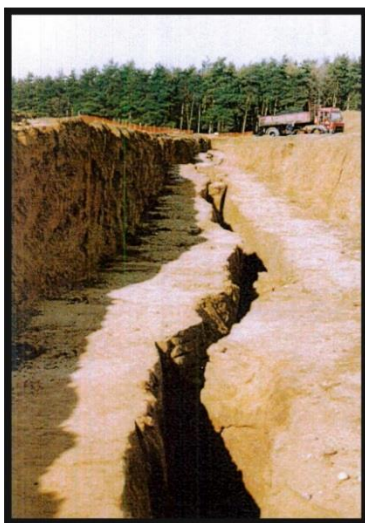
Mining-induced fissures have been observed to reach up to about 1m in width and several hundred metres in length (Donnelly, 2006; Donnelly and Rees, 2001) extending to considerable depths. Where superficial deposits overlying fissures are granular and permeable, surface water and/or groundwater can wash the granular deposits into open fissures causing surface subsidence. Weathering can weaken the sides of fissures producing a “spalled zone” towards surface, with the fissures reducing in width with depth. Figure 2 shows an example of an open fissure which has been exposed by excavation.

*Figure 2. Photograph of an exposed open fissure within Permo-Triassic sandstone, Nottinghamshire Coalfield (Coal Authority, unknown)*

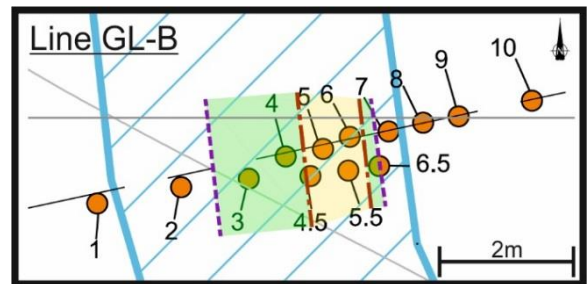
Figure 5. Section line GL-B showing broadly defined extent of infilled fissure prior to investigation (cross-hatch), conjectured extent of fissure (yellow), spalled zones (green) and probehole locations (Wardell Armstrong, 2018)

The depth of probeholes within the fissure vary from 12m to 16m, within the spalled zone from 3m to 5m depth and immediately outside the fissure probehole refusal depths were of the order of 3m. The fissure width is reasonably well defined at c.0.8m, indicated by a significant change in probehole depths. The materials within the fissure are characterised by the presence of extremely low strength fine grained soils and loose to very loose sands. Cone and sleeve friction resistance values reach almost zero within the fissure.

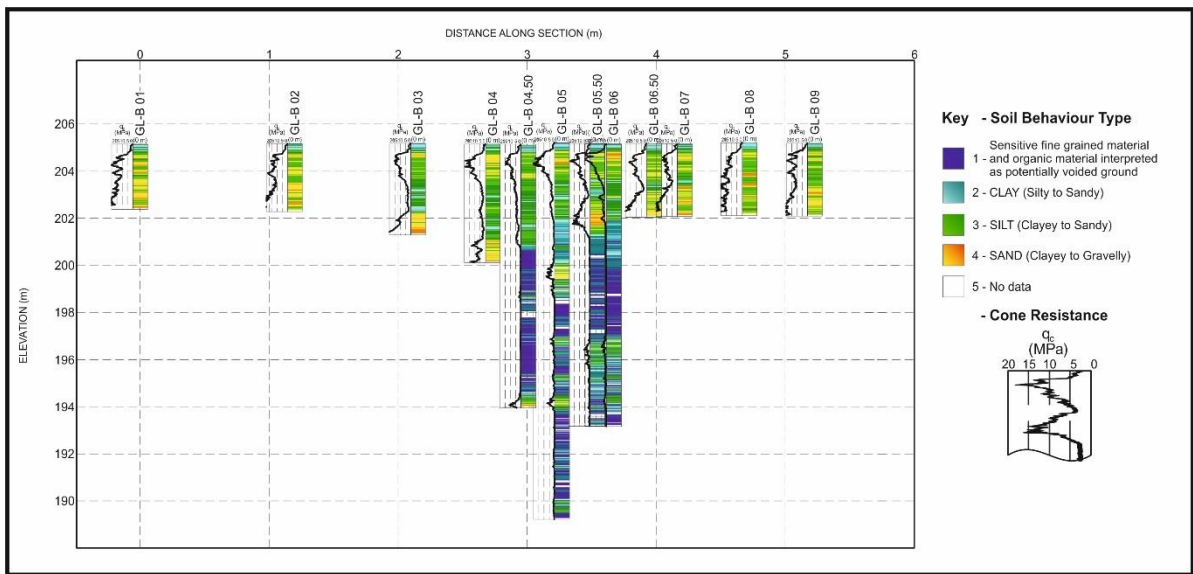
Figure 6. Cross section of line GL-B showing depth of probeholes, cone resistance values within and outside of the fissure and soil behaviour types. Produced by In Situ Site Investigation (In Situ Site Investigation, 2018) and edited by the authors

Illustrations of and cone resistance and sleeve friction responses to define the fissure along the section are shown as Figures 6 and 7 respectively. This comprises responses at test locations 02 (outside of fissure), 04 (within the spalled zone) and 06 (within the fissure).

Location 2 (outside the fissure) - High cone and sleeve friction resistance responses are recorded, with cone and sleeve friction resistance reaching 20 MPa and 500 kPa respectively. The material is reported as high strength silt and clay overlying dense to very dense sand and gravel, with probehole refusal at 2.9m.

Location 4 (within the spalled zone) - High cone and sleeve friction resistance responses are recorded at levels of up to c.20 MPa and 400 kPa respectively to c.1.6m depth, which is considered to represent engineered made ground. Below to a depth of c.4m the cone and sleeve resistance levels falls to c.2.5 MPa and c.27 kPa respectively, this material being defined as high strength to very high strength silt. Below the cone and sleeve resistance increases to c.14 MPa, and 300 kPa respectively, the material being

defined as medium dense gravelly sand, with probehole refusal at 5.03m.

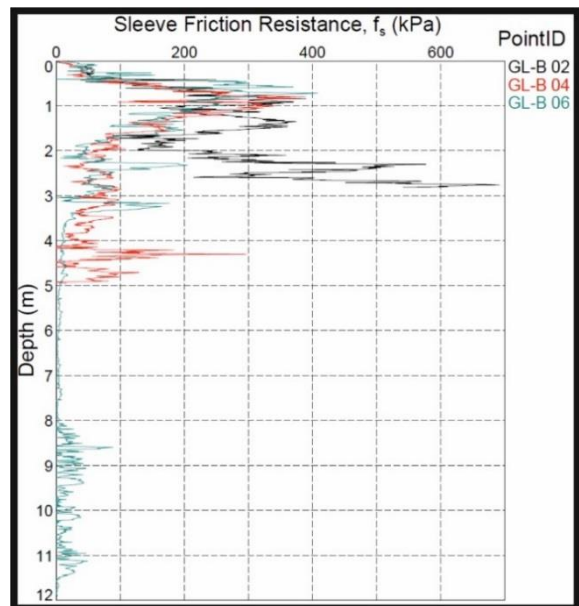
Figure 7. Examples of sleeve friction resistance responses within probeholes along section line GL-B, outside the fissure (02, black), within the spalled zone (04, red) and within the fissure (06, grey).

Location 6 (within the fissure) - High cone and sleeve friction resistance values are again recorded to c.1.6m depth (engineered made ground). Below to a depth of c.3.4m, the cone resistance falls to between c.2 and 6 MPa and the sleeve friction resistance to between c.9 and 216 kPa, the material being defined as high to very high strength silt. The materials to 8.2m comprise extremely low to very low strength fine grained soils, which are characterised by cone and sleeve friction resistance values close to zero, indicative of the presence of a fissure. Below the cone and sleeve friction resistance increases to c.5 MPa and c.109 kPa respectively (e.g. loose gravelly sand and extremely low strength soils) to refusal at 12.0m. It is considered that where the cone and sleeve resistance values are close to zero voided ground may be present rather than very low strength soils.
