# Failure of a massive geosynthetic-reinforced clay dyke for a waste disposal plant: investigation of the causes

**ABSTRACT:** To increase the capacity of a waste disposal plant located in a hilly site in central Italy, a new 25 m high barrage has been built to bound a valley and create a new waste storage over the upstream area. To minimize environmental risks, a geosynthetic-reinforced clay dyke has been designed for the plant. Just after the completion of the works and before entering into operation, clear signs of instability appeared at the upstream side of the dyke. To prevent the growth of such mechanism the dyke was immediately re-profiled by lowering the crest. A thorough ground investigations and monitoring were carried out to understand the causes of the instability; three main causes have been identified: unfavorable local geological conditions; inhomogeneity of the foundation soil; development of high pore pressures in the dam and in the subsoil. This case history turned out to be again an example of the importance of details for design and construction of geotechnical works particularly if of great impact for the environment.

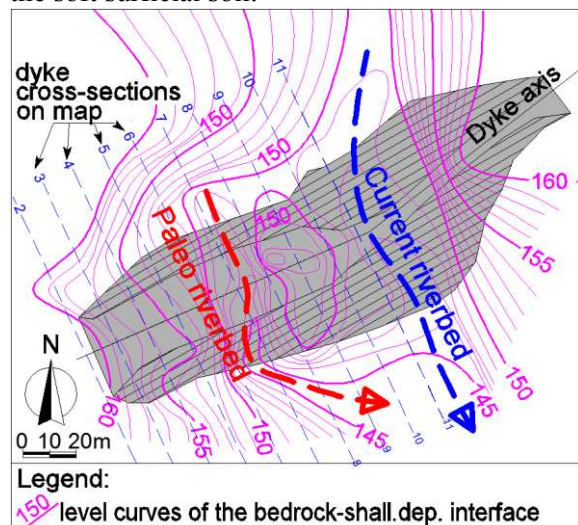
Figure 4. Level contours for the interface between bedrock and the shallow deposits

It is worth noting the displacement of the riverbed towards East and the consequent increase of the thickness of the soft soil filling. Such a displacement of the riverbed is linked to the immersion towards North-East of the bedrock and is the cause of the better geotechnical conditions of the left flank of the valley with respect to the right one. However the presence of a rather thick deposit of soft soil filling the paleo riverbed was not properly considered by designers and this posed the premises to the localization of a failure surface right in this zone of the dyke.

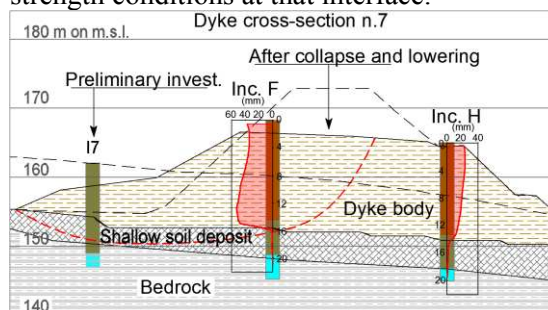
being the boundary of a block compound phenomenon, and is formed by a steeper segment in the upper part and a sub-horizontal one in the lower portion. The described geometry of the failure is however a simplification of reality, as the observed displacements at the upper part of the dyke show some rotational components that suggest compatibility with a log-spiral failure surface.

Figure 5 shows the cross section n.7 of the dyke (see Figure 3 for the trace of the sections), just where the instability occurred, with the relevant inclinometer profiles being shown. Note that inclinometer readings refer to the period after the paroxysmal event. The profiles show quite clearly that deformations are localized at the contact between the base of the dyke and the top of the shallow deposit. Moving upstream the failure surface deepens and localizes at the contact between the shallow deposit and the bedrock. Such geometry of the failure is very likely conditioned by the occurrence of residual strength conditions at that interface.

Figure 5. After collapse inclinometer profiles and resulting geometry of the failure surface

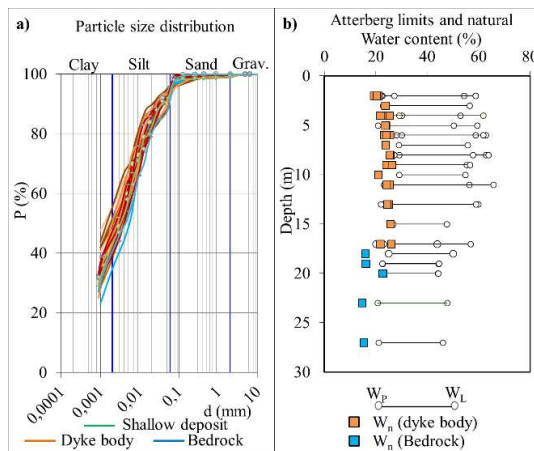
terberg limits indicate that the soil of the embankment and the soil from the shallow deposit, as expected, have the same index properties: in both cases the clay classifies of high activity (CH). On the other hand, activity of the clay from the bedrock is low (CL). In Figure 6b index properties are compared with values of the natural water content: water content of soil samples taken from the dyke is close to the respective values of plastic limit while, for bedrock samples, water content is lower than the plastic limit.

Figure 6. a) Particle size distributions; b) Soil index properties and natural water content

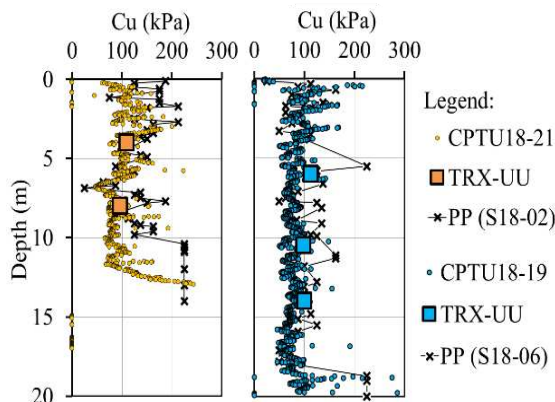
The samples taken from the body of the dyke show an undrained cohesion ranging from 80 to 100 kPa, independently of depth. Only occasionally, small values as little as 50 kPa have been registered. The same figure holds for the soil from the shallow deposit. Bedrock samples instead show undrained cohesion values ranging from 300 to 600 kPa.

Figure 7. Undrained shear strength profiles: derived values from CPT's, pocket penetrometer (PP) and Undrained Triaxial tests (UU)

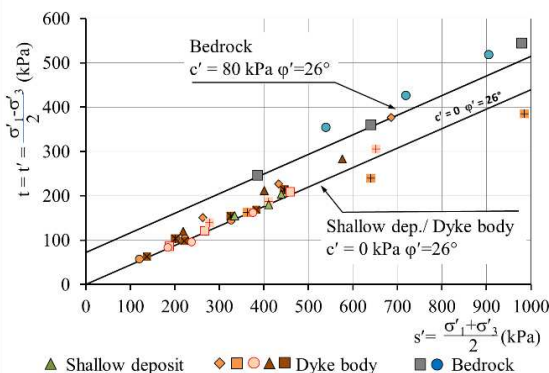
Effective shear strength have been evaluated by drained (TRX-CD) and undrained (TRX-CU) triaxial tests. Figure 8 shows the results of the tests in the plane of invariants. The estimated failure envelope for both the soils from the dyke and the shallow deposit can be described with a negligible effective cohesion and a friction angle of 26°. For the bedrock, the failure envelope gives an effective cohesion of 80 kPa and a friction angle of 26°. Such values well compare with the typical figures of this soil formation (e.g. Segato et al., 2015; Ruggeri et al., 2016). The residual shear strength was estimated by shear testing, either direct or ring shear. Samples from shallow deposit exhibit a failure envelope with a negligible effective cohesion and a friction angle ranging from 14 to 18°. Failure envelope for bedrock shows again negligible cohesion but a friction angle of 18°. This difference reflects those of the index properties between the two soils.

Figure 8. Failure envelopes from Triaxial Tests

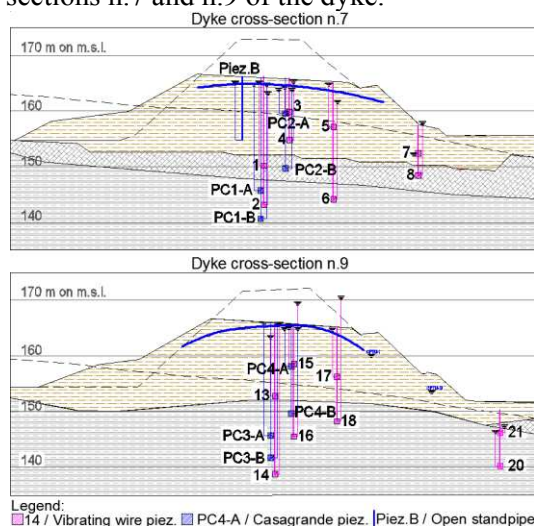
Figure 9. After collapse piezometric heads along cross sections n.7 and n.9 in Figure 4

The embankment is today fully saturated, and pore-pressures are significant both in the lower part of the dyke and in the ground. It is worth noting that two piezometers indicate that the piezometric level is well above the current crest.
