Assessment of peat slides and failure mechanism of blanket peat at Flughland, Ireland

P. Jennings & G Kane

Fehily Timoney & Company, Bagenalstown, Ireland. Formerly Applied Ground Engineering Consultants Ltd (AGEC), Bagenalstown, Ireland

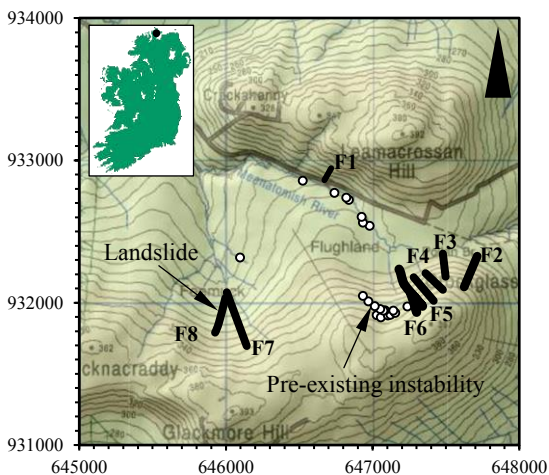
Figure 1. Topographical location of site showing landslide locations (base GSI, 2018)

There were no previous landslides recorded in the area (GSI, 2018). Nevertheless, inspection of the site showed pre-existing instability, such as pre-existing tension cracks, slumps, partially displaced peat likely representing re-activated relict failures (Figure 1).

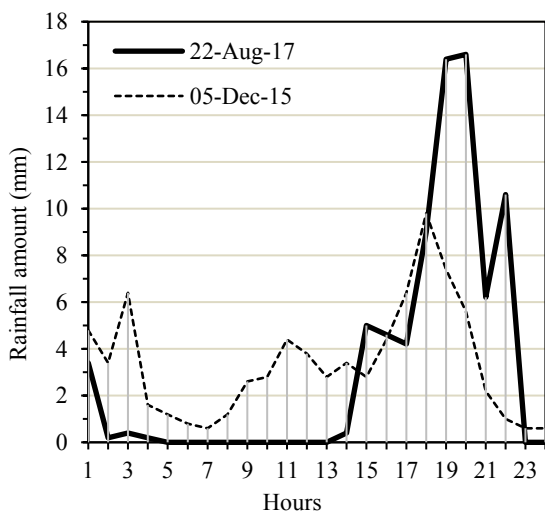
A comparison with the highest daily recorded rainfall at the station (80.6mm on 5 December 2015 during storm Desmond), in which no landslides were recorded in the area, is shown in Figure 2. The comparison shows that the hourly rainfall intensity on 22 August 2017 was notably

On 22 August, about 50mm fell in a 4-hour period. The hourly rates from 19 to 20:00 hours of 16.4 and 16.6mm/hr were the highest recorded at the station (since hourly records started in 1988) with the next highest falling a few days before on 17 August 2017. Clearly, the short-duration rainfall intensity was significant in initiating landsliding.

Figure 2. Hourly rainfall data (Met Eireann, 2018)

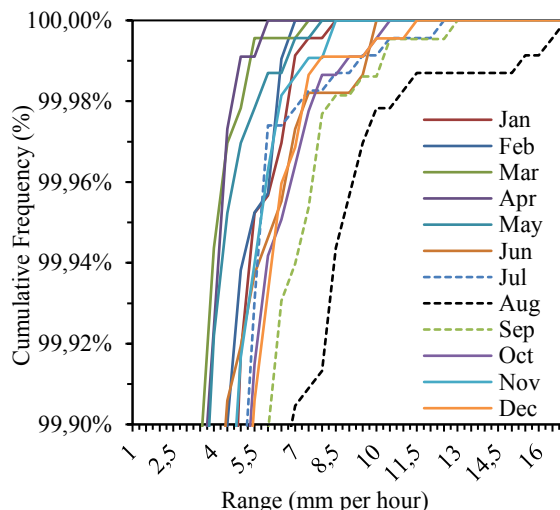
In north Co. Donegal the monthly rainfall averages vary from about 60 to 120mm, with broadly more rainfall occurring in the months October to January. However, rainfall intensity (mm/hr) is greatest from July to September. The higher intensity hourly rainfall amounts per month over about a 30-year period are shown in Figure 3, which clearly shows that August has a notably greater intensity of hourly rainfall; though the probability of such rainfall intensity is very low.

Figure 3. Hourly rainfall intensity for each month for 30-year period (Met Eireann, 2018)

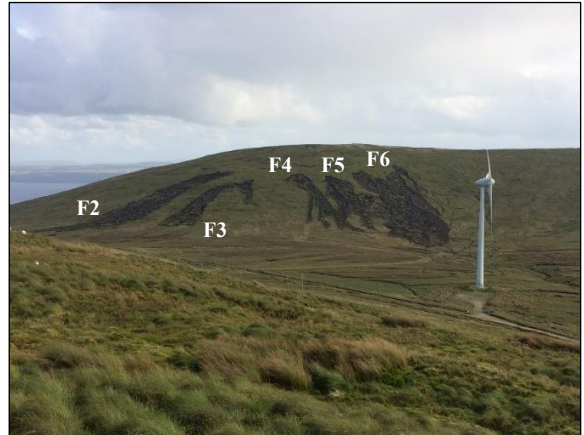
The landslides were clustered, and in some cases, there was little intact ground between

landslides (F2 to F6) see Figure 4. Landslide F1 blocked the local road, the remaining landslides occurred in open country and had no impact on infrastructure.

Figure 4 General view of landslides F2 to F6

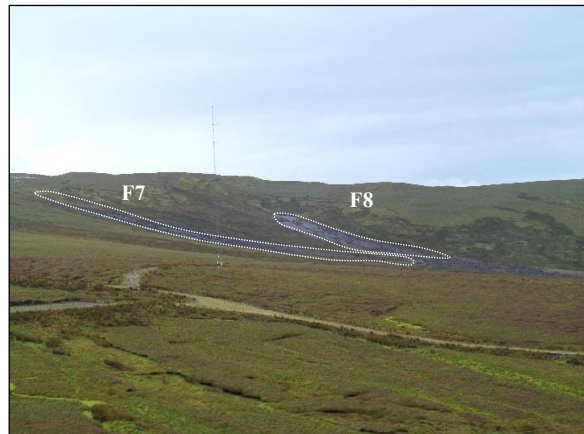
F7 and F8 occurred in the headwaters of streams within notably open and relatively uniform slopes with gentle gradients (less than about 10 degrees), see Figure 5.

Figure 5 General view of landslides F7 to F8)

- (6) Beyond the areas of recent landsliding there were signs of partial reactivation of pre-existing instability, such as multiple tension cracks (Figures 1 and 5). The failure mechanism that initiated this instability was undoubtedly similar to the above, but there was insufficient destabilising forces to cause full mobilisation of the peat. It is uncertain to what extent this relict instability existed prior to the recent rainfall event. In the face of a similar rainfall event, the presence of particularly pre-existing tension cracks could facilitate slope drainage and mitigate against potential build-up of excess groundwater, which could act to reduce the occurrence of similar rainfall-induced landslides. The presence of tension cracks though could increase erosion of the blanket peat.

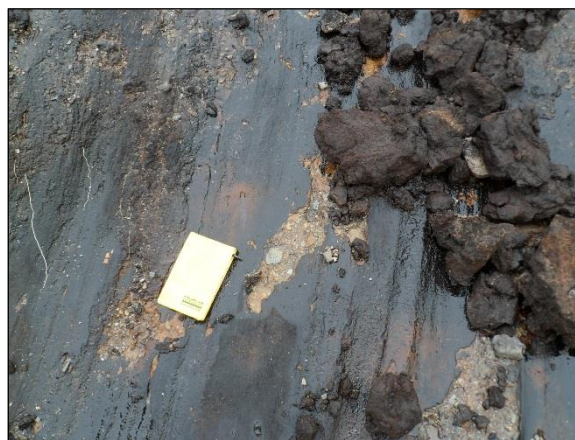
At a number of the landslides, the basal surface comprised a discrete black hard pan layer at the interface of the peat and underlying glacial soil (Figure 6). This layer was likely an accumulation of soluble humic colloids leached over time from the peat above and cemented to the underlying soil. The layer provided a discrete plane of sliding

and was essentially impervious and acted as an aquiclude. A similar hard pan was noted at the site of rain-induced peat slides at Polltomish in 2003 (Boylan et al, 2008).

Figure 6. Black hard pan below failed peat (F2)
