# Investigation into the likely cause of peat failure at Ballincollig Hill Wind Farm, Ireland

G. Kane<sup>+</sup>\*, R. Grennan\* & P. Jennings<sup>+</sup>\*

<sup>+</sup>*Fehily Timoney & Company, Bagenalstown, Ireland*

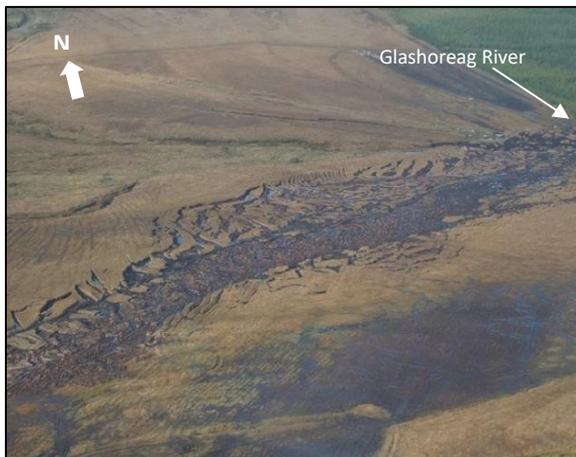
As a result of the failure a considerable volume of peat was displaced downslope (Figure 1) and entered the Glashoreag River.

Figure 1. Movement of peat towards the Glashoreag River

Machine cuts were recorded in the peat surrounding the failure scar, and at the failure head there were multiple cuts on the southern side indicating multiple phases of cutting. Survey information of the failure scar showed that the approximate volume of peat displaced was 120,000m<sup>3</sup> with an estimated 63,000m<sup>3</sup> entering the Glashoreag River.

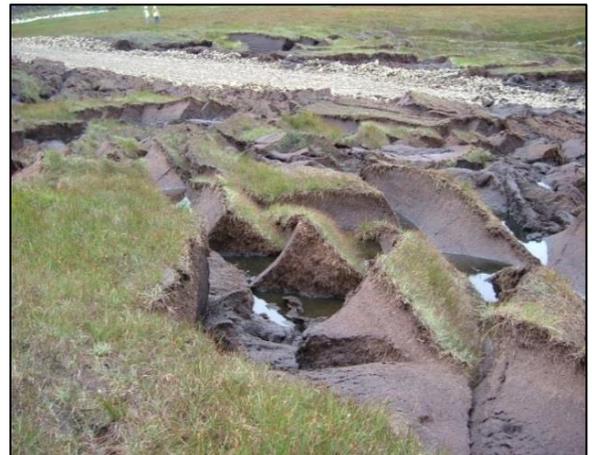
The failure scar was essentially rectangular in plan, measuring about 520m in length and varying between 50 to 100m in width. The shape of the failure scar was controlled to a large extent by the mechanical cuts which were formed during previous operations for turf production. Blanket peat in the north of the failure scar detached along the lines from mechanical cuts and moved as strips or rafts of peat (Figure 1 and 2). There were several locations along the failure scar where the peat debris accumulated on the intact peat.

Figure 2. Detachment of peat into strips along mechanical cuts

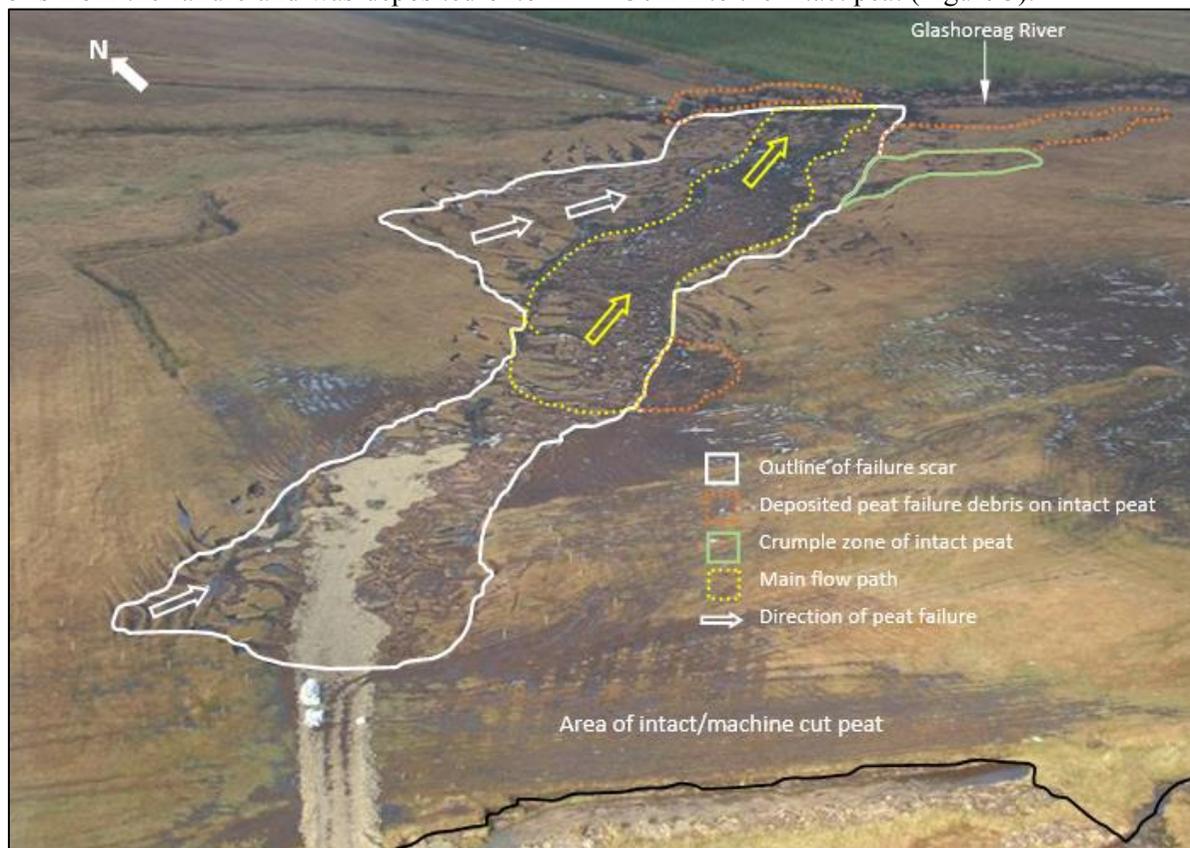
tact peat along the perimeter of the failure, including where the scar meets the Glashoreag River. On the southern side of the failure, upslope from an elongated debris deposit, there was a crumpled zone extending approximately 30m into the intact peat (Figure 3).

Figure 3. Morphological elements of the Ballincollig Hill failure

The crumpled zone represents the pressure or impact of the peat debris during the failure event.

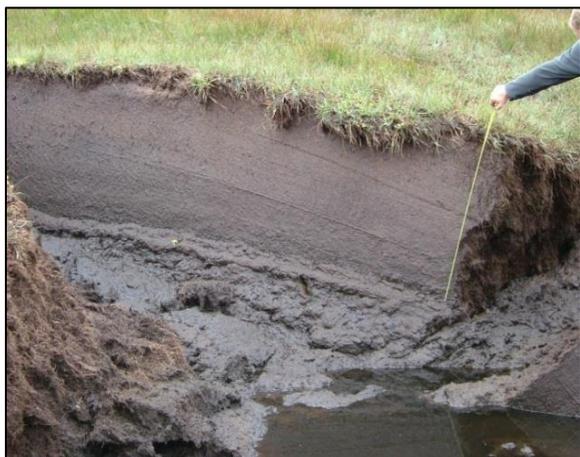
From examination of exposures, the failure appeared to have occurred about 100 to 200mm above the base of the peat and not at the peat/mineral soil interface or within the mineral soil. Following inspection of the site around the failure scar the thickness of peat varied from about 2.5 to 3m, the upper 1 to 1.5m consisted of fibrous peat (acrotelm) overlying humified peat (catotelm) (Figure 4). Typically, the in-situ undrained shear strength of the acrotelm varied

between 5 to 40kPa, while the catotelm undrained shear strength varied between 2.5 and 6kPa. It should be noted that in-situ field vane testing of peat, particularly within fibrous peat, can give an overestimated strength (Dykes and Jennings, 2008).

Figure 4. Typical composition of peat viewed from detached peat strips

The blanket peat was described as very soft to soft fibrous in the upper 1.5m grading to amorphous peat with an increase in depth (Figure 4). At the location of the failure the thickness of peat varied from about 2.5 to 3m. To the south of the failure scar the peat deposits were between 1 and 4.5m thick. The Von Post humification grading for the upper 1.5m of peat was relatively fibrous (humification of H3 to H5) with decreasing fibre content with depth (humification up to H8).

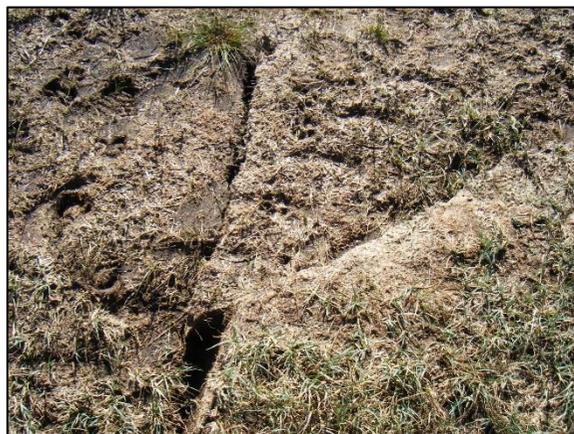
There was evidence of multiple phases of mechanical cuts in part of the bog surrounding the failure scar (Figure 5).

The mechanical cuts were about 1 to 1.5m deep and severed the acrotelm layer (upper fibrous layer) of the peat where most of the intrinsic (tensile) strength of the peat lies.

Due to the multitude of mechanical cuts it is likely that rainfall accumulated in the cuts and was prevented from draining away effectively which resulted in softening of the peat and a reduction in the undrained shear strength. Water retention within the cuts would have led to a lateral force being exerted onto adjacent peat and a resulting lateral displacement of the peat.

ing introduced into the bog. Water retention within the mechanical cuts would have occurred particularly where the orientation of the cuts were parallel to the slope contours (i.e. cuts were across the slope).

Figure 5. Multiple machine cuts in intact surface of peat

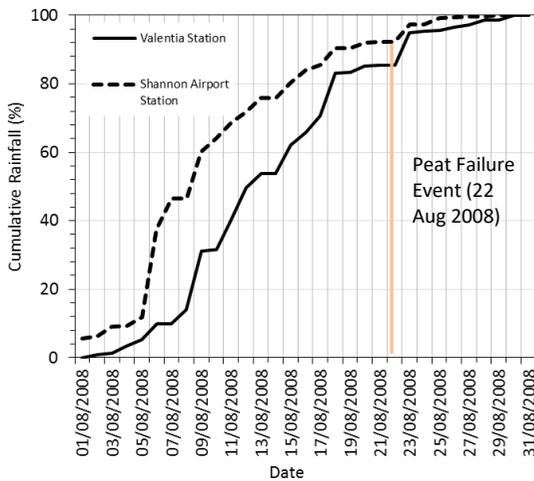
The antecedent rainfall during the first 21 days of August corresponded to about 90% of the total rainfall for the month and significantly occurred prior to the peat failure. This is highlighted in Figure 6 which shows the cumulative rainfall from both weather stations for the month of August in 2008. The significant rainfall before the peat failure would have resulted in a

significant amount of water being retained within the mechanical cuts made during the peat harvesting operations.

Figure 6. Rainfall records for the month of August 2008 (Met Éireann, 2018)
