# Geological-geotechnical characterization of a deep-seated landslide affecting a road-bridge in Alcoy (southeastern Spain)

J.L. Pastor, R. Tomás, A. Riquelme, M. Cano  
*University of Alicante, Alicante, Spain*

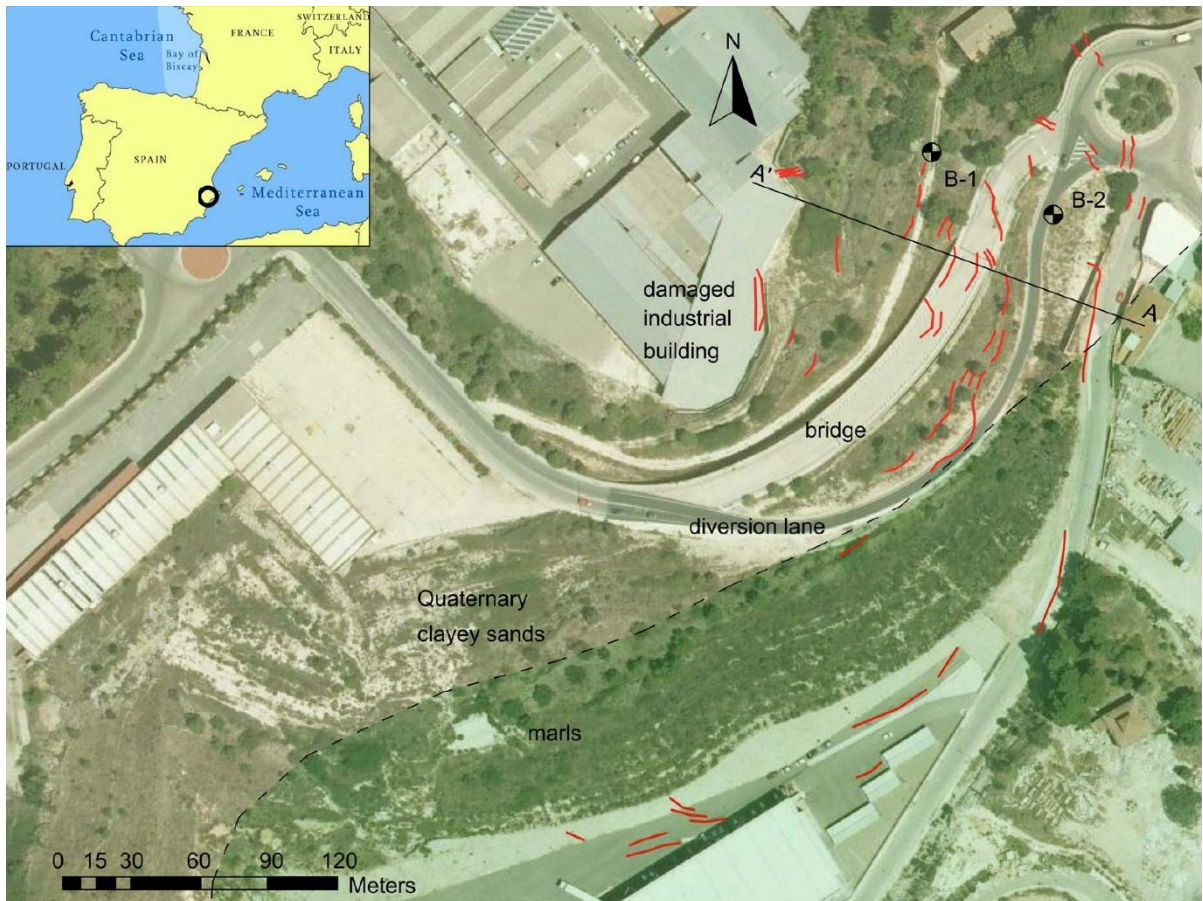
The spatial distribution of these layers is shown in Figure 1. It can be seen that the Quaternary deposits are located from the toe to the centre of the slope, whilst the marls are located from the centre to the top.

Figure 1. Geological and crack's distribution map of the study area and location of boreholes B-1 and B-2.

The tension cracks observed during the visual inspections of the slope and the nearby area are shown in Figure 1. A large number of tension cracks were detected near the north abutment of the bridge and between the bridge and the diversion line built after the damage caused by the landslide. Some cracks were also observed at the toe of the slope, by the damage industrial building, and at the top, on the edge of the access road to the industrial building located at the bottom of Figure 1.

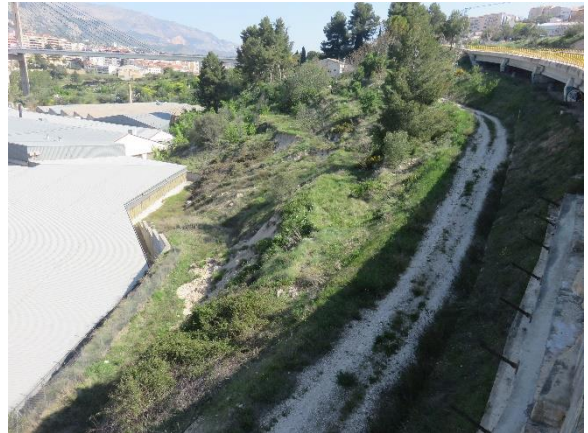
Figure 3 shows a general view of the damaged industrial building located at the toe of the slope (bottom left of the figure) and the bridge (top right of the figure) from the left side of the slope.

Figure 3. General view of the slope.

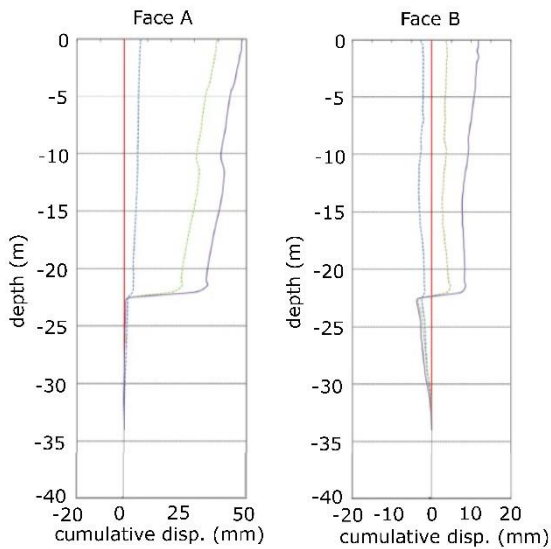
According to the information provided by the two inclinometers, the sliding surface is located at a depth of 23 m in the inclinometer 1 and of 7 m in the inclinometer 2. The location of the inclinometer is shown in Figure 1. The recorded displacements of the inclinometer 1 from November 2012 to February 2013 are depicted in Figure 2.

Figure 2. Profile of the Inclinator 1.

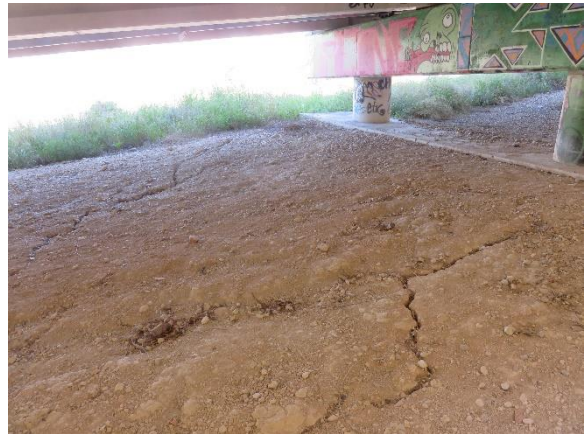
Two tension cracks located near the north abutment on the soil surface below the bridge are shown in Figure 4. The landslide has affected the bridge in such an extent that some of the precast beams have been displaced out from its elastomeric bearing pads. The displacements of the outside precast beams have broken the seismic shear keys of the bridge, Figure 5. All this damage alongside the active instability has ended in rendering the bridge unusable.

Figure 4. Tension cracks on the soil surface below the bridge

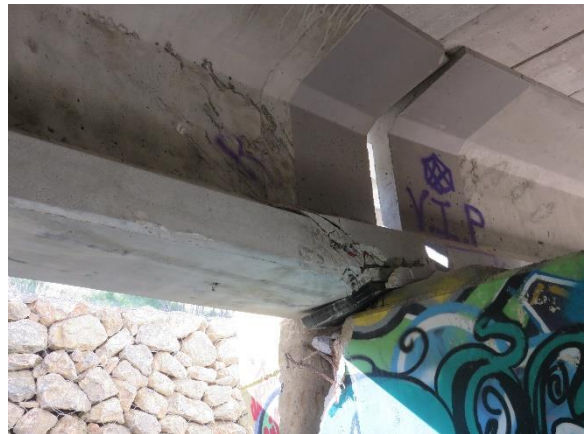
Figure 5. Damaged precast beam. Note the state of the neoprene bearing pad.

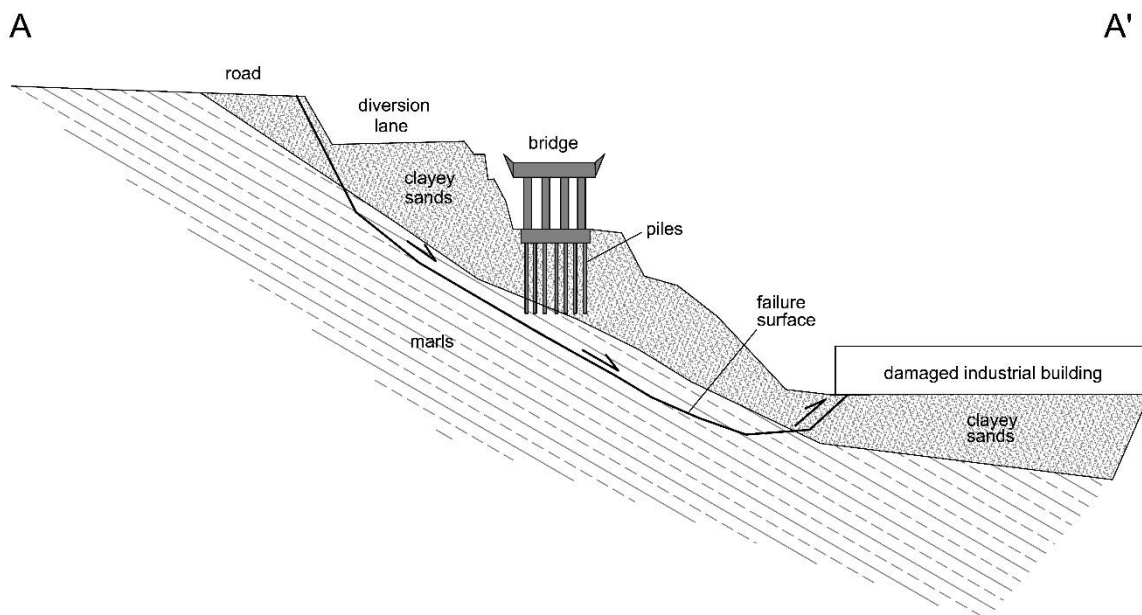
The information provided by the geophysical investigation along with the information obtained from the inclinometers have allowed to define the failure surface of this deep-seated rotational landslide, which is shown in figure 6.

Figure 6. Cross section AA' with the estimated failure surface.
