Damage assessment within the Kathmandu valley's World Heritage Monument Zones after 2015 Gorkha Earthquake

A. Kumar

Keywords: Nepal Earthquake; damage; liquefaction; heritage; monuments; forensic engineering

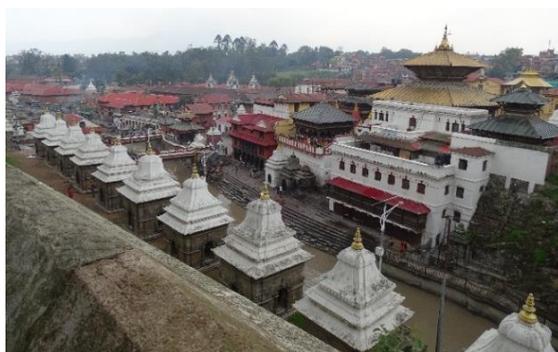
Figure 9. View of Pashupati temple region three years after 2015 Gorkha earthquake

Field reconnaissance was performed to study the damage patterns of the ancient structures near the Pashupatinath Temple complex and nearby Changu Narayan temple during the last week of May 2018. Symmetrical geometric configuration was the main feature of these ancient structures as shown in Figure 9. Brick masonry walls act as a load-bearing system where wall thickness varies between walls on different stories. Inclined timber struts transfer the roof loads from tiled roofs to the masonry walls. It is important to note that these temples have already survived the 1934 Nepal-Bihar Earthquake ($M_w=8.1$), the 1988 Udaypur Earthquake ($M_w=6.9$) and the 2011 Sikkim-Nepal Earthquake ($M_w=6.9$). During post-earthquake reconnaissance surveys conducted in 2015, minor to serious levels of damage were identified in most of the structures surveyed. Most of this has been attributed to age related deterioration of construction materials and also the lack of regular maintenance; however the rehabilitated strength of these temples is yet to be established. Diagonal and vertical line cracks near the corners of the masonry walls, cracks in the crown portion of the temples and the out-of-plane collapse of masonry walls were the main damage mechanism observed during the survey conducted in 2018. Figure 10 illustrates the out-of-plane collapse of an unreinforced masonry wall of a courtyard building located south-west of the main Pashupati temple complex. This may be mainly due to the inability of the mud mortar present in the masonry walls to resist the lateral forces induced by the Gorkha Earthquake. Inspection within the building revealed vertical cracks in

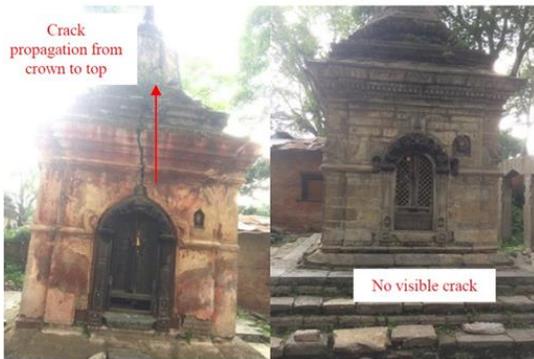
Figure 11 View of visible crack in a temple made of brick masonry and no such crack in a stone temple.

many masonry wall panels. Such level of cracking is difficult to repair and requires rebuilding parts of the wall. Figure 11 highlights a wide visible crack in the crown portion of a brick masonry temple located 300 m north of the main Pashupatinath temple complex. This damage pattern is attributed to stress concentration near the crown portion of the temples and their inability to bear bending stress induced during seismic shaking.
