Scour, Settlement & Stabilisation of Linton Bridge

A. Willoner

Mott MacDonald, Sheffield, UK

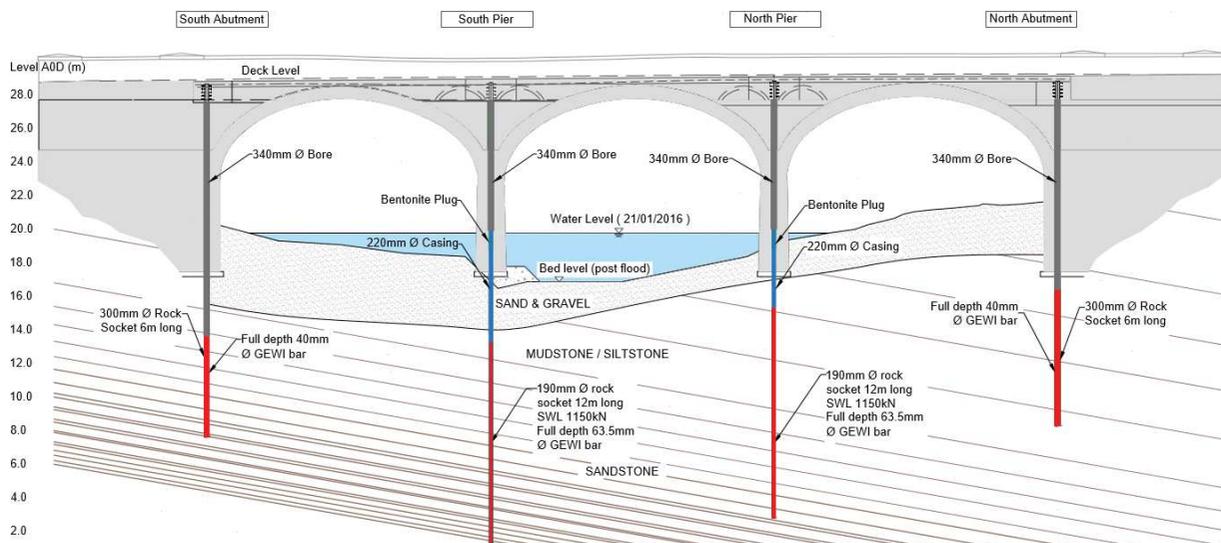
Figure 2. Geotechnical long section

The most significant geotechnical information regarding scour risk was the discovery that the south pier was founded on 2.75m of granular alluvium and the north pier on or close to rockhead (Figure 2).

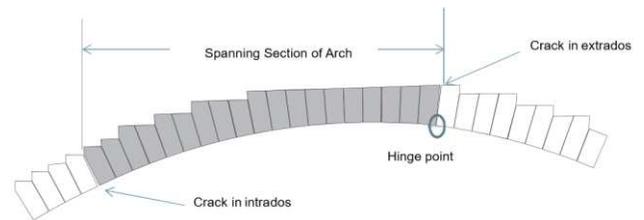
Figure 5. Diagram illustrating flattening of arch

The shaded voussoirs have rotated around a hinge point in the intrados at the south end. The settlement of the south pier to the left of the grey blocks opened up the transverse crack across the arch. The cracks in the intrados and extrados indicates that compression in the arch is lost. The assessment assumed that there would be reflective cracks on the extrados of the arches and this was confirmed when the south and central arches were exposed. Two large transverse cracks on the extrados of the central arch and small cracks on the south arch were observed beneath the carriage. Due to the twisting nature of the deformation, the south arch closed up on the extrados whilst the central arch opened.

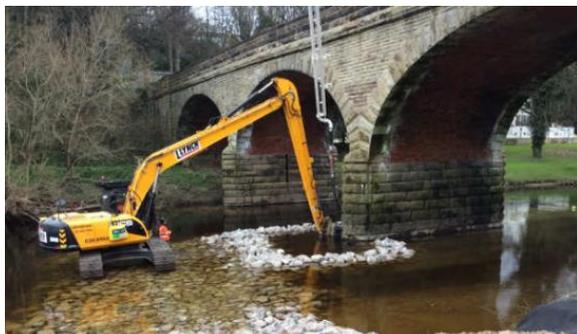
Figure 6. Emergency underpinning of south pier

Following the underpinning, it was considered safe to carry out a dive survey beneath the central arch where the crack through the barrel arch was narrow relative to the southern arch. The diver's records revealed a worrying picture of jostled stones and voids beneath the south pier. The sonar bed survey undertaken in January 2016 shows river bed scour between 200 and 1800mm relative to levels recorded in September 2015.

The primary cause of damage is clearly scour of the river bed and the distribution of concentrated scour was in the deepest part of the channel where flows were fastest and where vulnerable granular foundation soils were located.

Discussion with the Environment Agency enabled swift approval for a temporary stone causeway, underpinning the south pier with 18m³ of underwater concrete and placement of rock armor (Figure 6).

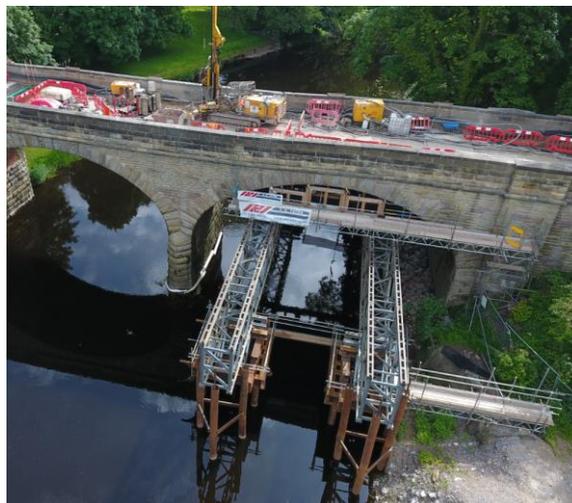
Figure 7. Temporary underbridge support

The temporary foundation solution, designed by Bam Nuttall Technical Services, comprised tubular steel piles driven at a safe distance from the bridge with compressed air flush. Pontoons were used to float temporary steel beams under the bridge before lifting them and the falsework onto the piles. Jacking support had to be in contact with the arch but it was important that the arch was not inadvertently lifted by over-jacking,

therefore grout socks were positioned at the top of the arch support which was then jacked to within 50mm of the arch and the grout socks slowly pumped to sufficient pressure to evenly support the undulating intrados without lifting the arch.
