# Sigalda dam leakage – a 40-year review

Vilbergur Kristinsson-Project Manager Dam Monitoring  
*Landsvirkjun, National Power Company of Iceland*

**ABSTRACT:** The Sigalda dam on the Tungnaá river in Iceland is a 44-m high asphalt faced rockfill dam. The volume of the associated reservoir is 195 million m<sup>3</sup>. The dam is founded partly on hyaloclastite volcanic rocks, (*moberg* in Icelandic) and to large extent on pervious postglacial lava flows. One of the reservoir abutments consist also of thin lava flows with pervious interbeds. Construction of Sigalda rock-fill dam was started late in the year 1973 and completed in late 1975. During first impounding of the reservoir in August 1976, leakage from the reservoir was much more than had been expected, and water entered the dam body from the pervious lava flows abutment causing high pore pressure in the rockfill body. Thus, impounding had to be stopped and the reservoir could not be filled completely, even if electricity generation could commence in the connected Sigalda Hydropower Plant. After several attempts to reduce the leakage during the first years of operation, the reservoir could be filled to spillway level. Since

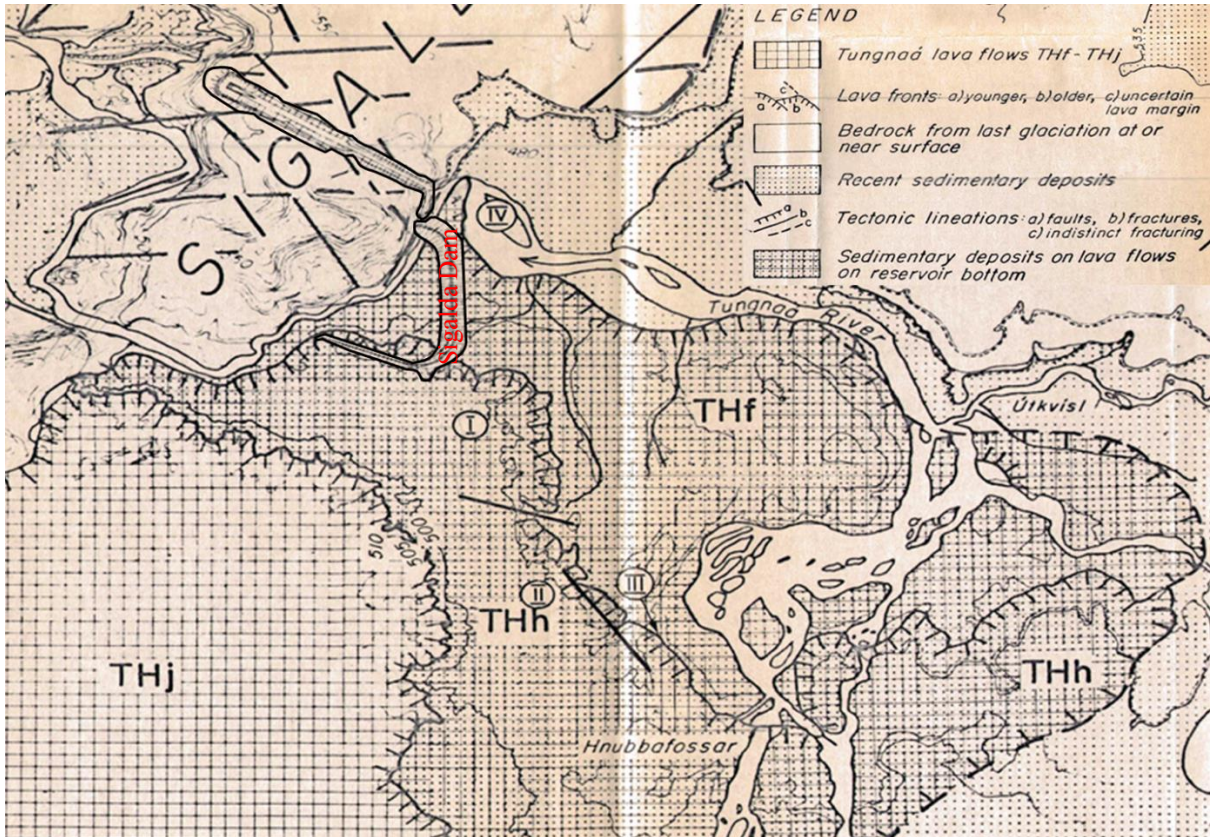
Figure 2. Geological map of the Sigalda dam and reservoir SW-rim

The Sigalda dam is founded on hyaloclastite rock (moberg in Icelandic) on the right abutment and the postglacial (4000-7000 years old) Tungnaá lava flows under the main dam body and on the left abutment, Figure 2. The reservoir abuts up to four of the Tungnaá lava flows with pervious interbeds.

At the time of construction, the reservoir was considered to be a reconstruction of an ancient lake emptied some 3000 years ago. The top lava flows were reported as very fissured with some deep depressions down to ground water level. However, the lava flows were believed to be filled with diatomaceous earth, ash and alluvial material from the ancient lake (R. Thorlaksson et al.). Some of the ancient sealing was reported to be eroded and needed re-sealing.

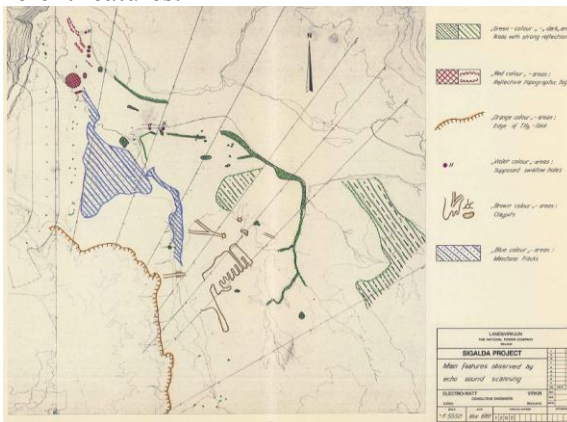
Figure 3: Typical results of side-scan survey

After the fourth filling, the bottom of Sigalda reservoir was mapped with a side-scan survey carried out by the Icelandic Marine Research Institute MRI (Kjartan Thors and co-workers). The aim of the survey was to see if the Sigalda reservoir bottom exhibited localised signs of leakage. Such signs were expected to be in the form of holes, coarse sediments or solid rock at the bottom. The side-scan sonar distinguishes such features well, as they are very reflective and give a strong, dark response on sonographs.

Because the topography of the reservoir bottom was very well known, the map from the MRI therefore emphasized features that were different from existing maps and aerial photos.

Figure 3 shows typical results of the side-scan survey. Different colours are used to describe different features.

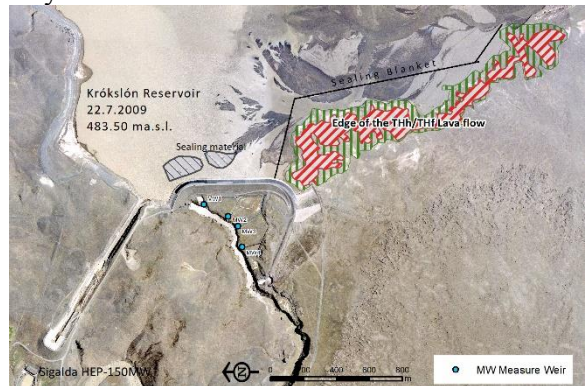
Figure 4: Reservoir bottom areas sealed in 1977-82. Areas sealed in 1981-82 with a barge are upstream of dam. Leakage monitoring weirs downstream of the dam are shown with green dots.

After the first two filling and emptying of the reservoir in 1976, the main concern was safety of the dam body. Thus mitigation measures were directed at ensuring its safety by excavation of drainage ditches at the dam toe and install toe drain rock fill with a drainage pipe. After the third filling, sealing of the reservoir bottom was started by placement of a sealing blanket of about 100.000 m<sup>2</sup> on the edge of the THh lava flow at elevation 485-491 m, Figure 4. Simultaneously, the river course, where the ancient fine material was eroded, was covered with 0,5 m thick clay layer.

After the fifth filling attempt in 1978 some 70 swallow holes at the reservoir rim were filled with sand and gravel.

In the spring of 1979 (after the 6th filling attempt), a dredging barge was used to dredge sand and gravel and dump over suspected leakage areas at the reservoir bottom. A total of 60.000 m<sup>3</sup> were dumped covering an area of about 40.000 m<sup>2</sup>.

After the 7th filling attempt in the summer of 1979, the reservoir was lowered to 485 m and leakage areas covered with filter fabric, sand and gravel. A total of 2500 m<sup>2</sup> of the THh lava edge between elevation 491-495 m was covered in this way.

After identifying leakage spots by tracer tests in 1980-81, a self propelled, splitted, 150 m<sup>3</sup> capacity barge was brought to the reservoir. The barge was used to dump moberg (hyaloclastite rock material) followed by dumping sand into areas previously identified by tracer tests as suspected leakage areas, shown as two area just upstream of the Sigalda dam on Figure 4. The sealing works were executed during August-October 1981 and June-August 1982. The areas were covered by 2 m thick moberg and 1 m thick sand. Total areas covered were 55,390 m<sup>2</sup>. A tracing test on the sealing carpet showed that the carpet was effective and the turbidity measured in leakage water reduced after placement of the carpet. A typical turbidity in reservoir water over the summer time is shown on Figure 5.

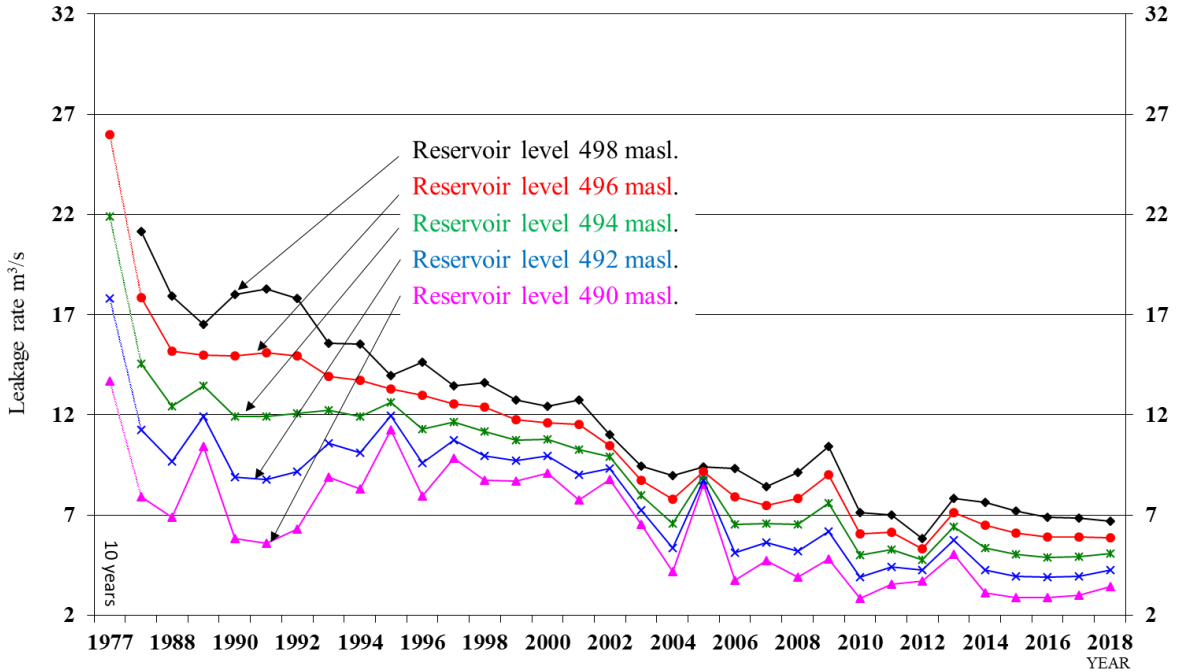
Figure 9: Total leakage from the reservoir during 1977-2018. Note: first interval shows 10 years

The Sigalda HEP was commissioned in 1978. During filling of the reservoir, leakage from the reservoir turned out to be much more than was expected. First mitigation measures concentrated on securing the safety of the Sigalda dam, followed by several seasons of reservoir sealing measures. Most effective sealing material was the moberg rock material (ripped pillow lava containing significant sand fraction). The reservoir could be filled to spillway crest in 1980. The sealing measures were successful in reducing the leakage significantly and in the 40 years of operation, the glacial river water has continued to fill voids in the lava flows abutting the reservoir. Thus, the leakage has been gradually reduced from more than 20 m<sup>3</sup>/sec. to about 6 m<sup>3</sup>/sec. in the last 40 years.
