Slope stability aspects for municipal waste landfills. Case studies and numerical modelling

L. Batali

Technical University of Civil Engineering Bucharest, Romania

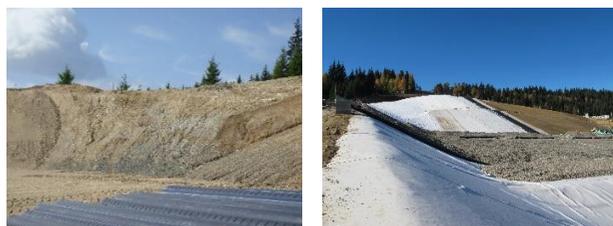
Figure 2 (left) shows the case of a new landfill, under construction at the time the photo has been taken, with too steep slope for the cells, of 2:3 (V:H), for 28 m in height and 60 m slope length. A simple stability analysis for the drainage layer on this slope showed the following:

- for dry conditions the safety factor was $F_s = 1.22$,
- for horizontal seepage, $F_s = 0.92$, unstable
- for seismic conditions, $F_s = 0.96$, unstable
- for construction equipment up slope in dry conditions, $F_s = 1.22$,
- for equipment up slope + horizontal seepage, $F_s = 0.95$, unstable

- for equipment down the slope, $F_s = 1.16$.

Figure 2. Example 2 – new landfill – improper design of the side slopes without geotechnical calculations – before (left) and after remodelling (right)

Also, the geocomposite clay liner to be installed on this slope was tensioned with 85 kN/m, above its tensile strength. Therefore, the slope was remodelled to a less steep inclination (1:3 V:H) and by introducing a berm and a veneer reinforcement by geogrid in the drainage layer (Figure 2 - right).

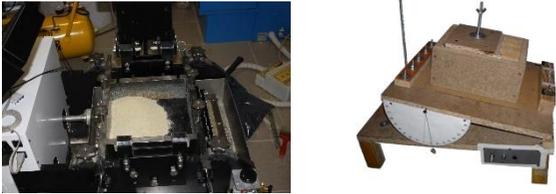
Shear tests have been performed at the interface between the various materials in contact (shear box and inclined plane – Figure 4), the results showing that the friction angles varied between 14° and 19° (for 18° slope inclination). The tensile force to be overtaken by the drainage geocomposite (108 kN/m) was far

beyond its strength, leading to the observed rupture. But also, it has been found that the geomembrane was textured on only one face and had very heterogeneous roughness and that the drainage geocomposite has a too low peel strength and non-homogeneous bonding between the components (Figure 5).

Figure 4. Example 3 – shear tests at interface (Batali et al, 2014)

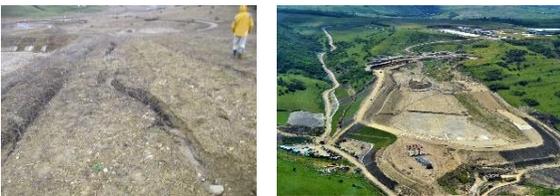
Figure 6 (left) shows another example of improper design, but also improper execution, this time for the dikes of a new landfill, which have been built using inadequate materials (local clays) and without proper compaction, which eventually led to failure of the dikes. The dikes had to be demolished and re-built using the local soil improved by mixing with hydraulic binders (fly ash and lime) (Figure 6 right).

Figure 6. Example 4 – new landfill – improper design and execution of the dikes (left), after reconstruction (right)

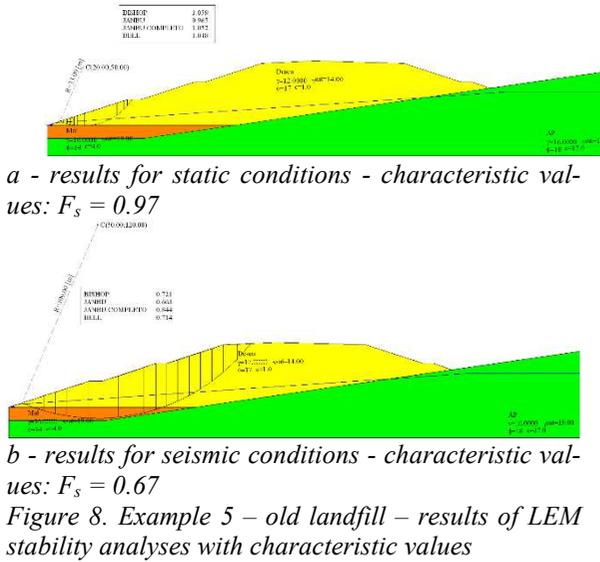
The forensic analysis carried out showed that the geotechnical investigation consisted of only a couple of boreholes of max. 6 m deep and disposed around the site, therefore no knowledge about the geotechnical characteristics of the site below the waste, no hydrogeological data and no slope stability analysis. Also, the landfill had no drainage system, thus the leachate accumulated within the waste mass, leading to the instability phenomenon. A new, proper, geotechnical investigation allow to carry out slope stability analysis. The waste geotechnical characteristics ($\phi = 17^\circ$, $c = 0$ kPa) have been chosen based on literature and by back – calculation such as obtaining a safety factor slightly less than 1 for the actual conditions. Figure 8 shows the LEM results for the actual situation in static and seismic conditions.

To be noted that the technical regulations recommend to check the stability also by superposing a high level of water and the seismic action. Also, to be noted that the failure surface in static conditions is in the waste mass, which corresponds to the observations on site after the landslide occurred, while for seismic conditions the critical failure surface is deeper caused by the presence of a muddy layer (deposited waste from waste water treatment plant) discovered during the final geotechnical investigation.

The stability analyses showed that the rise of the leachate level in absence of a drainage system, combined with an overcharge at the slope crest by an additional waste mass were the cause of this phenomenon. But, in fact, the lack of design and investigation can be considered to be the real cause. The landfill is now under consolidation works including pile retaining structure and a gabion retaining wall and drainage system.

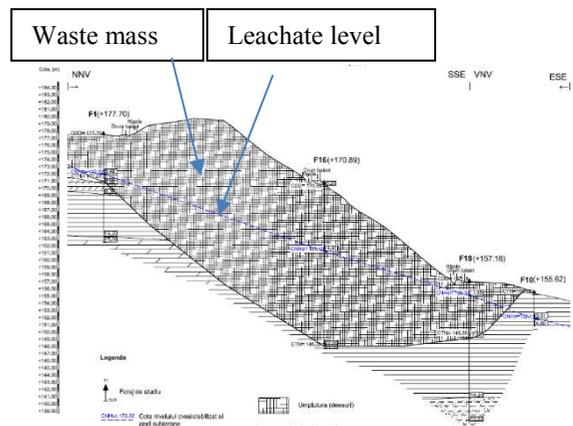
No geotechnical investigation has been carried out before the design of the closure, while the design was a typical one, according to the “recipe”, with no stability analysis. Geotechnical and hydro-geological investigations performed after the events on site showed that the waste layer was thicker than expected (up to 19.60 m) and an old man-made excavation filled with waste, having a maximum thickness of 19.6 m, was emphasized. The ground beneath the waste was a clay, sometimes silty, in saturated state, soft to stiff consistency. Figure 10 is showing a cross-section.

Figure 10. Case study – old landfill – cross-section

The leachate level was particularly high, varying between +0.24 m (above ground level) and -10.04 m (below ground level). It was supposed that the natural valleys existing on site were blocked by the waste, obstructing the natural water flow and producing accumulation of leachate. The permeability of the waste has been determined by 10 in situ tests.

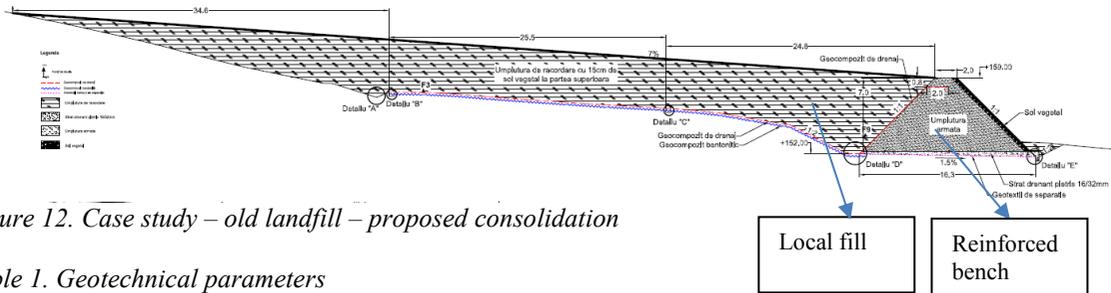
The conventional LEM stability analyses showed that the bench increases the stability of the landfill in seismic conditions to a safety factor slightly above the limit ($F_{smin} = 1.04$). Calculations have been carried out according to EN 1997-1 (Eurocode 7).

Figure 12. Case study – old landfill – proposed consolidation

Thus, it was proposed to consolidate the landfill in 2 main stages:

1. a drainage system - 6 vertical wells and 3 lines of drainage trenches - for lowering the leachate level to approx. +1.50 m above the ground level, level to be maintained min. 270 days, while monitoring the landfill settlements.

2. a mechanical consolidation for ensuring the required safety margin against failure in seismic conditions – a geosynthetic - reinforced soil bench disposed at slope toe (Figure 12).
