# The Älvkarleby Test Embankment Dam

**ABSTRACT:** The Älvkarleby test embankment dam was constructed as a large-scale physical model to investigate damage detection, mechanical behaviour and internal erosion of embankment dams under controlled conditions. Designed in accordance with Swedish dam safety guidelines, the 4 m-high dam incorporated intentional defects and was instrumented with a comprehensive suite of geotechnical and geophysical monitoring systems. The project aimed to evaluate the performance of these monitoring techniques, assess the dam's response to initial impoundment and cyclic reservoir level fluctuations, and examine the effectiveness of remedial grouting. The results demonstrated that traditional sensors effectively captured pore-pressure and deformation trends, while advanced monitoring methods, such as 3D electrical resistivity tomography and distributed acoustic sensing, provided valuable insights into subsurface anomalies. The dismantling of the dam confirmed several of the monitoring-based observations, including the development of a preferential seepage path near the base of the core. The study highlighted the importance of integrating multiple monitori

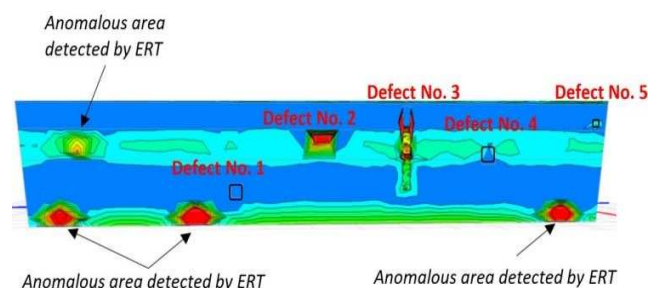
Figure 5. Example of result from ERT measurements viewed from the downstream side toward upstream side (opposite as shown in Figure 3) Although these signals were still under analysis.

Importantly, ERT monitoring successfully identified two of the five deliberately embedded core defects, namely the horizontal high-permeability layer in the central core (Defect No.2 in Figure 5) and the vertical gravel column (Defect No.4 in Figure 5). These features manifested as localised resistivity anomalies that were distinct from the natural background, although their positions were slightly displaced in the inversion images (Norooz et al., 2024). A third defect, the concrete block (Defect No.3 in Figure 5) intended to simulate a boulder, was only weakly indicated in the resistivity data as a moderately resistive zone and was not clearly resolved. The remaining defects, including the second horizontal layer near the abutment (Defect No.5 in Figure 5) and the wooden cube (Defect No.1 in Figure 5), were effectively undetected by ERT, probably because they did not generate a sufficiently strong resistivity contrast under the prevailing seepage conditions.

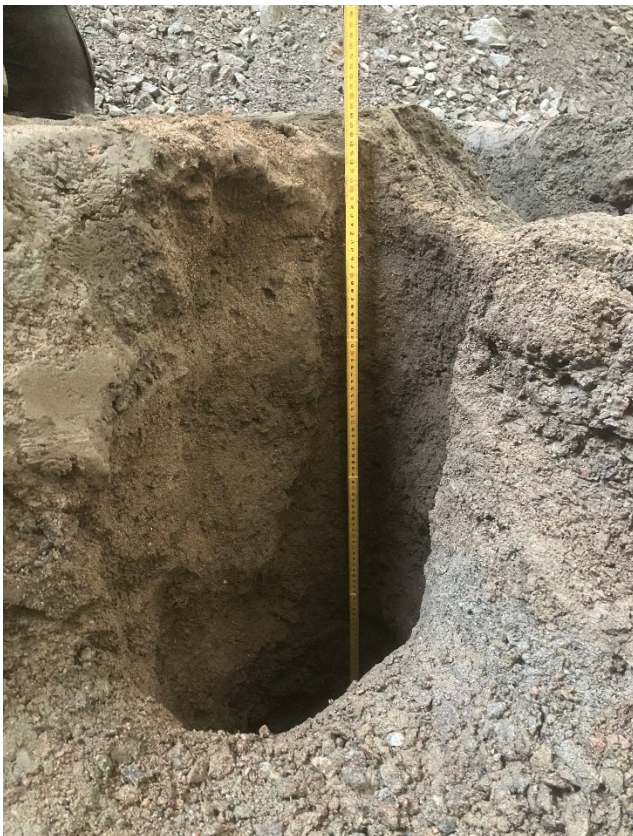
The sequential dismantling of the dam confirmed many of the predictions derived from the monitoring programme and also revealed some unexpected findings. All artificial defects were recovered at their intended locations, and the surrounding soil exhibited changes consistent with the recorded measurements. Notably, in the downstream half of the core near the base (approximately at the location of piezometer P3), the soil showed clear evidence of internal erosion. A subtle flow channel and deposits of transported fine material were observed, indicating enlargement of the originally placed loose zone between the core and the filter. This physical evidence corroborated the abnormally low pore-pressure readings and the slight increase in leakage turbidity measured after reservoir cycling, effectively demonstrating that a small internal pipe had begun to form along the core-filter interface at the foundation level, see Figure 6.

Internal erosion of the core soil was identified in several locations within the lower half of the dam. In particular, initiated internal erosion was found in between the core soil layers. The primary cause was most likely that the delivered core material was finer than anticipated in the design specifications. As a result, the fine filter material, although supplied according to design, was effectively too coarse to satisfy the required filter criterion for the actual core gradation. Additionally, the delivered core soil had an excessively high moisture content. Due to the onset of winter and project time constraints, the material had to be placed without adequate drying. This high moisture content prevented proper compaction, reducing the achieved density and increasing susceptibility to internal erosion. Despite these issues, no uncontrolled internal erosion occurred in the sense of a progressing pipe or breach. The eroded fines were successfully retained within the filter zones, and the overall integrity of the dam remained uncompromised.

Figure 6. Eroded core soil removed, leaving the intact core soil in place during dismantling. Damage ~120 cm deep with an estimated volume of 300 litres.
